City of Raleigh Parks and Recreation

Chapter 6 | Appendices

City of Raleigh Parks Observation Site Analysis

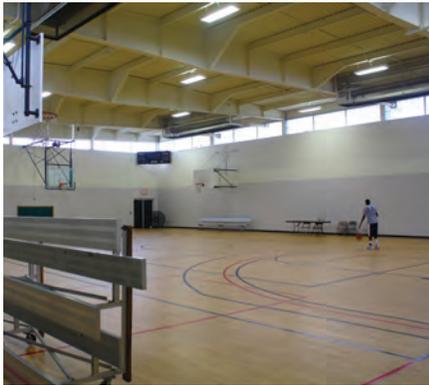
Park is heavily used and programmed. Open views from most directions promote a feeling of safety. Hardscapes are cracked/ uneven while Community Center is older but well maintained. Exterior shelters are older and not well maintained. Landscape needs refreshing.

Topography limits stormwater treatment with direct runoff and closed system existing. Community Center has new energy efficient lighting and A/C. Transit access could be improved directly to park.

- Coordinate pool season with shelter needs for users
- Air-conditioning for Gym is not provided
- Landscaping is aged and lacks sustainable, low impact, yet hardy species

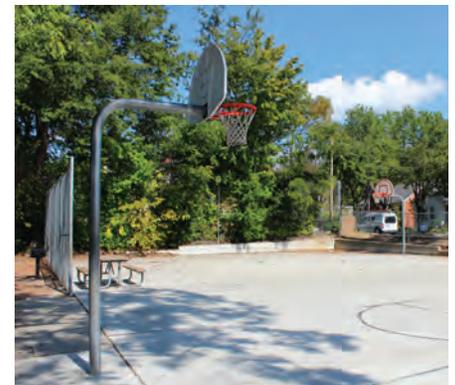
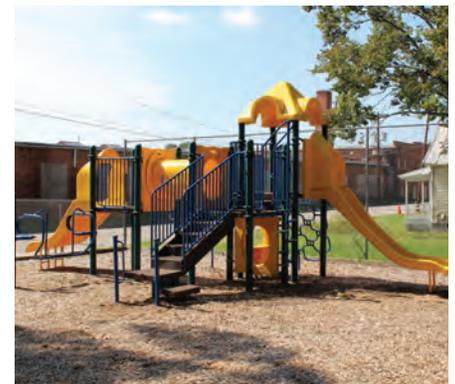
Park is heavily used with litter and evidence of loitering. Vacant buildings and few eyes on park limit feeling of safety. Pavement is old and crack with few seating options. Few stewardship techniques utilized.

Direct stormwater runoff to adjacent parcels, with limited space on site for treatment. Excellent multi-modal access with on-street parking, transit, cyclist access with potential for pedestrian access if sidewalk network is completed.

- Accessibility via sidewalk network to park is limited
- Increase active patrolling of park to discourage problematic loitering
- Hardscape surfaces are aged and cracked

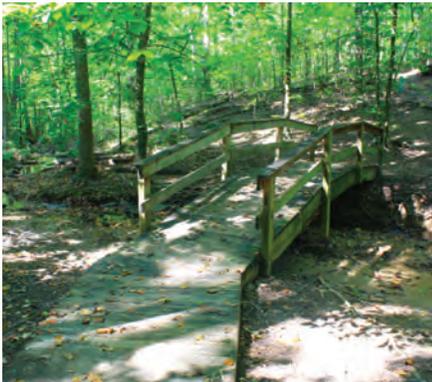
Care of park is not consistent with other parks. Natural vegetation hides developed areas of park from surveillance. Pavement is cracked and uneven throughout with limited seating options and a small shelter.

Parking utilizes solar lighting, however, poor multi-modal options requires parking for vehicles in a neighborhood area.

- Accessibility into park lacks clearly defined routes and sidewalks
- Trail hardscape (asphalt) is cracked and uneven
- Limited protection from weather for users by shelters

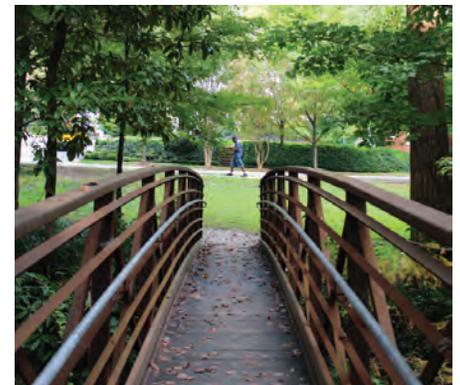
Park is well maintained, however, heavy vegetation creates secluded areas that are unsafe. Site has limited choices in seating and protection from weather. Evidence of stewardship through plantings and design is strong.

Stormwater is mostly treated on-site, however a stronger connection to nearby high school could still improve water quality opportunities. Lighting is provided by street lights.

- Promote multi-modal connection to park
- Increase connectivity to high school
- Protection from weather for users is lacking in park

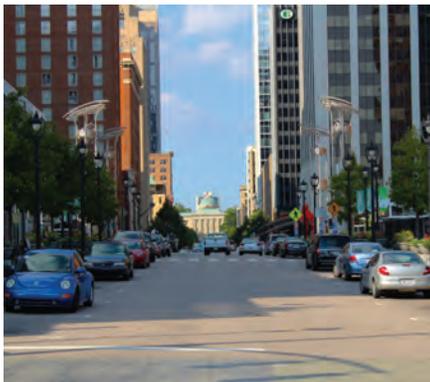
Space is heavily used and supports materials which will stand up to the daily wear and tear. Food is provided by local businesses along with protection from the weather as needed. Pavers limit use of sidewalk for setup of special events.

Semi-permeable pavers and sustainable species in street planters promote stewardship. Multi-modal transportation options increase accessibility to site.

- Replace subgrade of pavers with more stable choice to decrease maintenance
- Promote revenue generation uses along street with permitted uses

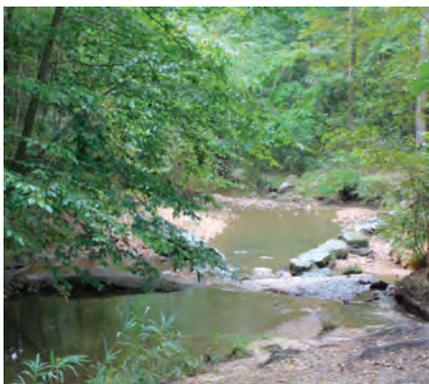
Kentwood Park is accessible via shaded sidewalks and nearby transit. Slopes within site may exceed accessibility limits. Signage standards are observed with clarity in identification of amenities and access.

Park offers multi-modal choice with nearby transit, but a relocated stop at park would improve function. Lighting and facilities are not energy efficient. Stormwater is untreated direct runoff throughout site.

- Energy efficiency with existing facilities is minimum
- Open space availability at park could be increased with multi-purpose space
- Vandalism present and existing structures are in poor condition

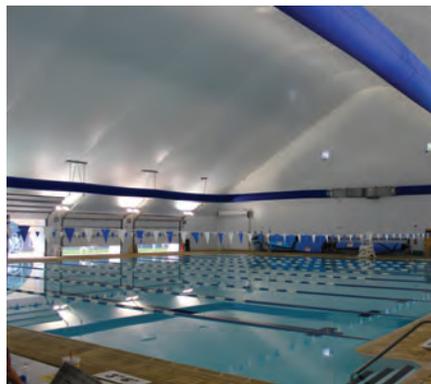
Adjacent fire station and high school create a co-location of infrastructure needs for the community. Stormwater treatment and energy efficiency is limited throughout site.

- Energy efficient lighting throughout park and facilities is minimum
- Crosswalks from transit stops are missing
- Flexibility of existing single-use facilities such as baseball fields minimum

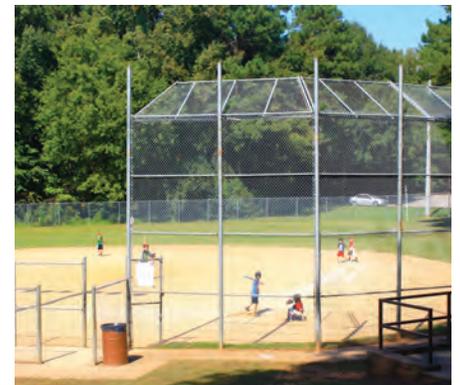
Topography and vegetation limit flexibility of spaces. Trail connectivity provides access from nearby neighborhoods. Stormwater runoff directly drains from site with little or no treatment.

- Pedestrian access and signage for park is minimum
- Stormwater treatment is minimum and erosion problems apparent

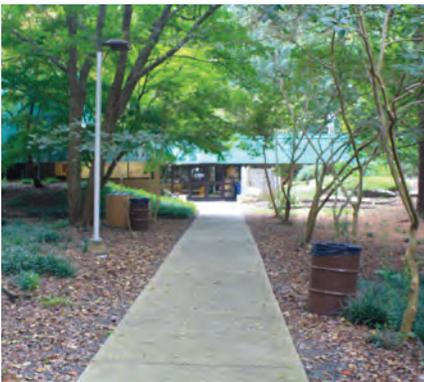
Location adjacent to high school promotes civic co-location of facilities. Charging stations for vehicles provided in parking lot. Stormwater is direct runoff and untreated for most of site.

- Sidewalk access into park is missing
- On-site water management and energy efficiency lacking
- Appropriate direct sidewalk access to high school property is missing

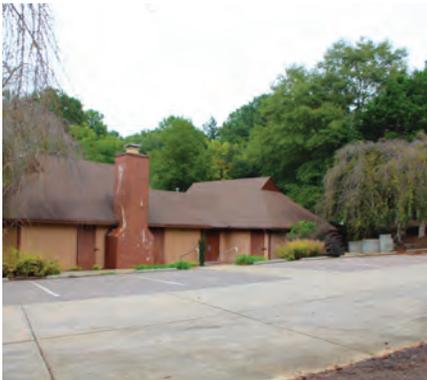
Stormwater is managed mostly on site with lake. Multi-modal is sufficient for most needs but is lacking in choices. Energy efficiency throughout site is needed.

- Programming is minimum while neighborhood center is closed
- Energy efficiency throughout site could be promoted
- Hardscape and landscape is in poor condition

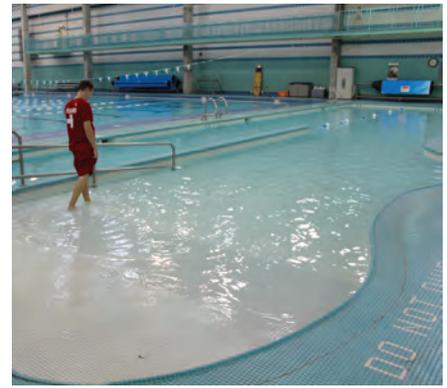
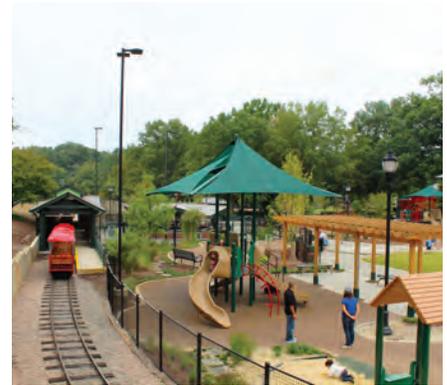
The park is well maintained and very clean throughout. Exterior and interior conditions are good with ample seating choices and protection from weather from multiple buildings and shelters.

Multi-modal access to the park is promoted. Stormwater management is mostly on-site and energy efficiency is minimum in several areas of the park. Co-location of multiple community centers creates a strong civic connection to the park.

- Natural areas of park near NC State Campus are minimally promoted
- Energy efficient lighting could be promoted throughout park
- Interior conditions at community center and aquatics center are poor

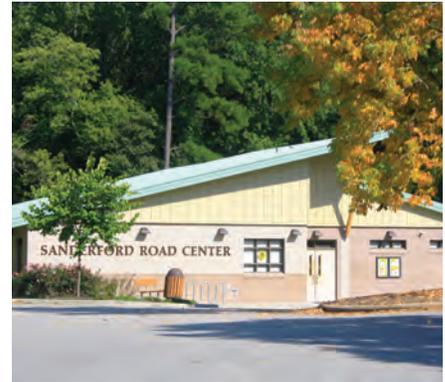
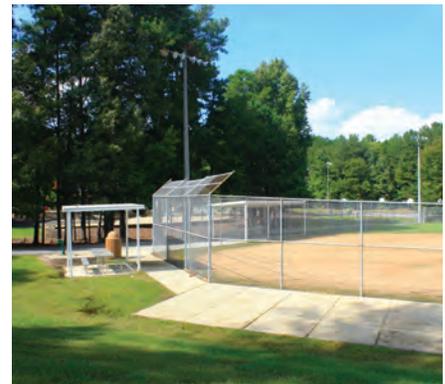
Stormwater is primarily direct runoff throughout site within limited treatment for water quality. Though lacking sidewalks, most users were walking in ditch to access park. LED lighting throughout park is efficient.

- Programming for elderly age group is minimum
- Border with residences is cluttered with unsafe access routes
- Direct sidewalk access into park along Sanderford Road is missing

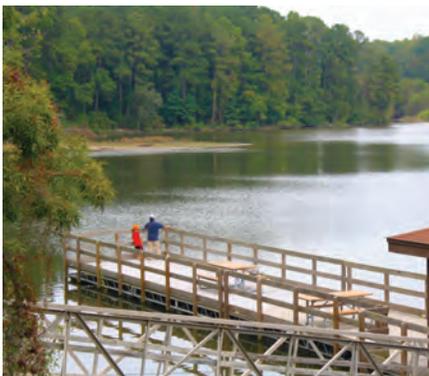
Site has a wonderful natural scenic attraction, however, basketball court and picnic areas are not maintained well. Erosion is problem throughout site. Lake restroom facilities are not accessible and in very poor condition.

- Restroom facilities at lake are in poor condition
- Accessible routes to lake and crosswalks into park are missing
- Picnic areas with shelters is not provided

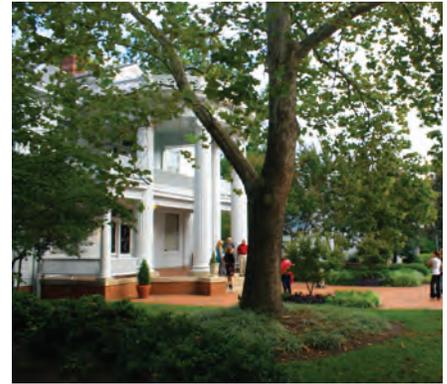
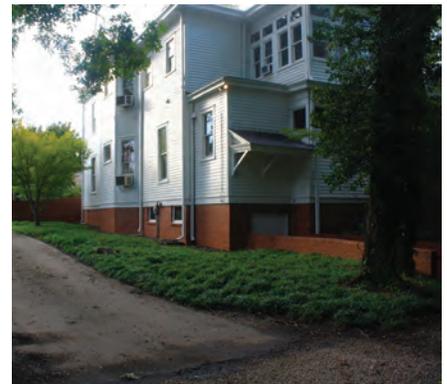
Multi-modal access is highlight of efficiency at this site. A school is located across Persons Street, however, minimum sustainable techniques have been utilized on site, specifically techniques that would be appropriate to site's history.

- Bike racks are missing and seating options are minimum
- Sustainable techniques such as water harvesting could be used as appropriate
- Accessible routes from parking lot into building are missing

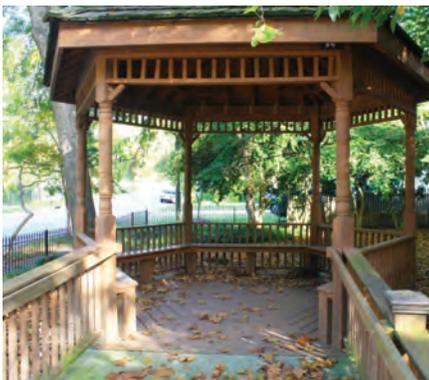
Stormwater is managed on-site and as direct run-off to surrounding streets' closed systems. Lack of bike racks slightly limit multi-modal access to site. Park is adjacent to the Oakwood Cemetery.

- Bike racks and crosswalks at park entrance are missing
- Energy efficient security lighting in shelter could be provided if needed

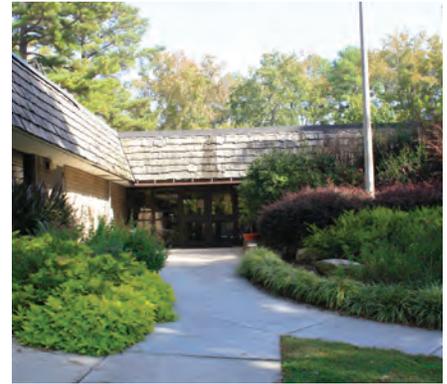
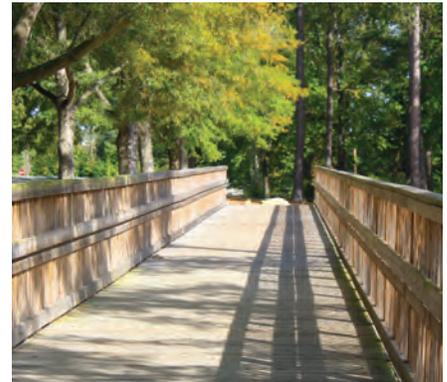
Stormwater is direct runoff, typically untreated for most of site. Multi-modal access is provided by vehicle and limited safe access to bicycles and pedestrians. School nearby promotes common civic facilities.

- Sidewalk and bicycle access to both entrances of park is missing
- Protection from weather on eastern area of park is lacking
- Seating options and stormwater treatment is minimum

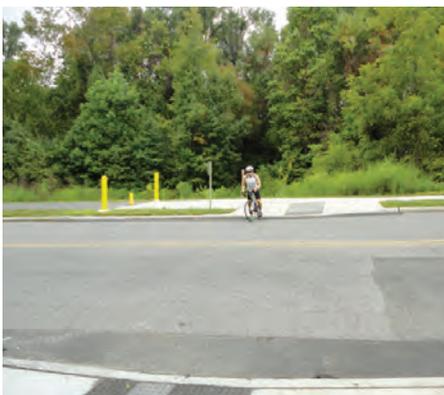
Trail striping is missing on most curves and centerlines of the trails. Spur along Horton St. connects to park amenities. Crosswalks are needed along the driveways for safety. The trailhead provides parking for approximately 15 vehicles and includes accessible parking. South of Horton, centerline striping is needed to warn bicyclists of the limited sightlines and steep grades.

House Creek Trail does not have centerline striping. Centerline striping is recommended for transportation trails, and at a minimum, should be installed at

- Underpasses lacks effective advanced warning signage and lighting
- Centerline striping is best for transportation controls
- High visibility crosswalk striping is lacking on Glen Eden Dr. and Horton St.
- Curb ramp is not present at Glen Eden Dr. trail entrance

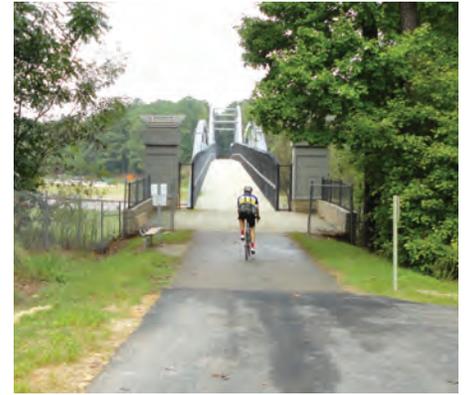
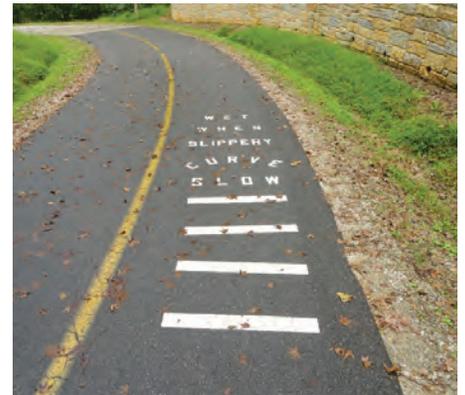
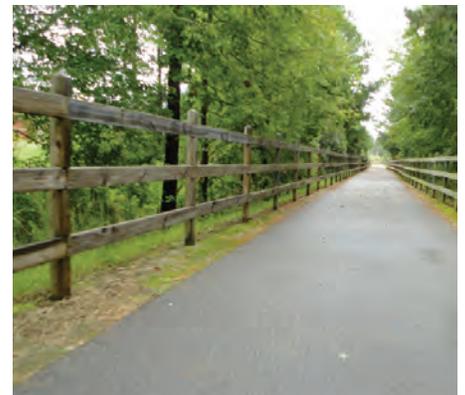
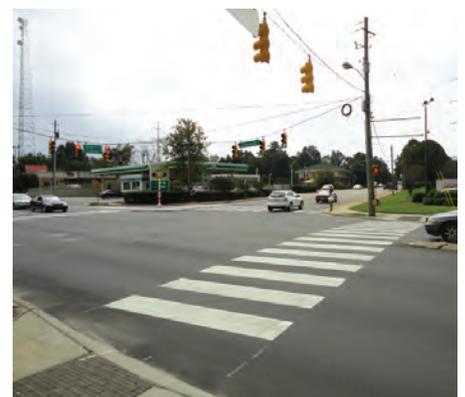
- Some ponding near underpass
- Trail tread is aging, cracking

- Underpass lacks effective advanced warning signage and lighting
- Trail is 8-foot-wide and could widen to 10-feet to accommodate high use
- Asphalt is aged and could be resurfaced in sections
- Blue Ridge Road, Gorman Street intersections could be studied for biking and walking safety improvements
- Wayfinding lacking along Gorman Street
- Curb ramps are not present in several areas

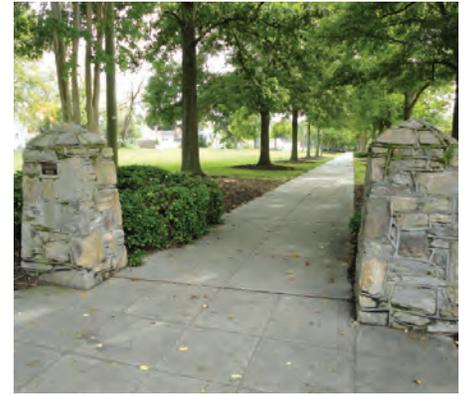
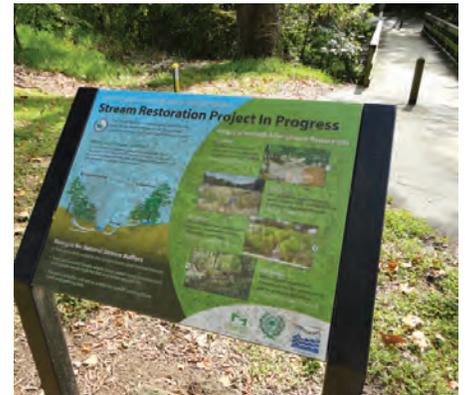
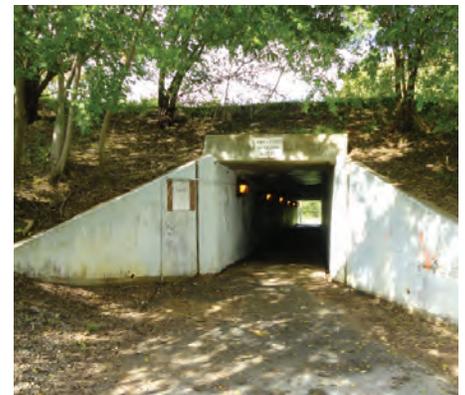
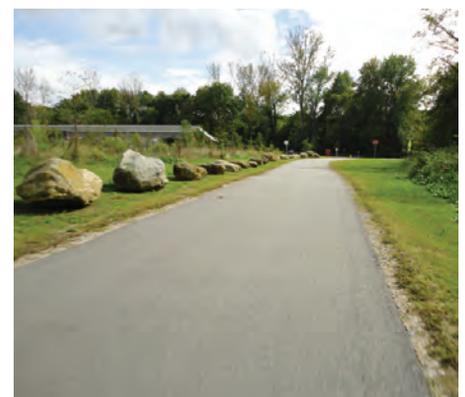
beginning to show signs of deterioration. The scored concrete along Chavis Way is not bicycle-friendly. There are some drainage problems north of the Cabarrus St. intersection. There are negative perceived safety concerns where the trail extends through Chavis Park due to loitering and poor site lines.

- Asphalt near and along Chavis Park is in poor condition
- Increased patrols at Chavis Park could increase perceived safety
- Number of all wayfinding, interpretive, and kiosks with current signage is minimum
- Roadway intersections with ADA-compliant curb ramps and high visibility crosswalks are lacking
- Mid-block crossing with signage at Bragg Street is missing
- Trail width is below 10 feet

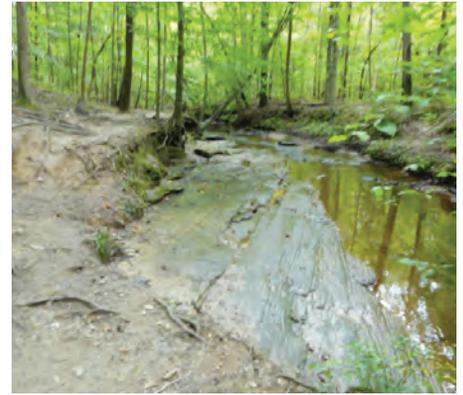
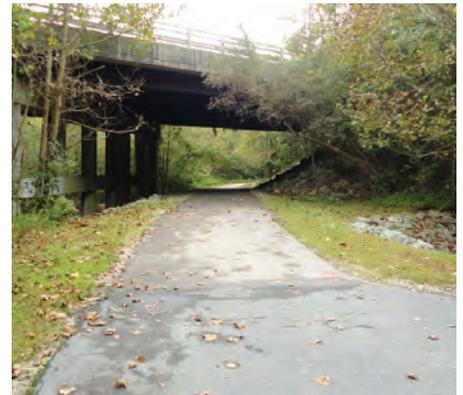
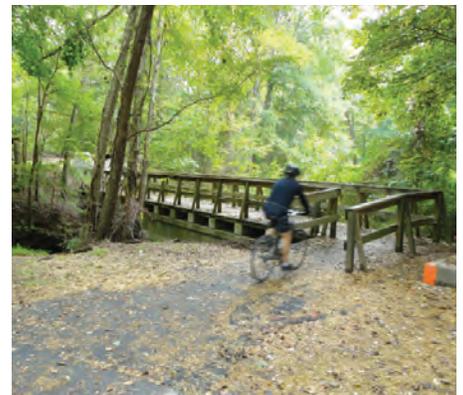
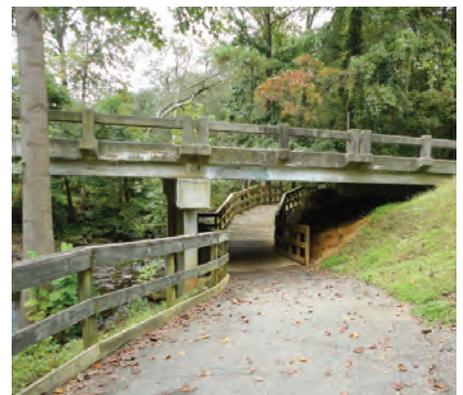
- Sediment, ponding, washing out along shoulders
- Downed branches
- Drainage issues of concern with tread slumping, flooding near Milbrook

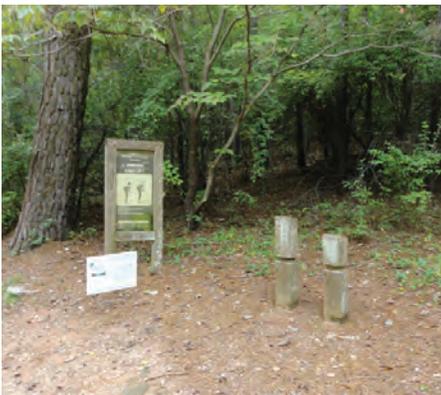
At the southeastern portion of the lake, the grades are steep and not accessible.

- Trail width is minimum for high level and variety of uses
- Asphalt is aged and needs repair
- Wayfinding and regulatory signage at intersections and parking area is lacking
- Trail etiquette signage are not provided
- Existing boardwalk is in poor condition
- Recycling receptacles are not provided
- Fitness stations are aging/deteriorating

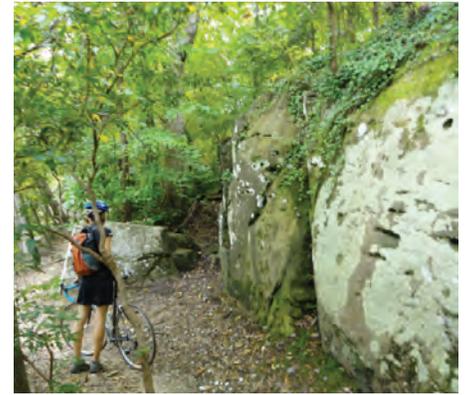
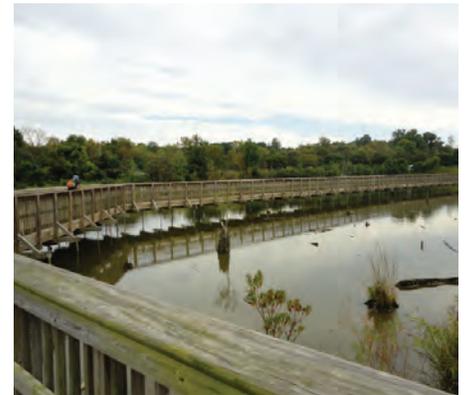
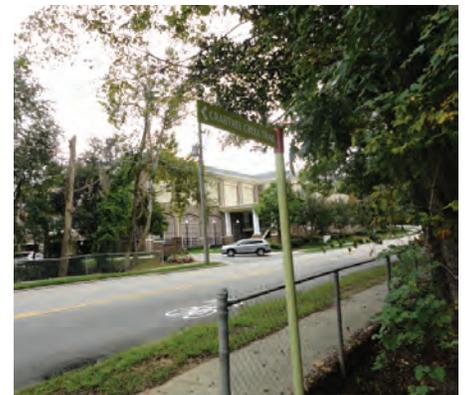
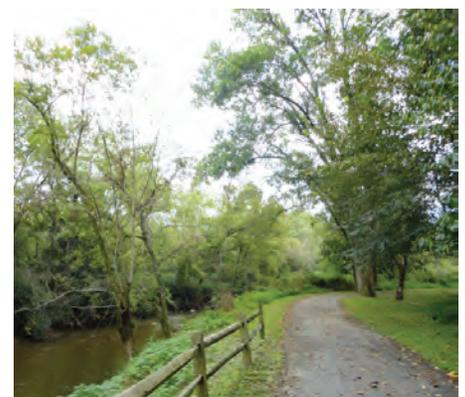
- Pedestrian bridge just south of I-440 does not provide 2-way pedestrian traffic and ADA access
- Signage lacking or rerouting needed where pavement ends near Hertford St.
- Wayfinding signage is minimum
- Lighting and regulatory signage at Capital Blvd. underpass is missing
- Roadway/trail intersection at Milburnie Rd. is minimum
