**REPORT OF
PROPOSED DOWNSTREAM WIDENING OF
HORSESHOE FARM PARK DAM**

**RALEIGH, NORTH CAROLINA
F&R PROJECT NO. 66M-0065**

Re: Proposed Downstream Widening of Horseshoe Farm Park Dam
Horseshoe Farm Road
Raleigh, North Carolina
F&R Project No. 66M-0065G

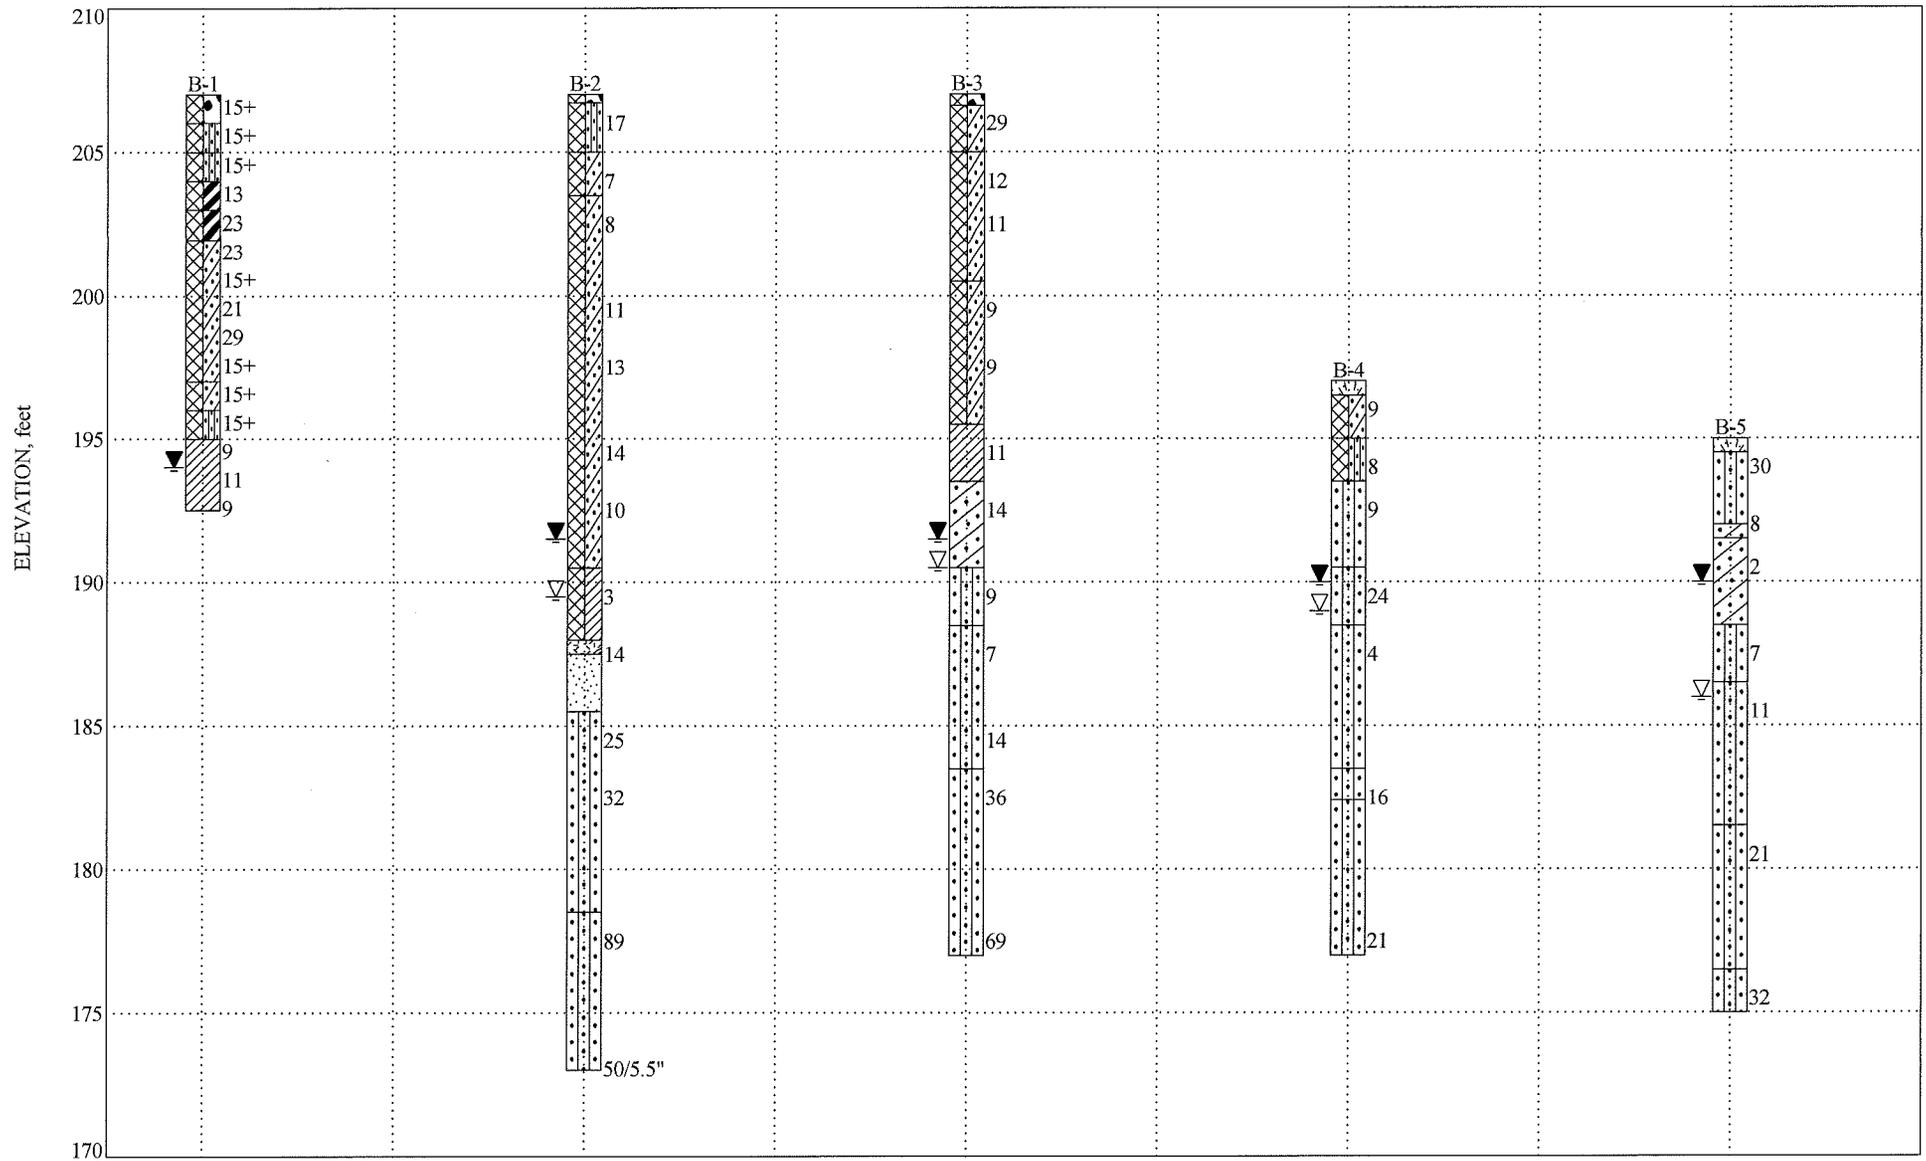
SUBSURFACE PROFILE Figure No. 3

A generalized subsurface profile along the dam alignment has been prepared from the boring data to graphically illustrate the subsurface conditions encountered at the site (see Figure 3 in Appendix I). A cross section through the dam in the vicinity of Borings B-1 and B-5 is shown in Figure 4. More detailed descriptions of the subsurface conditions at the individual boring locations are then presented in the boring logs enclosed in Appendix II. Strata breaks designated on the Boring Logs and Subsurface Profile represent approximate boundaries between soil types. The actual transition from one soil type to another may be gradual or occur between soil samples. The generalized subsurface conditions at the site are described below.

Fill soils were encountered in borings B-1 through B-4 from the existing ground surface to depths ranging from approximately 3 to 19 feet below existing ground surface. The fill generally consisted of loose to medium dense silty and clayey fine to medium sands (USCS – SM & SC) and soft to stiff fine to medium sandy clays (USCS – CL & CH). The fill exhibited standard penetration test (SPT) resistances ranging from 3 to 29 blows per foot (bpf) with values typically in the range of 8 to 12 bpf. These SPT values indicate generally moderately well to well compacted conditions since similar type soils would be expected to exhibit SPT values of 9 to 12 bpf or higher when well compacted. It was also noted that the fill at the drilled locations did appear to be relatively clean, i.e., without significant concentrations of organics or other debris, however a majority of the soil samples contained traces of wood and root fragments.

It is noted that a 2 to 3 foot thick layer of soft, sandy clay was encountered in boring B-2 at a depth of approximately 16.5 to 19 feet. The soft clay exhibited an SPT N-value of 3 bpf. Some wood (19.0 to 19.5 feet) was encountered below the clay layer. The presence of the relatively thin layer of soft clay and wood is probably associated with the placement of an initial bridge lift of soil over the original ground surface during the early stages of construction of the dam several decades ago.

Underlying the fill soils, and at the ground surface of boring B-5, native soils were encountered. The native soils consisted of loose to very dense silty and clayey fine to medium sands (USCS – SM & SC) with SPT N-values ranging from 2 to 89 bpf. The SPT N-values of the native soils were typically in the range of 11 to 14 bpf, with a majority of the SPT N-values greater than 20 bpf.

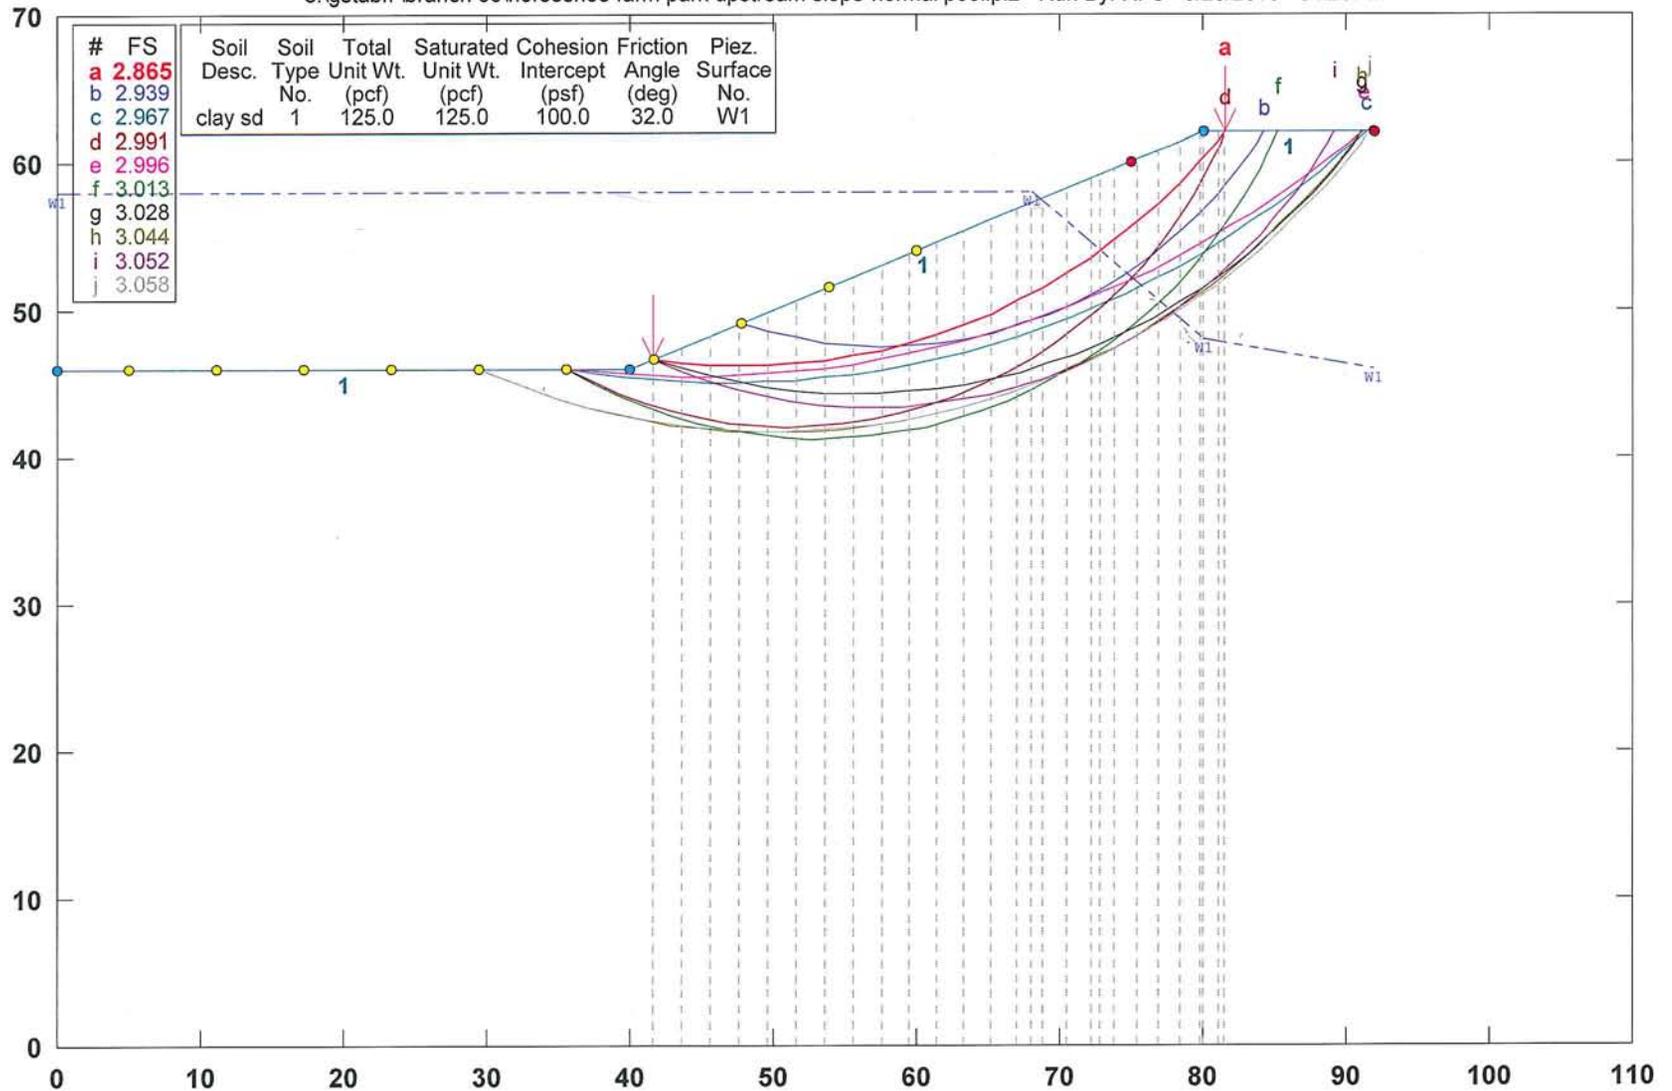
horseshoe farm park existing upstream-normal pool

GSTABL7 v.2 FSmin=2.865

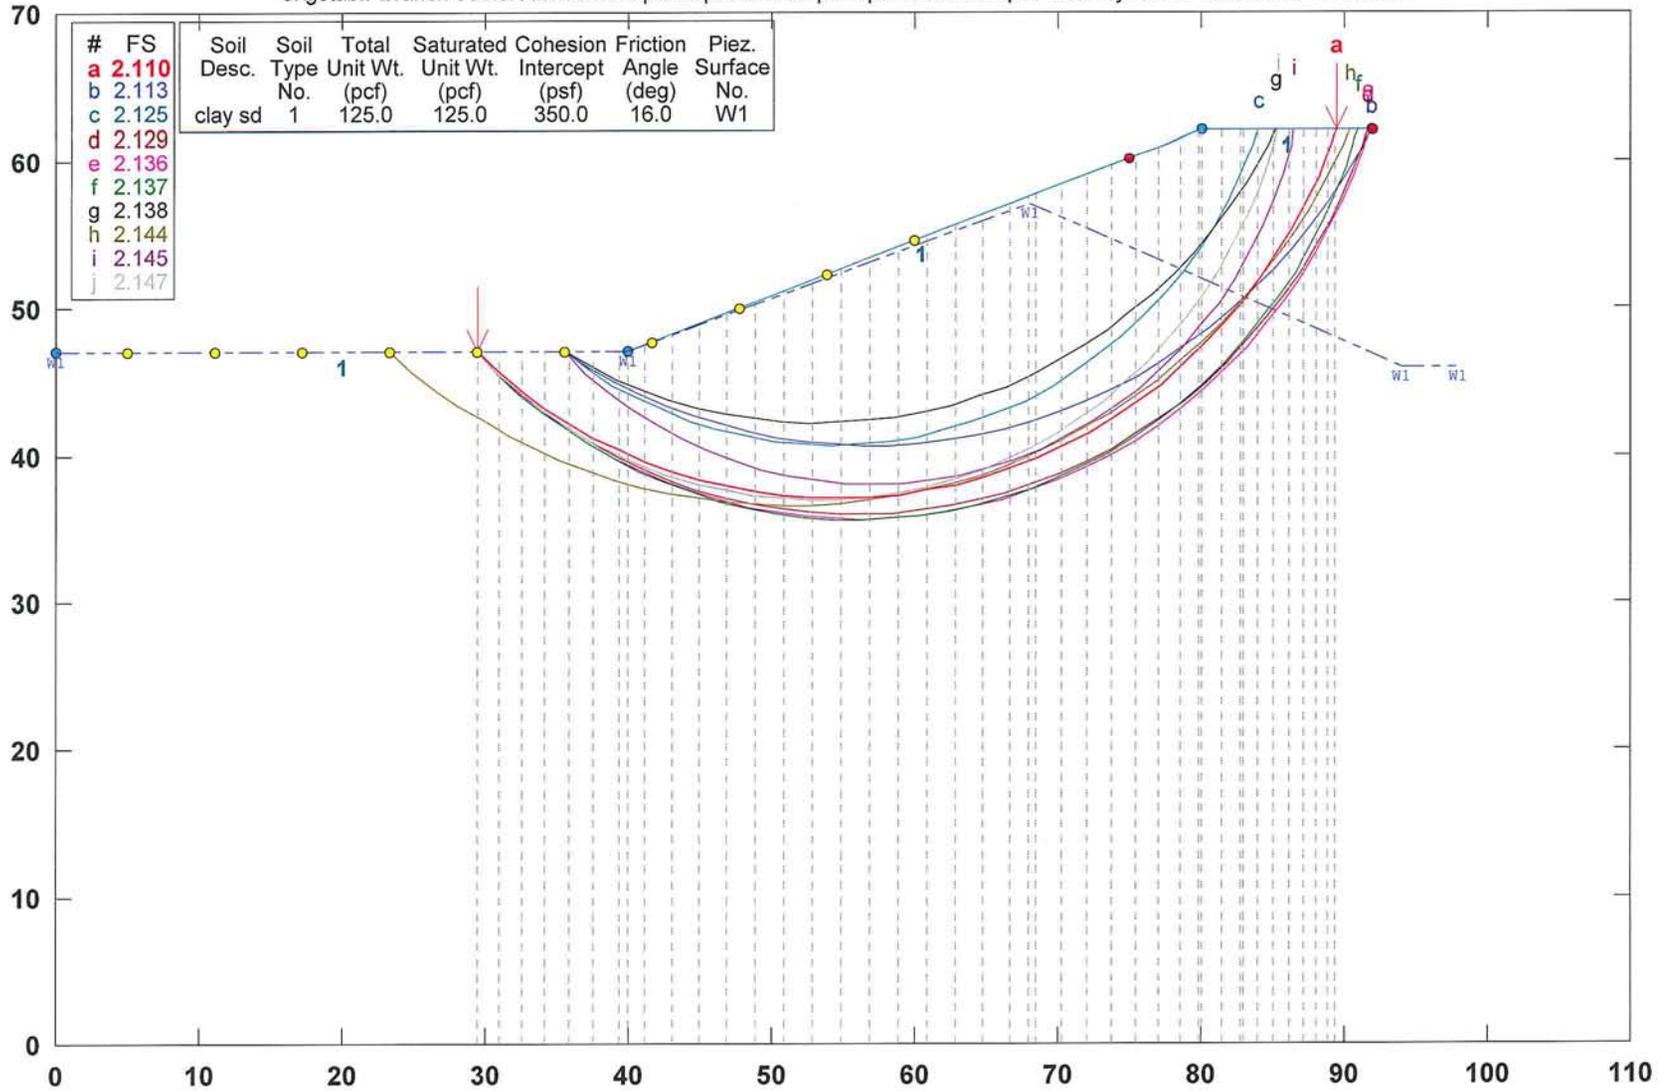
horseshoe farm park existing upstream-rapid drawdown

GSTABL7 v.2 FSmin=2.110

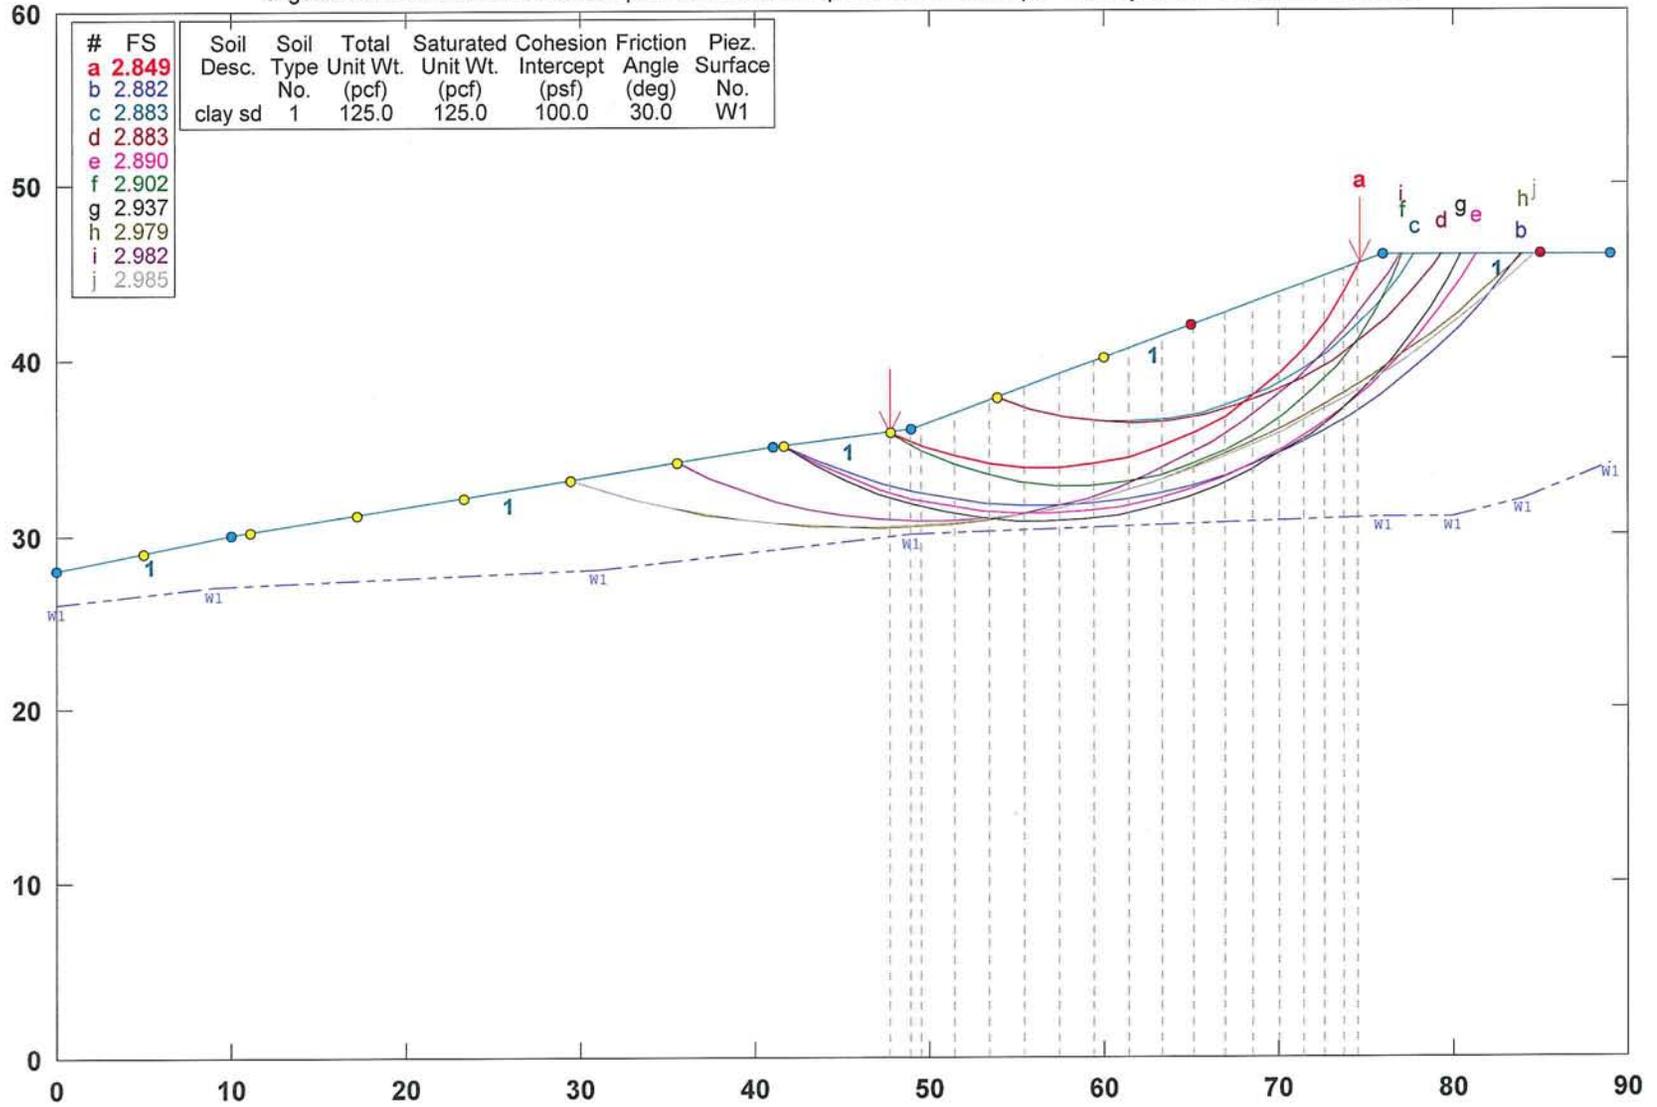
horseshoe farm park existing downstream- normal pool

GSTABL7 v.2 FSmin=2.849

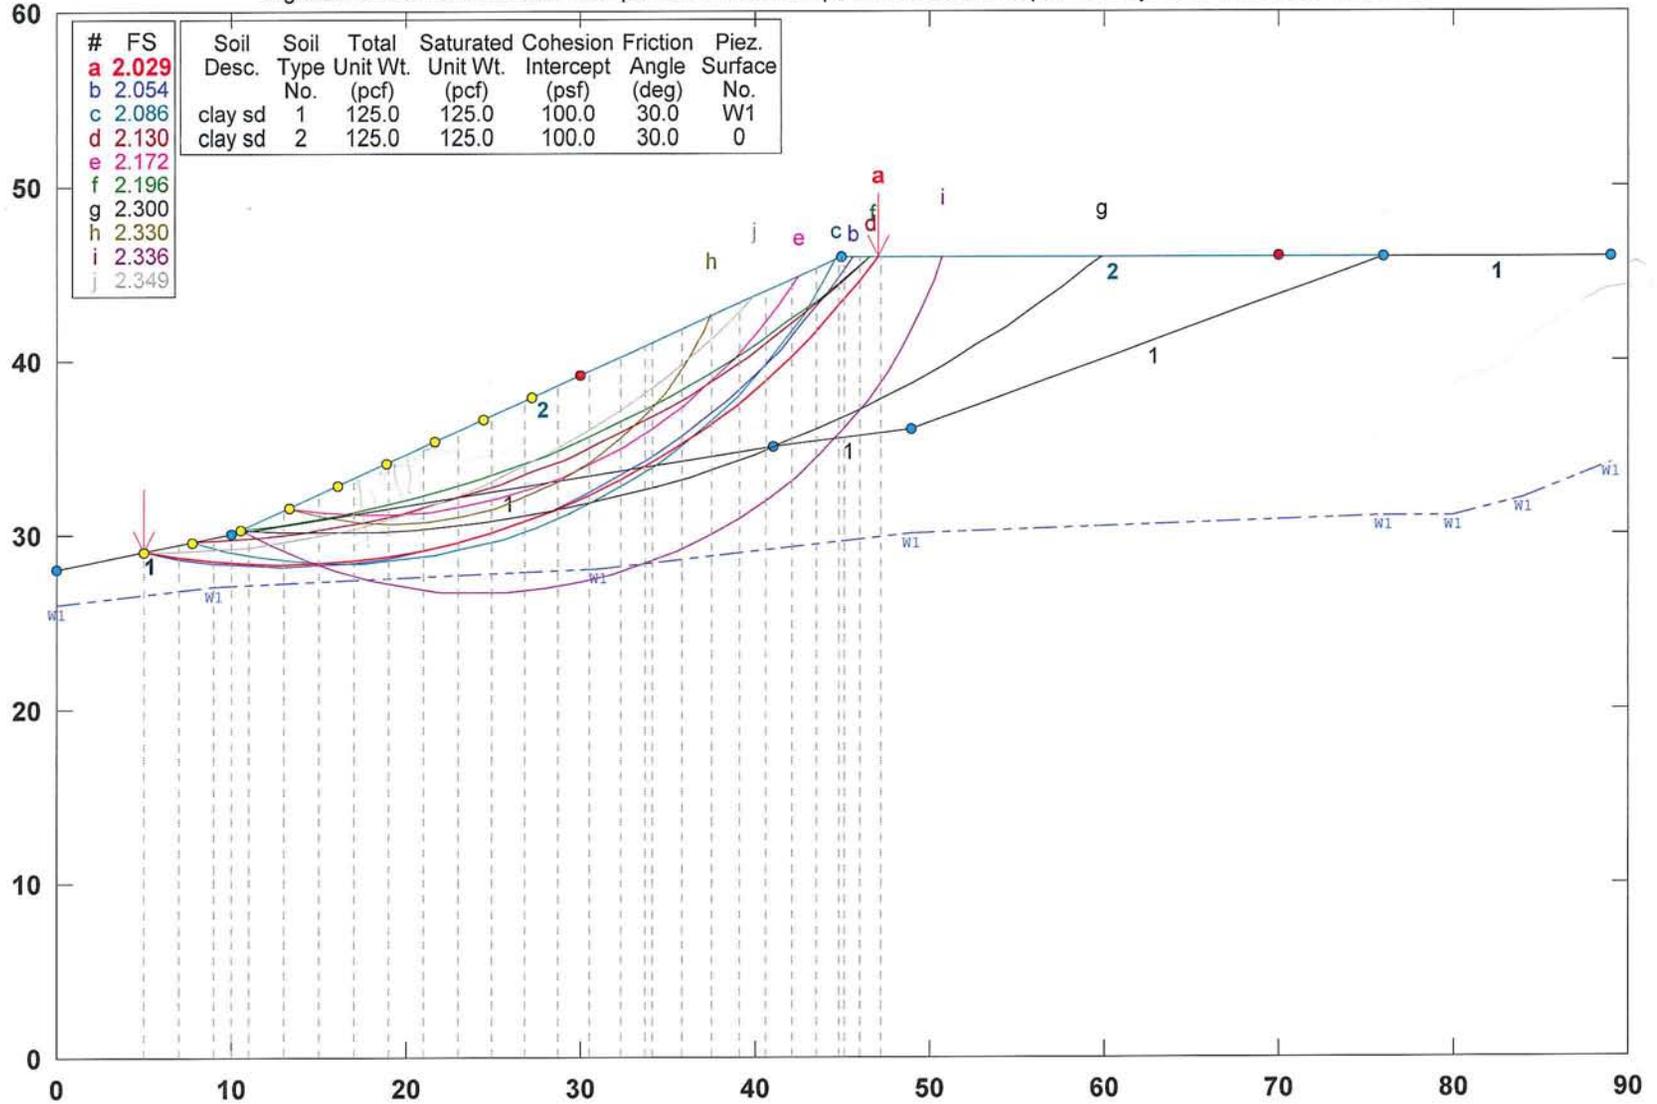
Figure #8

GSTABL7 v.2 FSmin=2.029
