PULLEN ARTS CENTER AND NORTH PULLEN PARK IMPROVEMENTS PROJECT

EXISTING CONDITIONS REPORT

September 2015

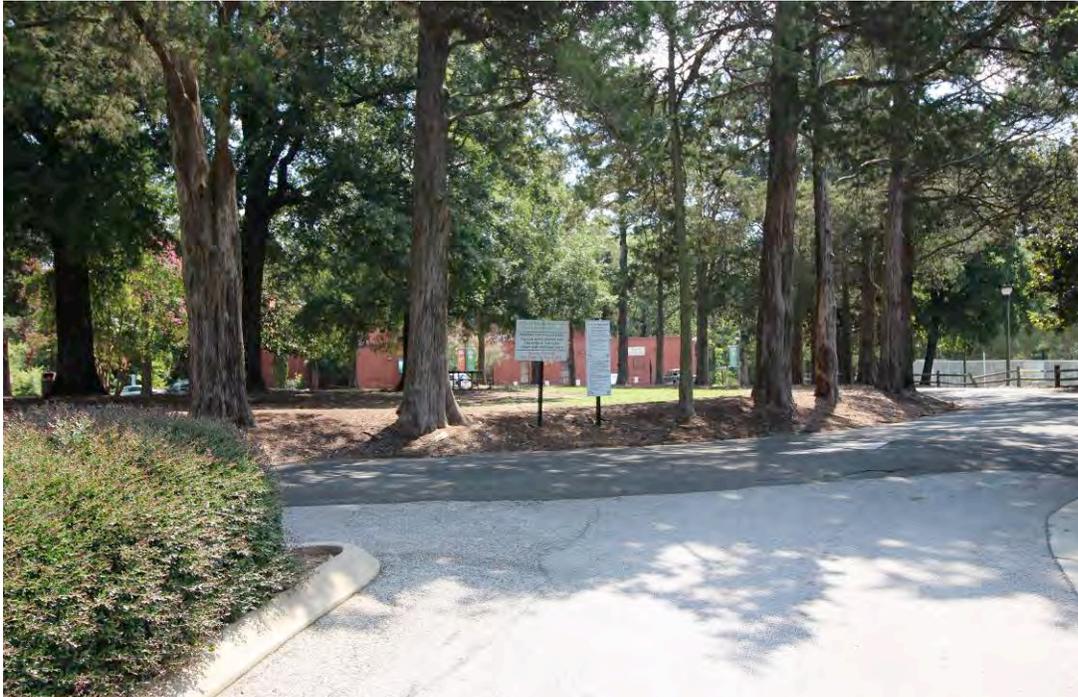
Figure 8 View of main roundabout within North Pullen Park, Theater is visible through trees, signage is undersized

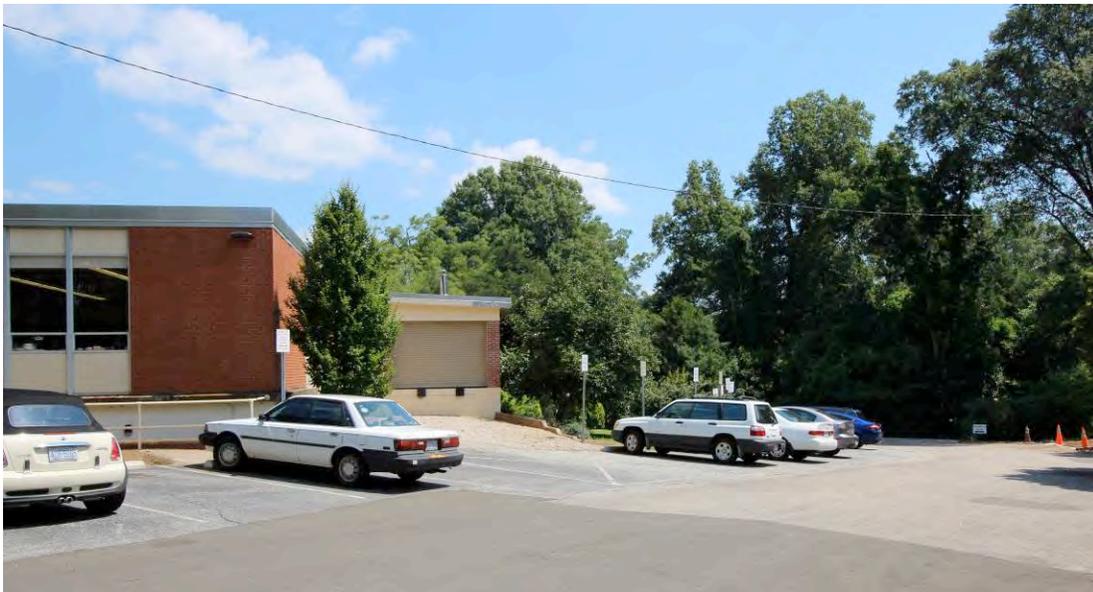
Figure 9 View of loading dock for the Arts Center. This loading dock must serve 67 foot long interstate tractor trailers.

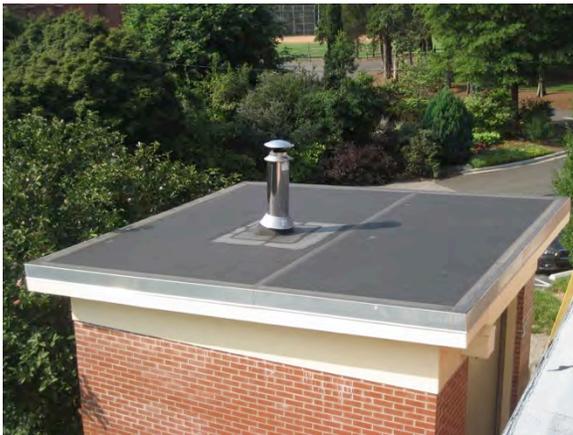
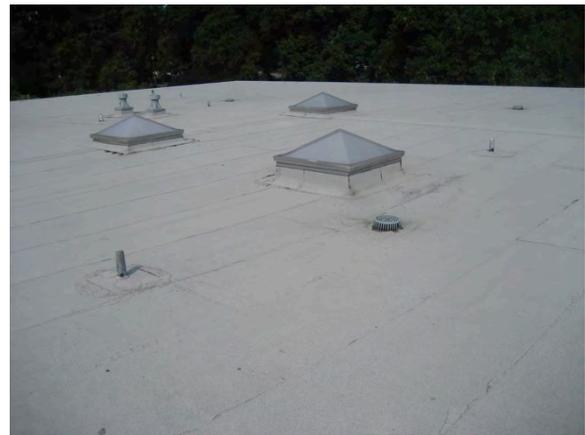
The roofing membrane on the main building is a modified bitumen single-ply that is in excellent condition. It appears to have been installed fairly recently and has been maintained well. No deferred maintenance issues were identified. The roof membrane on the freestanding support building is a single-ply EPDM that is in good condition.

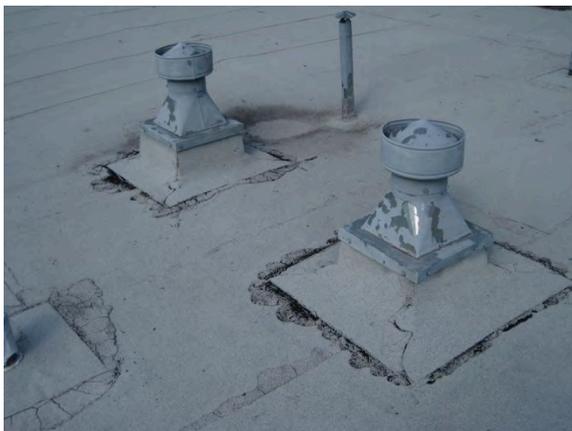
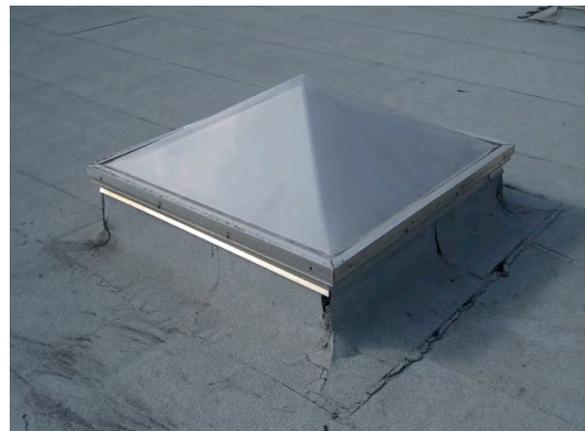
The roof has multiple penetrations including plumbing vents, exhaust fan release vents, flue for the gas boiler and numerous skylights. All of the curbs and flashing around these penetrations have been completed properly and no deferred maintenance issues were noted.

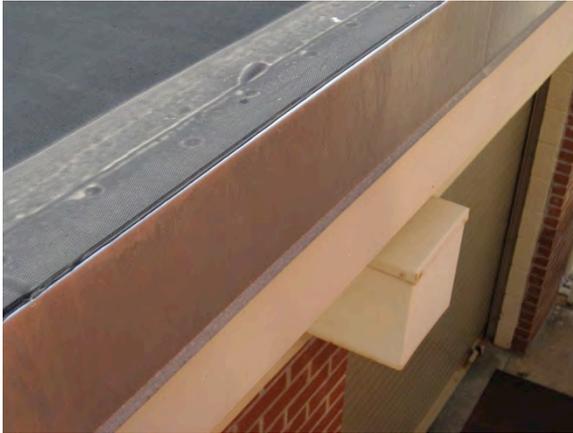
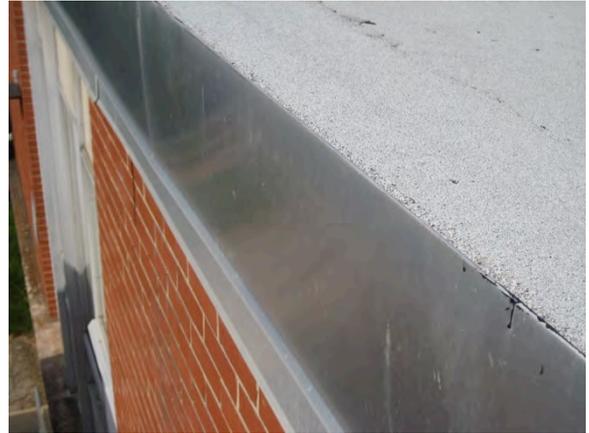
The perimeter of both the main building and the freestanding smaller structure have aluminum edge flashing/fascia that is in very good condition.

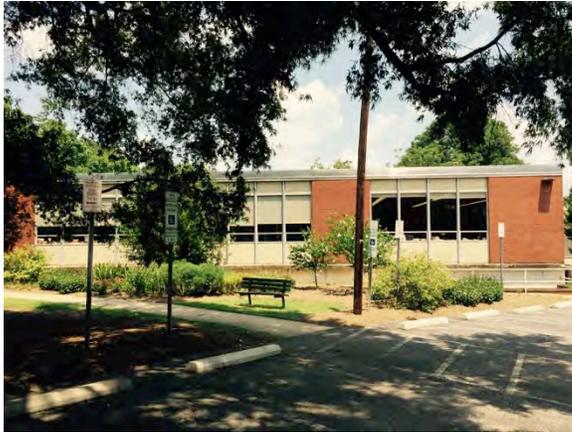
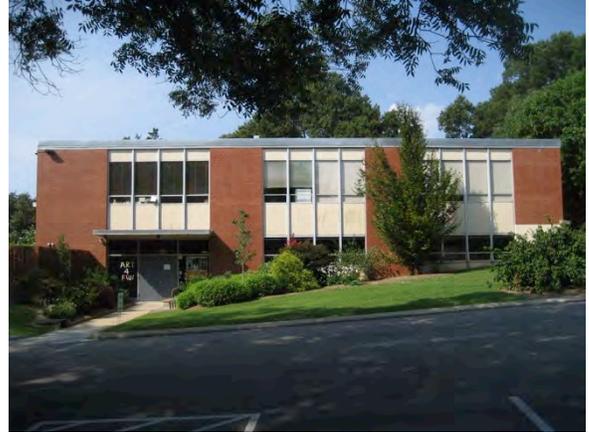
The exterior walls on the building are masonry with an exposed face brick on the concrete masonry backup. We found no evidence of cracking in the masonry and all mortar joints appear sound.

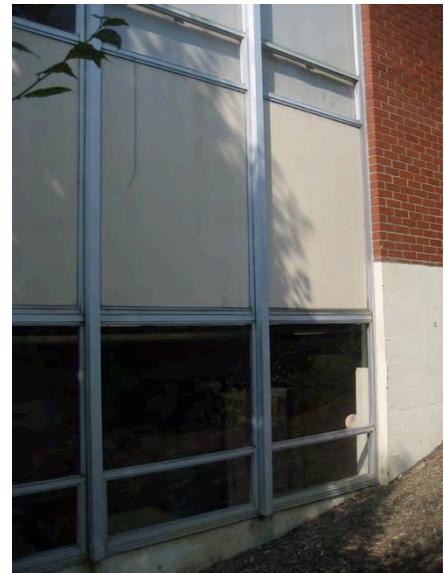
Much of the exterior is a single-glazed aluminum storefront with metal panels and aluminum doors. The storefront is original and is in good condition. The single glazing, however, does not meet today's energy codes and is a source of significant heat loss and heat gain.

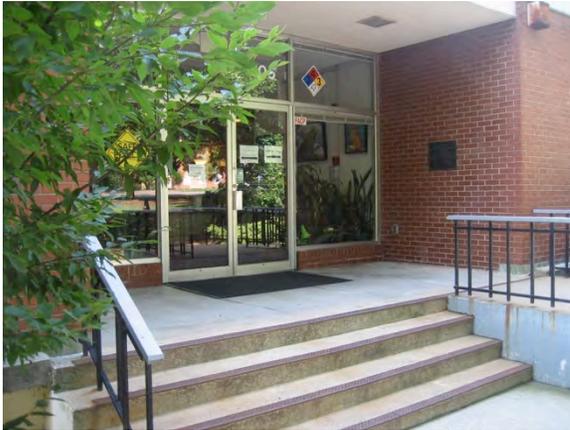
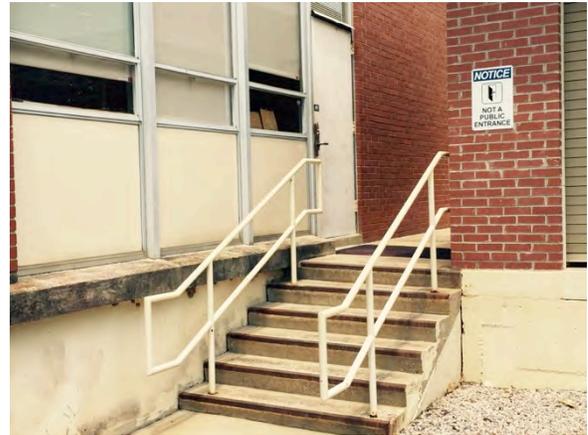
The main entry doors are part of the storefront system. Other doors include hollow metal doors in hollow metal frames at the lower entry and service side as well as (2) manual coiling metal doors on the freestanding surface building. All the doors are in good condition given their age.

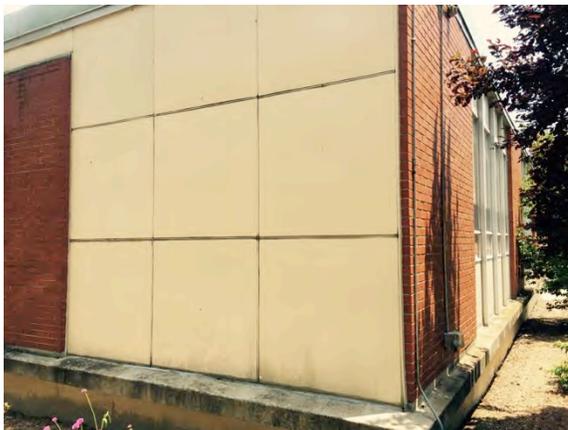
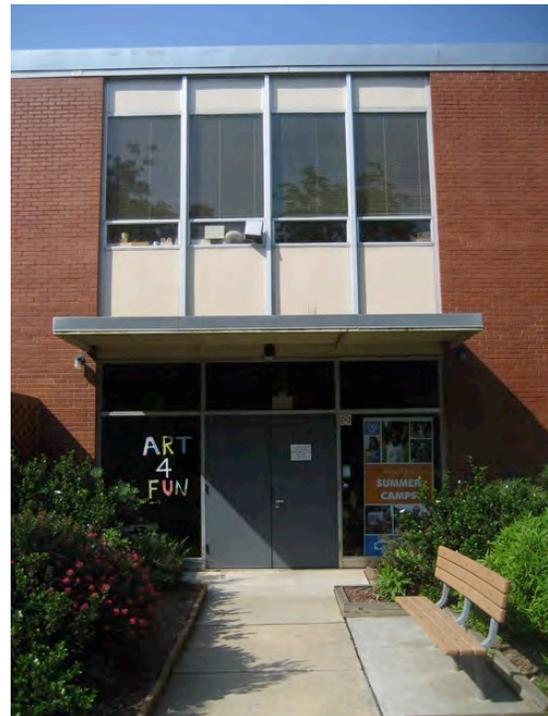
There is a minor use of metal panels on the main front elevation. These appear to be in reasonable condition.

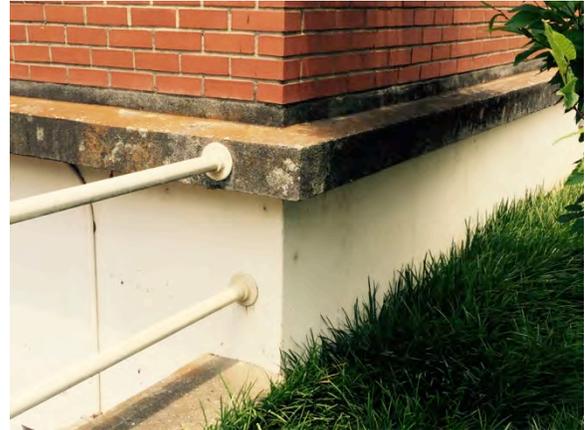
Foundation walls are poured-in-place concrete that have been painted. These appear to be in good condition.

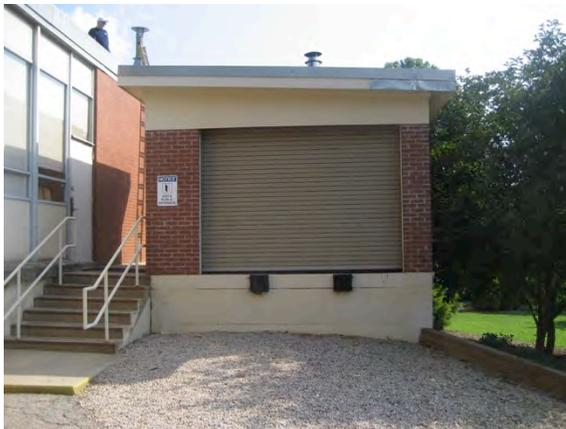
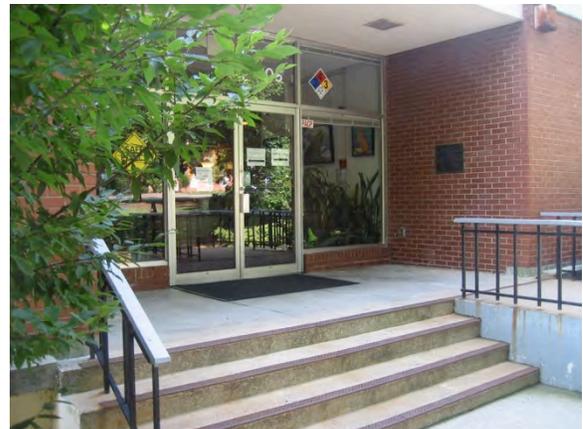
Access to the main level at both the front door and the rear service door are via concrete stairs with metal painted rails. These are in fair condition.

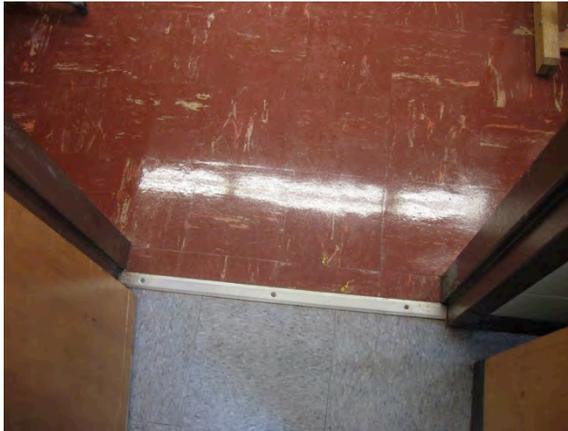
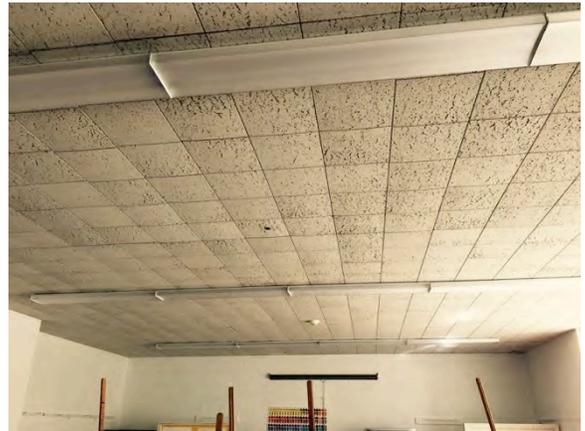
- a. We noticed 9" square vinyl floor tile which typically is asbestos containing. We did not see any evidence of asbestos at the boiler or in pipe insulation. The 12" square acoustical tile ceiling in one of the classrooms is the type that often is asbestos containing. If this has not yet been tested, we recommend that samples be taken and tested.

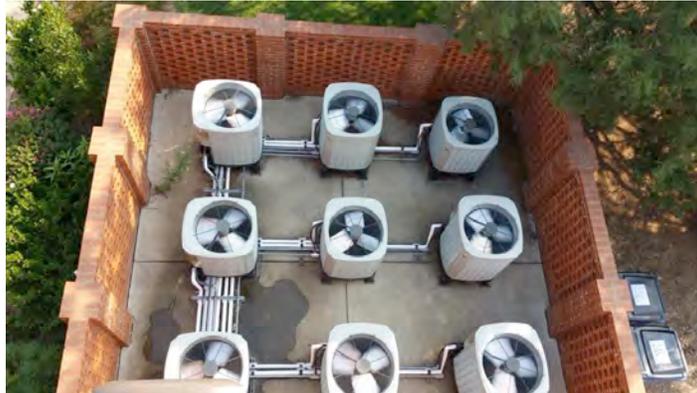
Condensing Units

The building is served by constant speed 5 split system A/C units with hot water reheat. These units are in excellent condition. Air handlers 1, 2, 3, and 5 each have 2 separate cooling coils, and condensing units. AHU-4 is a standard single coil/single condensing unit. This arrangement allows for good part load control of the space, however, without variable speed drives on the fans, activating a single coil can result in higher discharge air temperatures and less dehumidification.

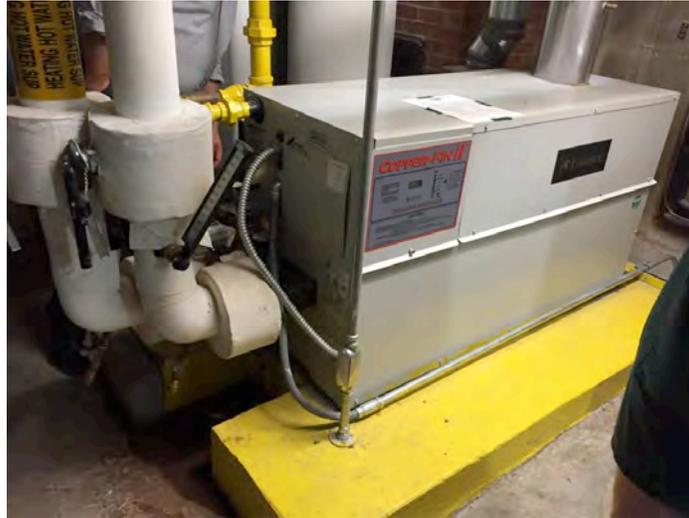
Lochinvar HW Boiler

The hot water is generated by a Lochinvar Copper Fin II boiler that appears to be in excellent condition and appropriately sized for the building heating load.

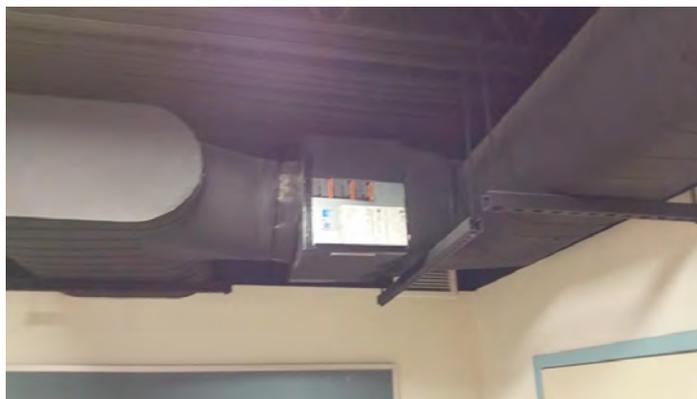
Existing Zone Damper

The building is split into 5 zones, one air handler per zone. Further zoning is provided via zone dampers to keep the spaces from over cooling. Zoning seems appropriate for the size and use of the spaces.

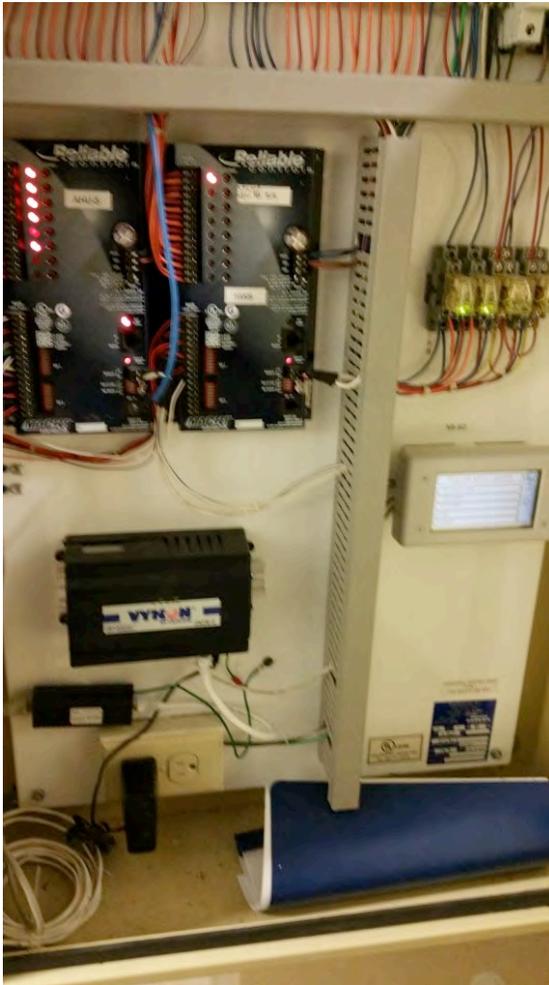
Existing VYKON Jace

A Vykon JACE-6 has been installed by Envirocon and appears to be in compliance with current Parks and Rec requirements. Systems appears to be in good condition

and functioning properly. Additional points could be added to this system, as needed.

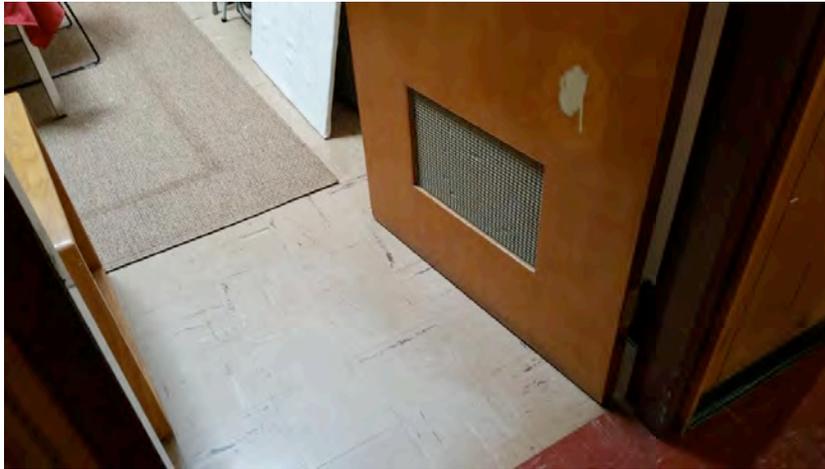
The first issue that should be addressed is the non-code compliant return air pathway. On the first floor, the Painting room and Break Rooms all transfer their return air into the corridor, before going to AHU-2 return grill open to the hallway. This creates a smoke hazard, because if there was a smoke or fire event in either of these spaces, it would be carried into the exit corridor and into the path of other evacuees. This condition should be fixed in any renovation project.

Transfer Grille in Door

- a. Most of the Mechanical systems in the building are in excellent condition and should be salvaged or reused in any planned renovation project.
- b. AHU-2 return air needs to be re-worked so that the exit corridor is not used a return air pathway.
- c. Air distribution devices in the floor should be located to the ceiling and increased in size.
- d. Both of these items might be corrected by replacing AHU-2 with a Roof Top Unit instead.

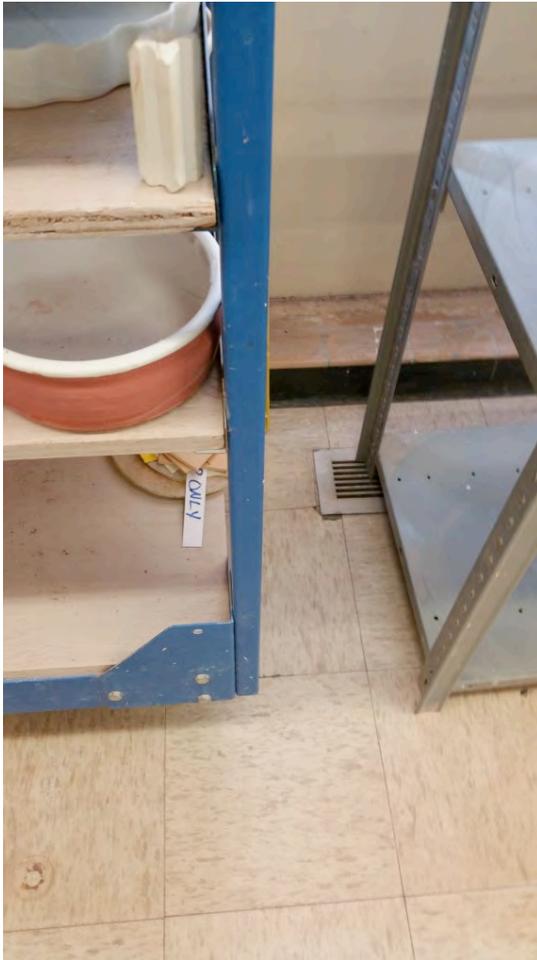
Another air distribution issue is related to the size and location of the floor grilles. Where placed, these floor distribution devices are often covered up with shelving or equipment and fail to properly provide airflows into the space. These supply grilles are original to the building and are very undersized for the new airflows. They are creating high supply airflow velocities, that are not only loud, but also the “wind” generated is disrupting activities in the spaces. Any renovation project should plan to address this nuisance issue.

Floor diffuser covered with shelving

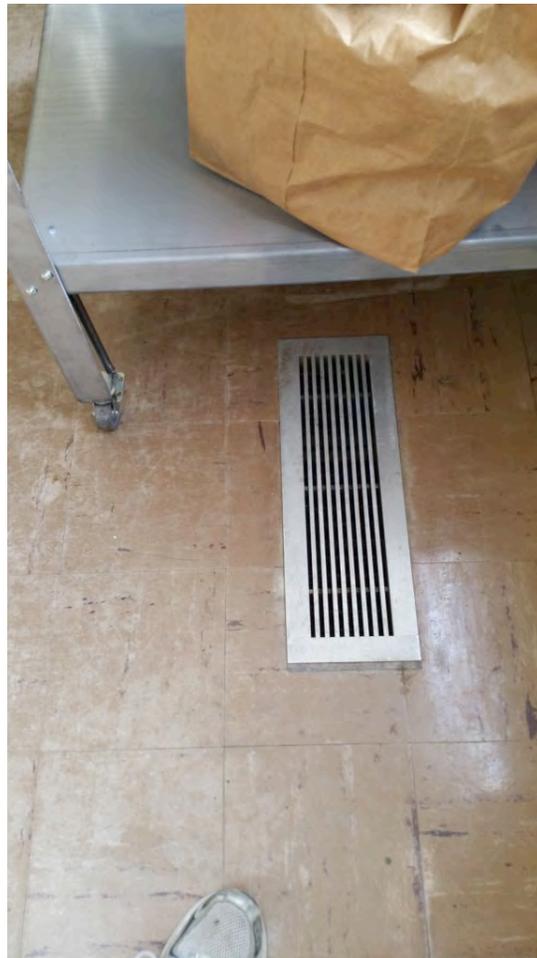
Undersized floor diffuser.

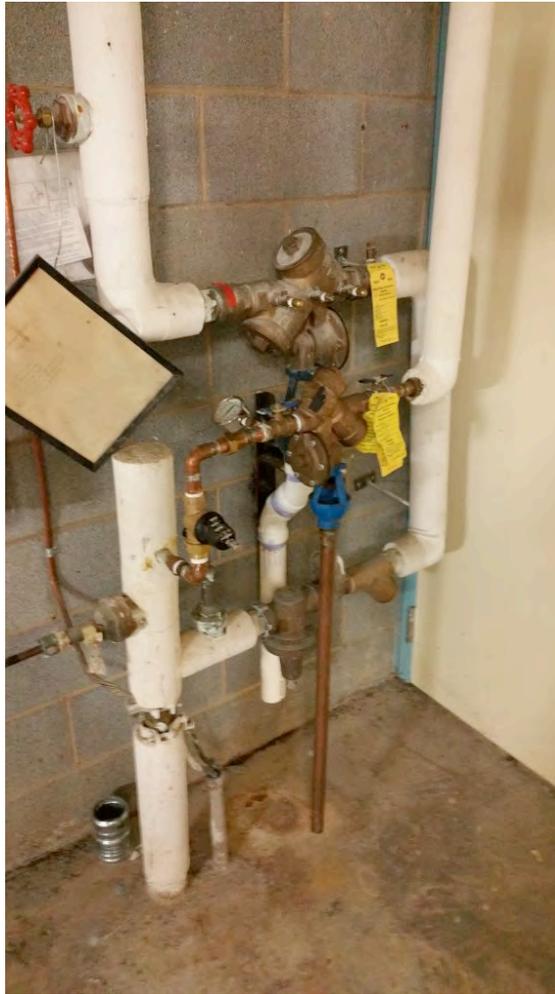
Domestic Water incoming service.

The building has an existing 6" Sanitary Sewer connection and a 1 ½ domestic water connection. The domestic water service connection is protected with an RPZ, however it is not in compliance with current City of Raleigh backflow requirements and so any renovation will need to address this. Additionally, the incoming 1 ½ is just large enough to serve the fixture count of the existing building but will likely need to be upsized if the supply water demand fixture count is increased.

- a. Clay traps should all be cleaned or replaced.
- b. Domestic water tap may need to be upsized to 2" if any more fixtures are added

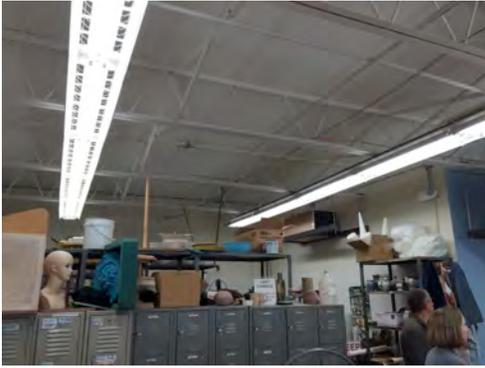
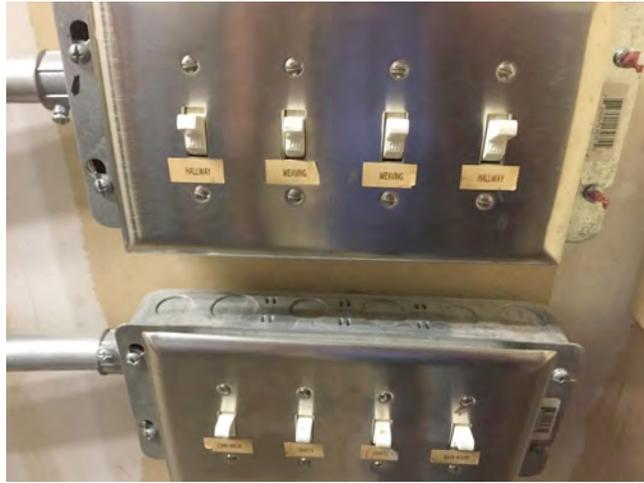
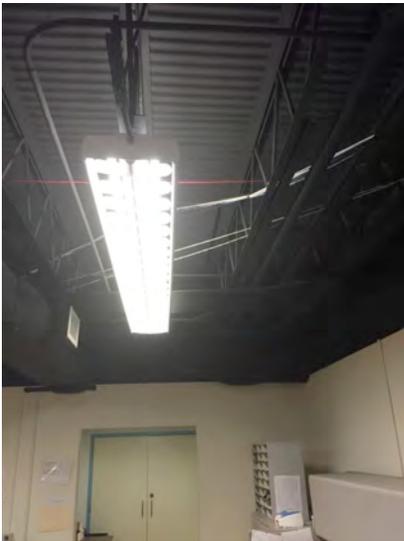
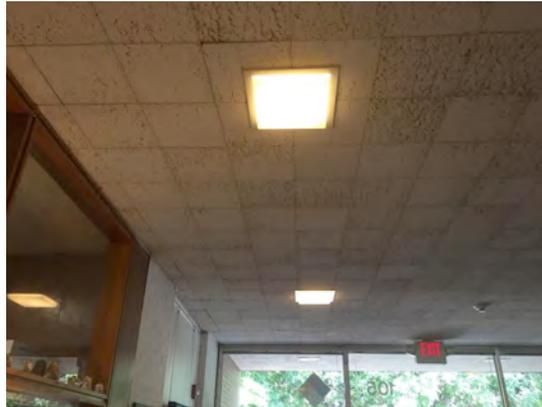
Lighting Pictures (Clockwise from bottom left: 1st Floor Installation, 2nd Floor Installation, Lighting Control in basement, Lobby Installation)

One area that should be addressed in any renovation is the entry lobby. The fixtures in this area appear to be original to the building and should be replaced with a more energy efficient lamp source.

Building lighting control appears to be handled at a bank of switches in the basement electrical room. This may not meet current Energy Code depending on how Code officials view building operations. This arrangement is only allowed under situations where control in the individual spaces could lead to a unsafe condition.
