FEASIBILITY REPORT

STRUCTURAL SURVEY AND FEASIBILITY STUDY PROPOSAL FOR
THE EXISTING HOUSE AT HORSESHOE FARM PARK : RALEIGH, NC

PRELIMINARY CONDITION ASSESSMENT OF EXISTING FARMHOUSE RALEIGH, NC

Prepared by:
Charles E. Murphy, P.E.
SGI Engineering
200 North Greensboro St, Suite B13A
Carrboro, NC 27510
February 8, 2011

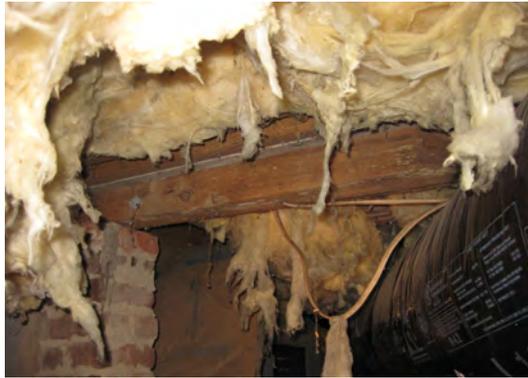
The original house construction consists of rough sawn framing and brick foundation piers. The crawlspace is enclosed by CMU infill of more recent construction. The additions are framed with surfaced dimensional lumber except for the kitchen, which is framed with rough sawn lumber. The foundations of the additions consist of continuous CMU foundation walls except for the front porch, which is brick piers and open.

1 ROUGH SAWN FRAMING + BRICK PIER

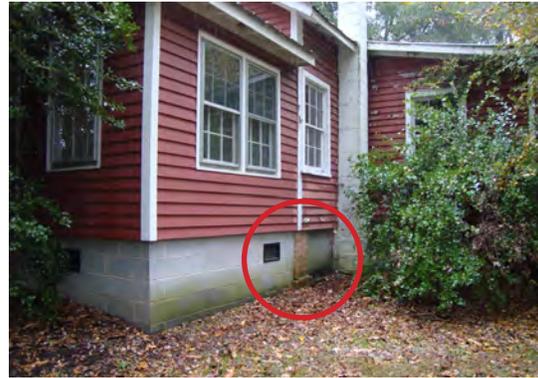
2 CMU INFILL BETWEEN BRICK PIERS

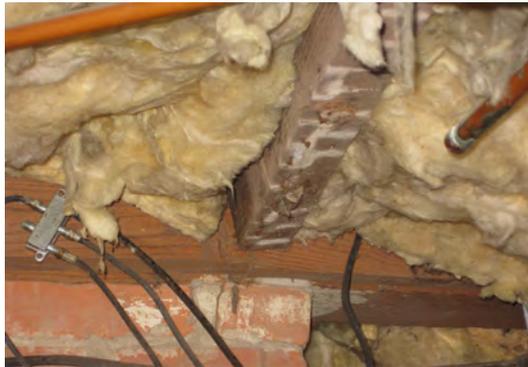
3 ROUGH SAWN FRAMING AT KITCHEN

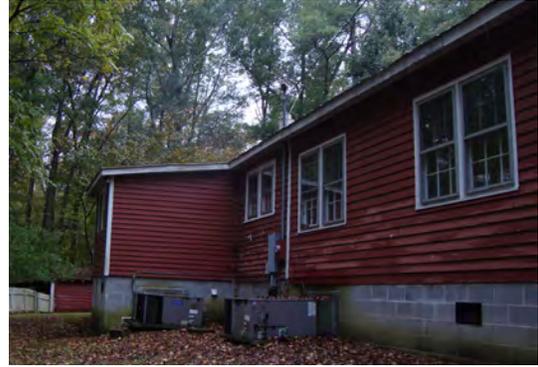
4 NEWER CMU FOUNDATION WALLS

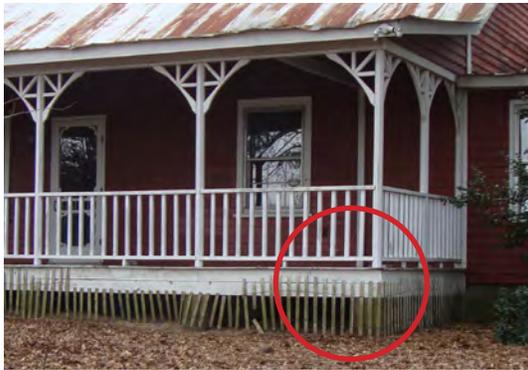
5 OPEN BRICK PIERS

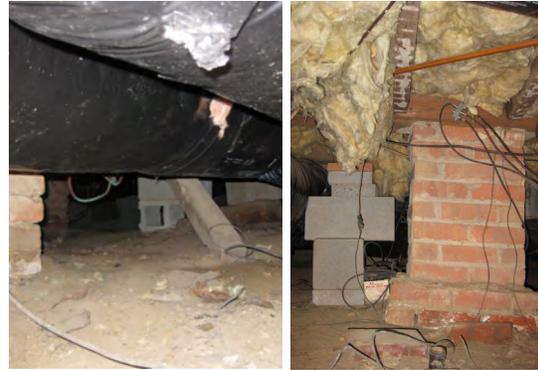
The crawlspace under the original portion of the house was congested with ductwork and temporary shoring. Due to access limitations the front and right sides of the crawlspace were not reviewed. No deterioration was noted in the floor framing that was reviewed. However, possible water damage at the front sill has previously been reported. Deterioration was noted at the roof fascia but appears to be limited.

6 CONGESTED DUCK WORK + TEMPORARY SHORING

1. remove all temporary shoring in crawlspace
2. add intermediate piers at girders
3. add intermediate drop girders @ joist spans or sister joists to increase LL capacity
4. add structural sheathing to roof
5. replace round timber header @ ceiling with structural girder
6. misc repairs @ sill, fascia, window opening

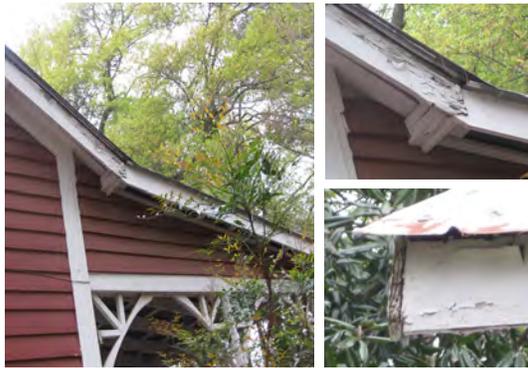
7 DETERIORATION AT ROOF FASCIA

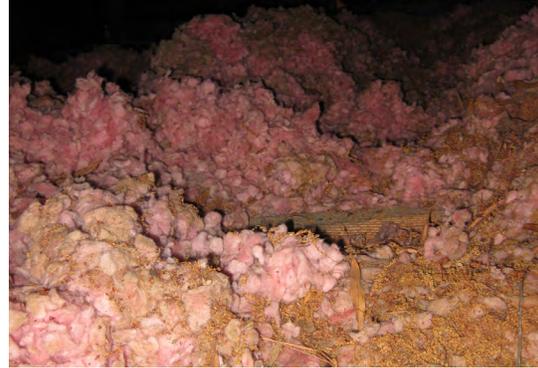
In the original construction, the ceiling joists span from front to rear and break over an interior wall on the right side of the chimney. At the left side of the chimney, a round timber beam spanning approximately 12.5 feet supports the ceiling joists. This construction is overstressed under the ceiling self weight and is inadequate.

8 CEILING JOIST RUNNING FRONT TO REAR

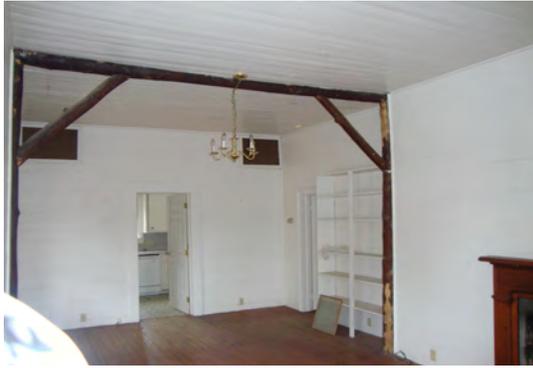
9 ROUND TIMBER BEAM

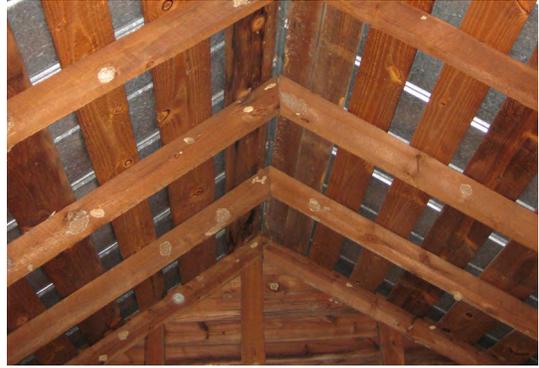
The gable roof over the original construction is framed with rough sawn 2x4 rafters, no ridge member, and 1x skip sheathing. Although the rafters are of marginally acceptable strength and the construction appears to free of distress, the skip sheathing does not provide adequate diaphragm action to resist lateral loads accumulated in the roof plane.

10 1X SKIP SHEATHING + NO RIDGE BEAM

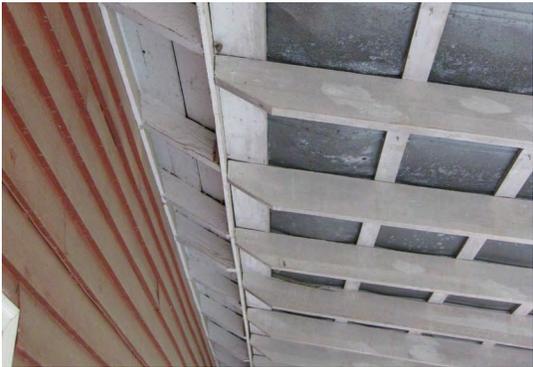
The front porch is lightly framed with an estimated floor live load capacity of 27 psf. The porch roof rafters are toenailed to the main roof fascia board. This construction is inadequate but appears to be free of distress.

11 TOENAILED PORCH RAFTERS

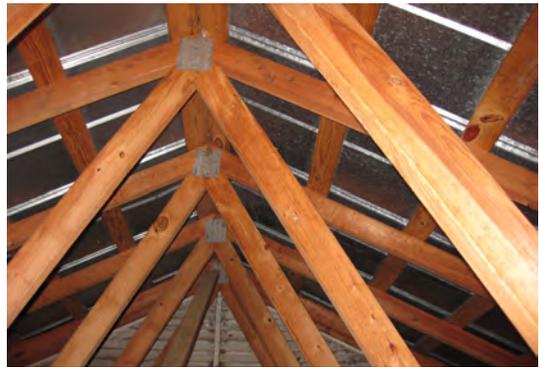
The two story addition on the left side and the connecting sitting room are of more recent construction. The gable roof of this construction is framed with metal plate connected wood trusses. However, the roof is skip sheathed with 1x4 spaced at 24 inches. While the roof framing is likely adequate the skip sheathing is not.

12 METAL PLATE CONNECTED ROOF TRUSSES

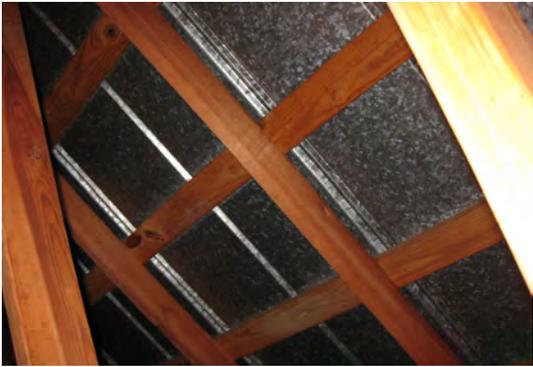
13 1X4 SKIP SHEATHING SPACED AT 24 INCHES
