APPLICATION FOR A CERTIFICATE OF APPROPRIATENESS – STAFF REPORT

COA-0013-2019 308 S BOYLAN AVENUE

## **Montfort Hall**

## Montfort Hall Restoration

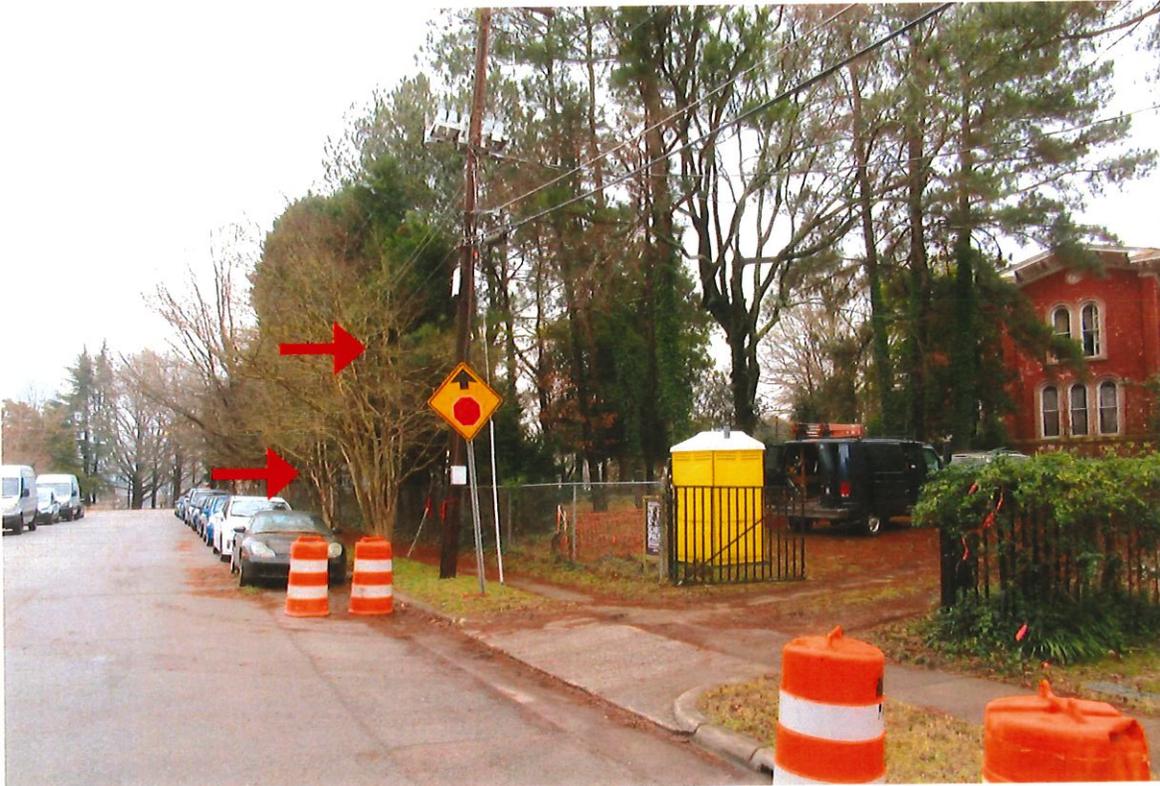
07- Existing curb cut and two street trees proposed for removal/replacment

1.1.5 Two replacement street trees are proposed in the Right of Way where two trees will be removed at the location of the new curb cut. The species is to be determined, in consultation with the City's Urban Forester. Replacement trees will be proposed in a separate CoA with a Master Landscape Plan.

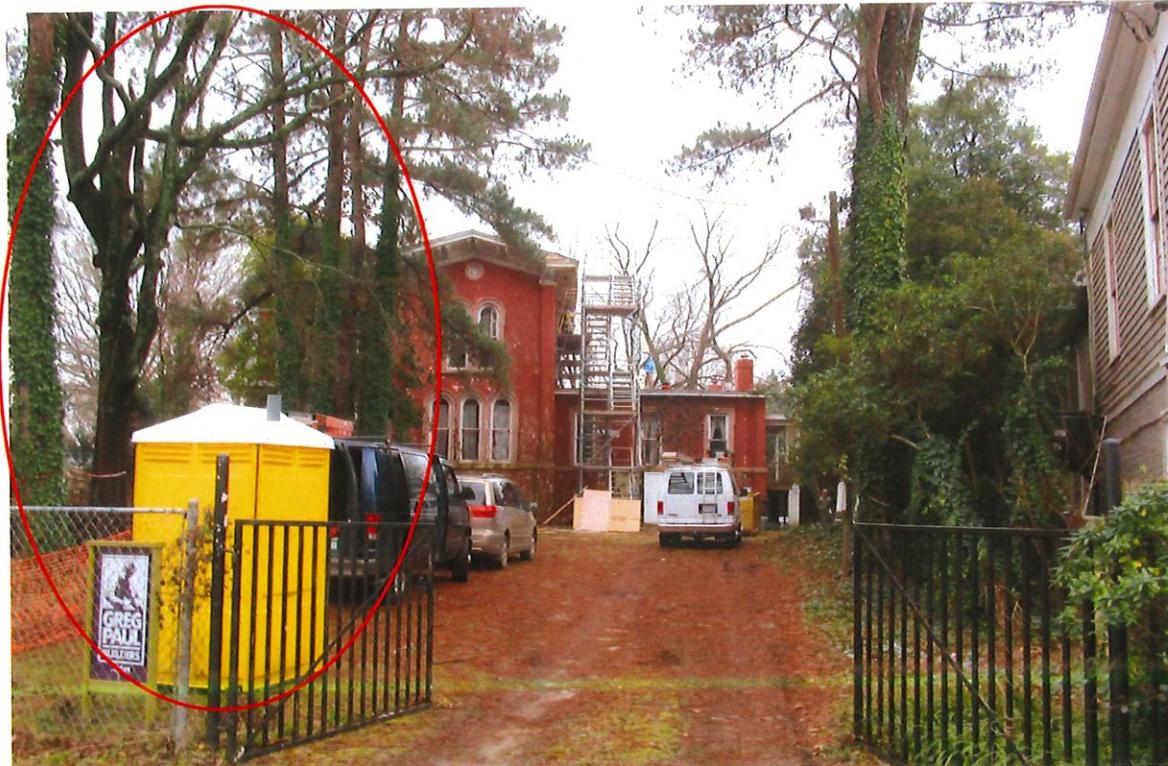
08 - Existing gravel parking area showing area of trees to be removed

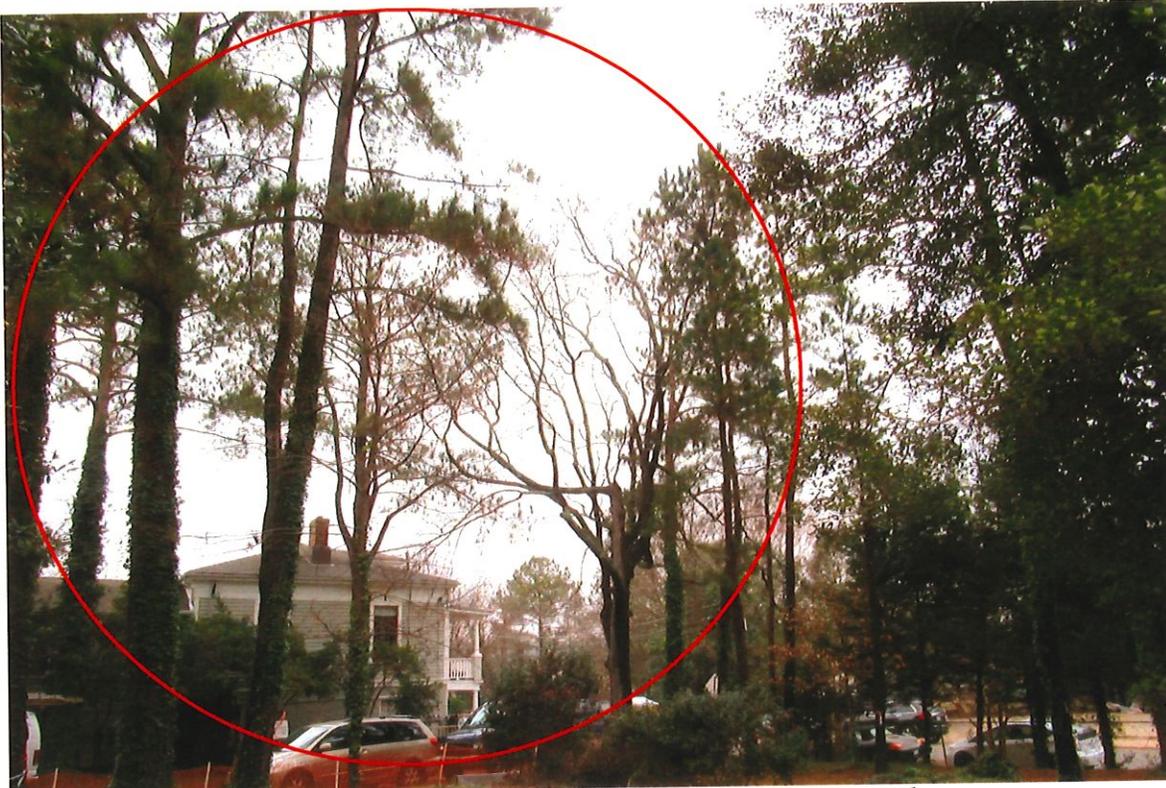
09- Existing parking area showing where trees are proposed for removal

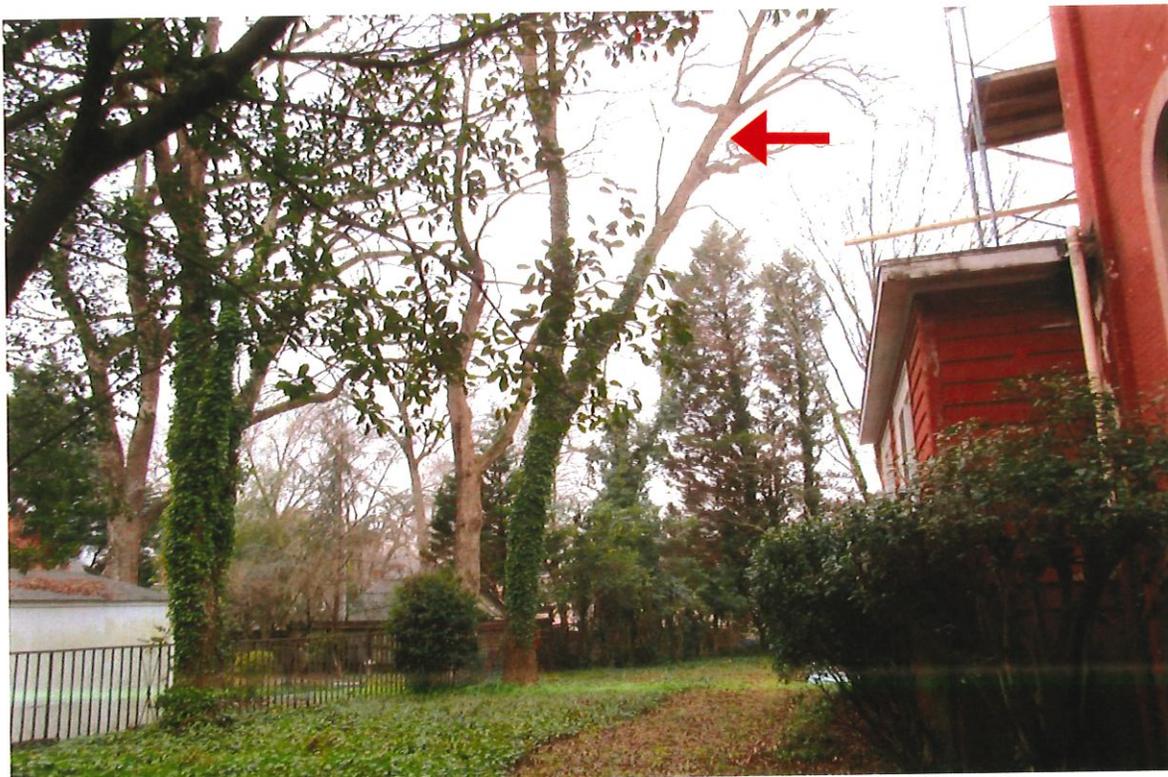
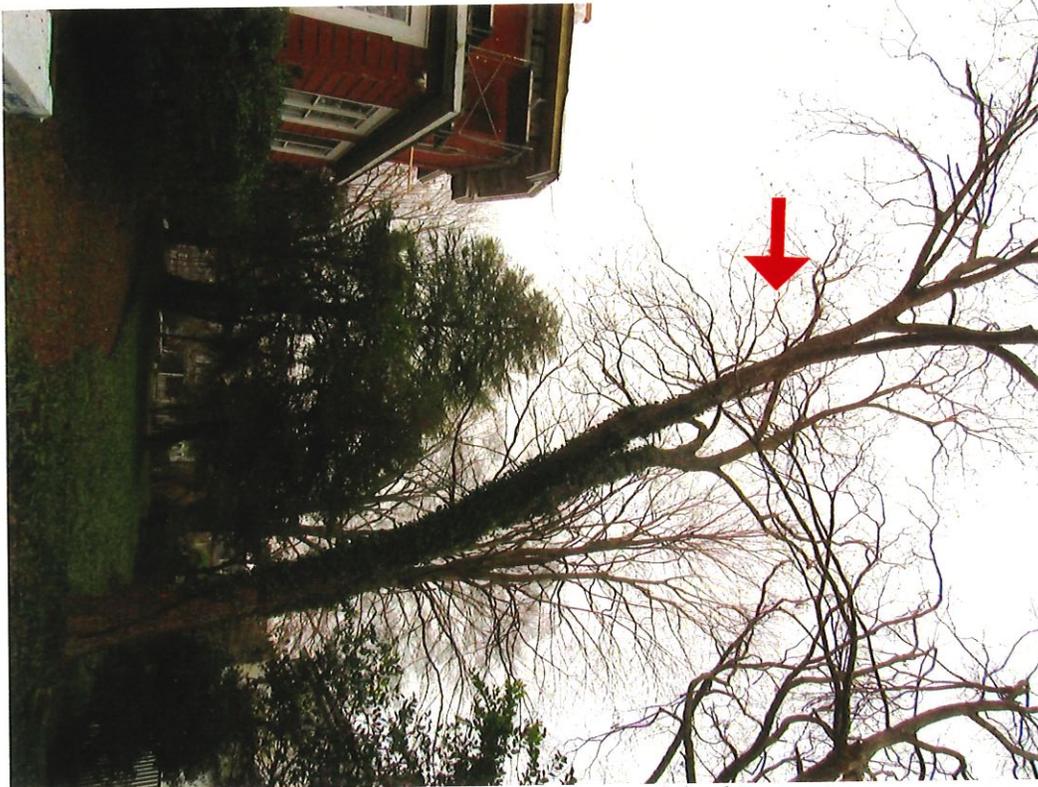
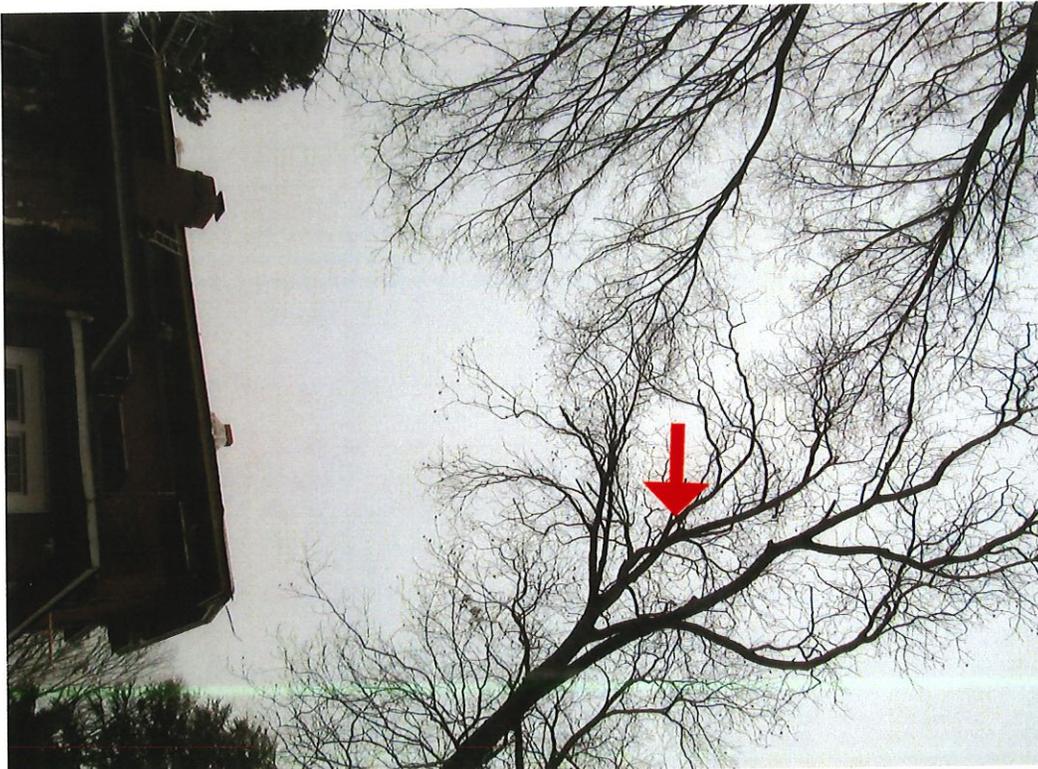
10 - Damaged/diseased 28" Pecan tree to be removed, looking west

11 - Damaged/diseased 28" Pecan tree to be removed, looking east

12 - Crown of damaged/diseased 28" Pecan tree to be removed, looking east

The 28-inch DBH Pecan tree with Poor Form, near the left rear corner of the home is leaning and growing over the structure. This tree is more likely to fail due to the heavy leaning - Should be Removed to prevent damage to the home in the event of a storm.

1.3.5 Two diseased and damaged trees are proposed for removal, a 28" Pecan tree on the southern property line and a 16" Holly tree northeast of the building. See letter from ISA certified arborist regarding removal of these trees.

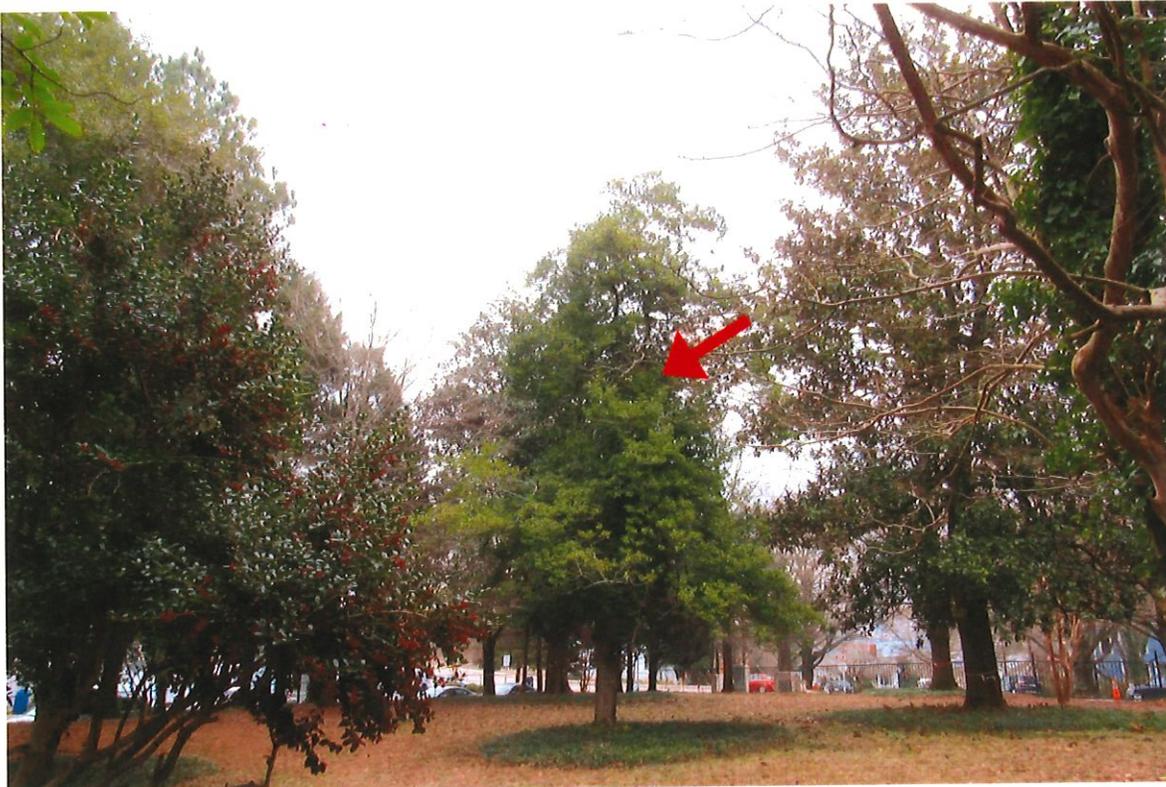
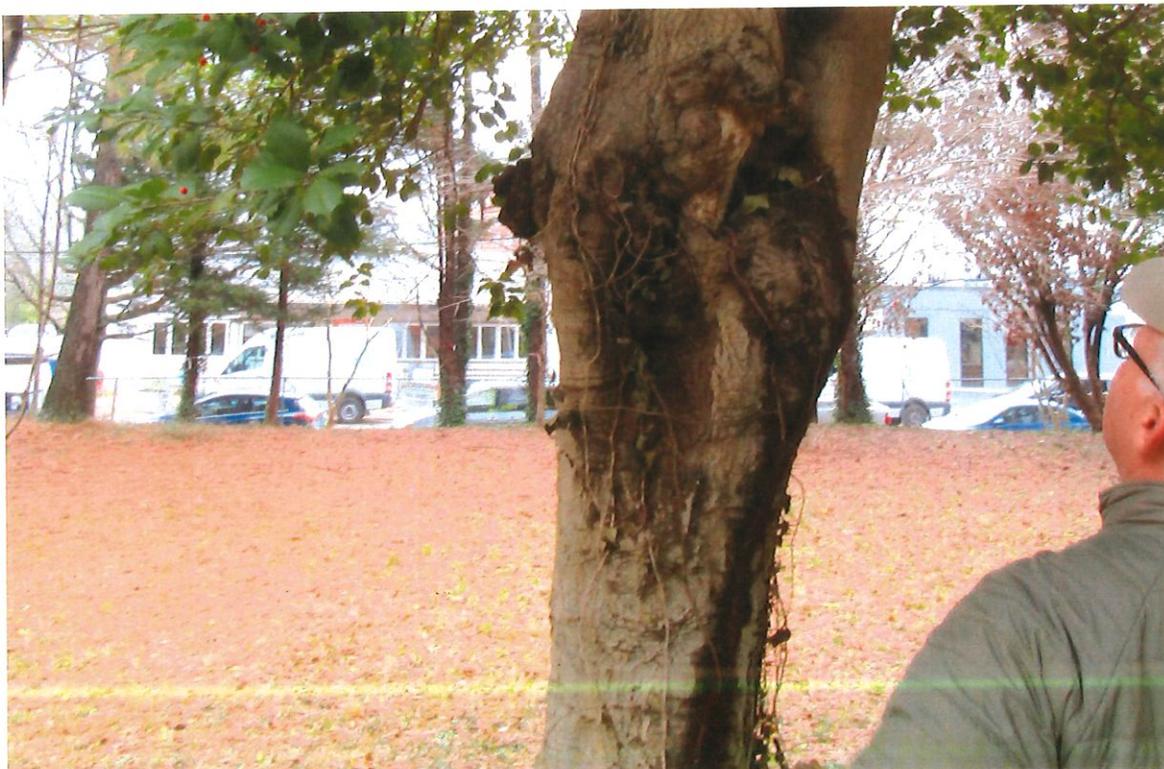
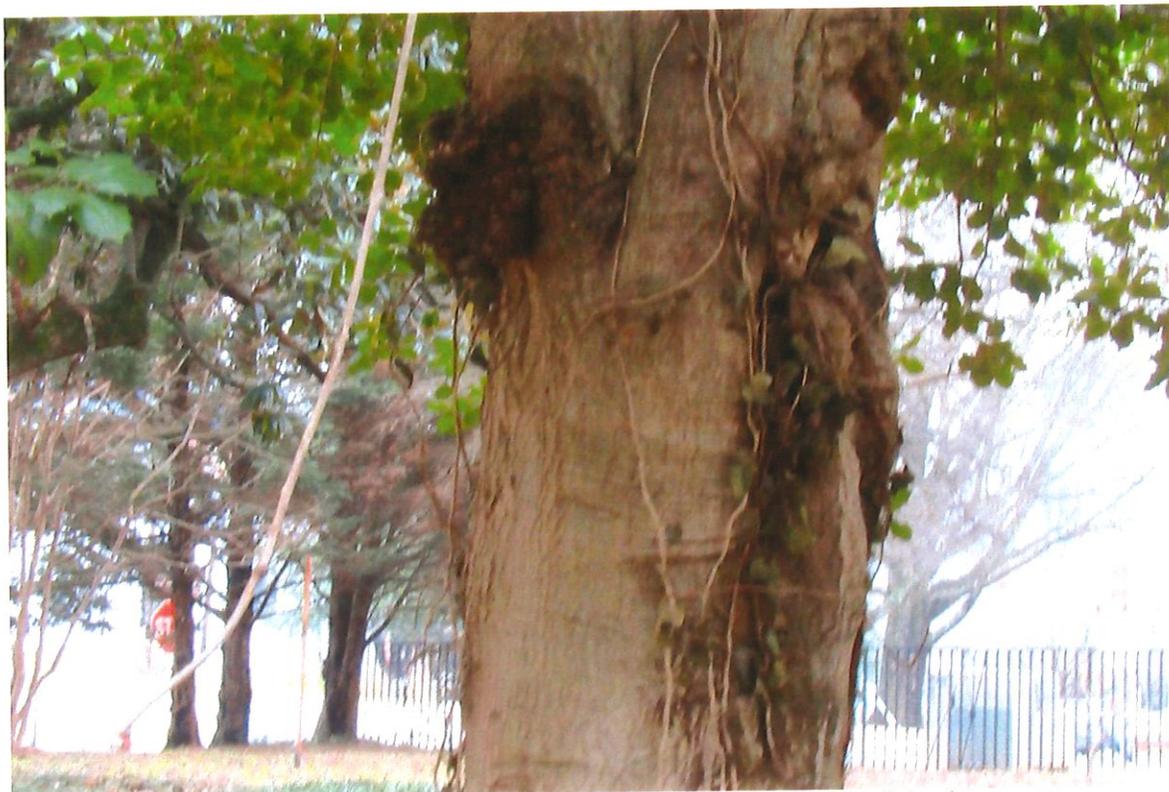
13- Damaged/diseased Holly tree proposed for removal

14 - Large stem canker on damaged/diseased Holly tree to be removed, looking north

15- Large stem canker on damaged/diseased Holly tree to be removed, looking east

The 18-inch DBH Foster Holly in the front lawn, right of the home – Should be Removed due to the very large stem canker on the main stem, approximately 6 ft from the ground. The canker disease has weakened the tree and made it very likely to fail.

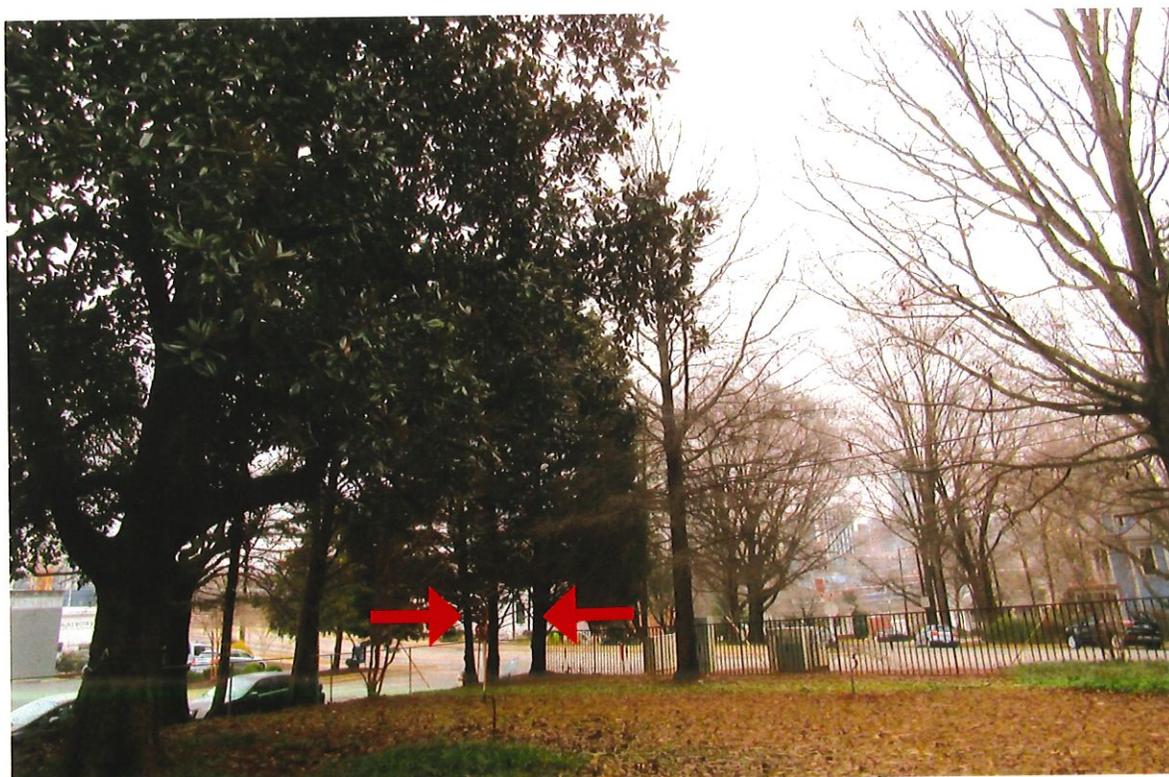
16 - 13" and 8" Cypress trees proposed for removal in significant view corridor

1.3.1 There are 50 mature trees on the site with a DBH of 8" or greater. 35 of these trees are to be retained. In the location designated for a new parking area, 11 trees are proposed for removal. At the northeast corner of the property and the intersection of Boylan Ave and Mountford St., two trees are proposed for removal in order to thin out and restore the significant view in this location.

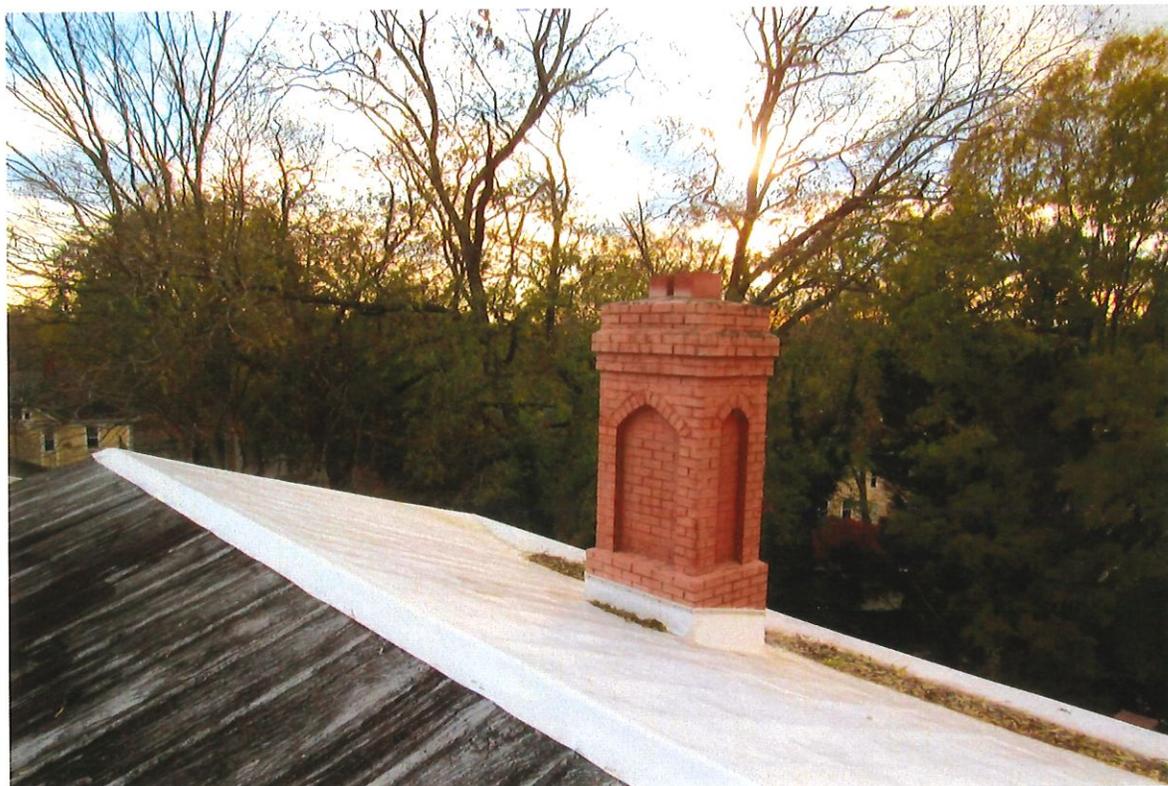
Per the NR nomination, the Boylan Heights Baptist Church bought the building in 1954 and began an extensive renovation which included the coating of all exterior masonry in a white cement based paint. The building and chimneys were later repainted in a dark red acrylic paint. There are four chimneys on the upper roof and two on the lower roof. Two of the chimneys (3 & 4) on the upper roof have been either partially or completely rebuilt. Chimney 4 has been rebuilt from the roof up to match the detailing and dimensions of the original chimneys. The masonry has been painted in red acrylic paint. This chimney is not historic.

01 - Existing, rebuilt chimney 4 - not historic

The architect and general contractor recommend removing existing chimneys 1 - 4 and rebuilding from the surface of the roof up, along with replacing the original terne roof with a new metal roof. The new chimneys will match the original chimneys in detail and dimension. Rebuilding the chimneys from the roof up while the roof is being replaced has many advantages over the life of the building. The new masonry chimneys can be properly waterproofed and through wall flashing installed at the base above the roof, ensuring that any moisture in the exposed portion of the chimney will be expelled before being allowed to enter the building envelope. Damaged structural members will be repaired and the new roof will ensure that the building is protected and weather-tight. The roof is approximately forty feet above grade. The only portion of the roof that is visible from the ground is the cupola roof. While two of the four chimneys on the upper roof are believed to be original and can be partially seen from the ground, the chimneys themselves do not significantly contribute to the character of the historic building. Rebuilding the chimneys to match the original and replacing the 160 year old roof will ensure the long term preservation of the structure as a whole.

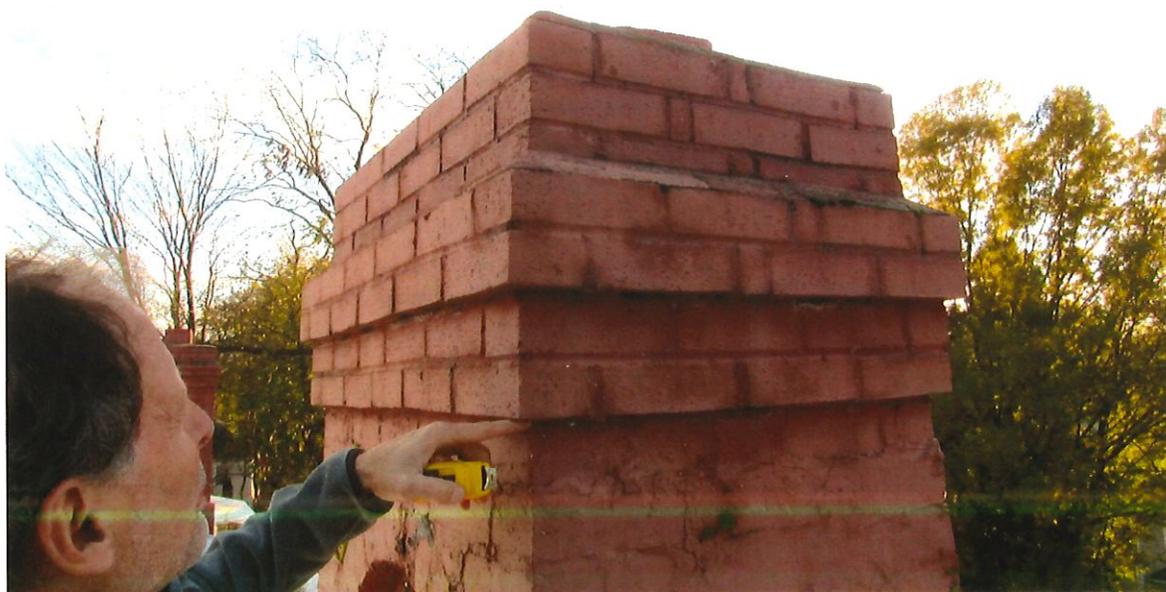
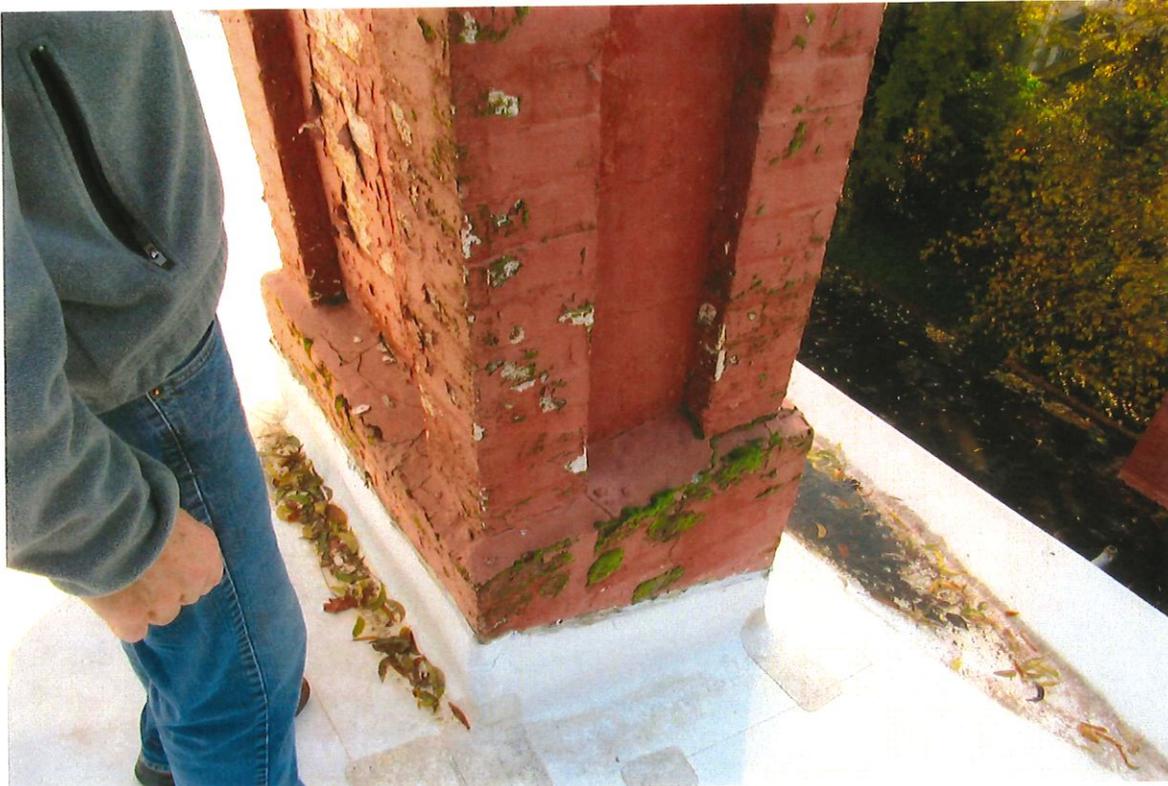
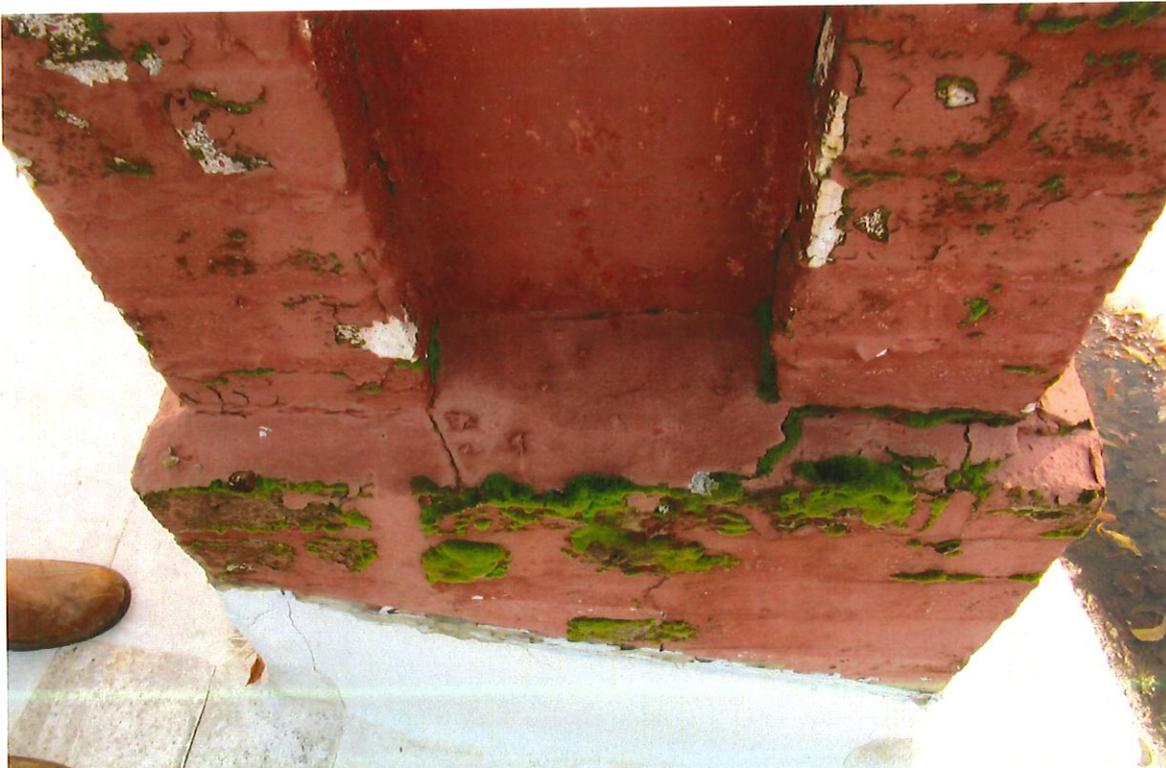
Chimney 3 has had the cap rebuilt which is painted in the red acrylic paint; the lower portion of the chimney is coated in the white cement based paint and a layer of acrylic paint. There is significant moisture trapped inside the masonry chimney, resulting in the growth of moss, etc. The layer of red acrylic paint is blistering and peeling, and the under layer of white paint is cracking and coming off in large chunks, taking the face of the brick with it.

02 - Chimney 3 with rebuilt cap

03- Base of chimney 3, north side

04 - Base of chimney 3, north side

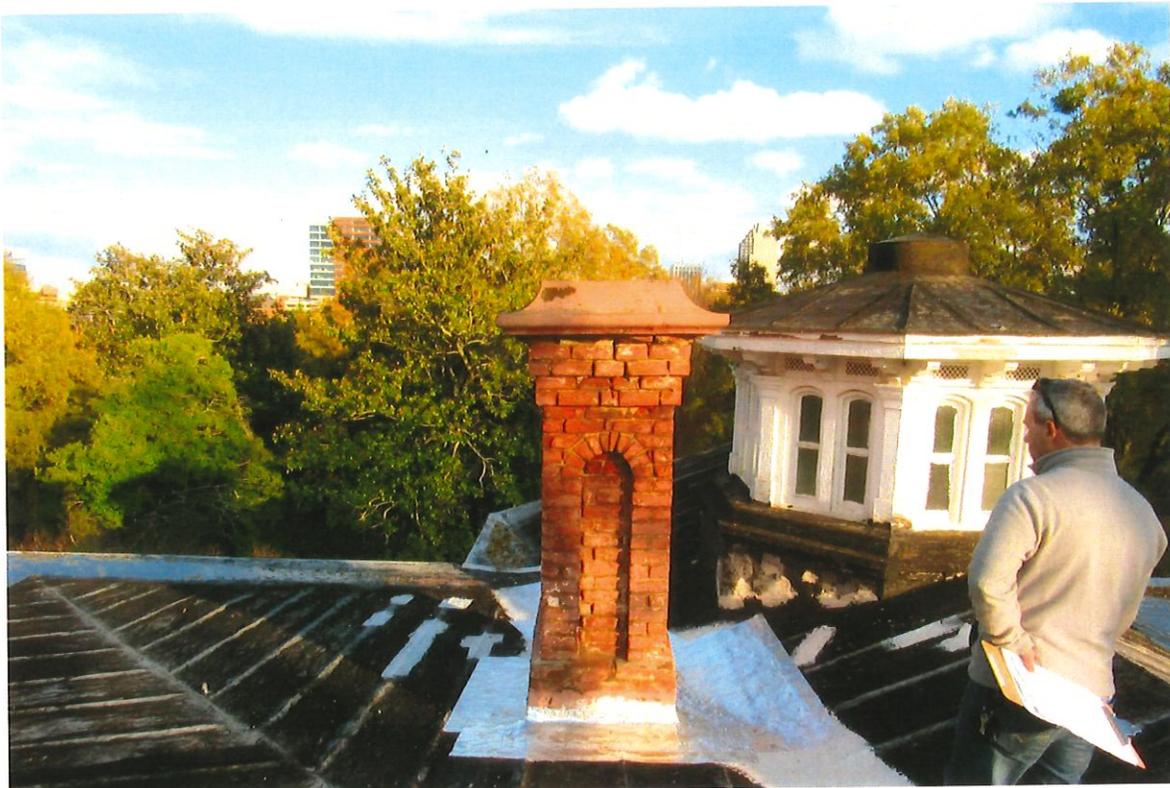
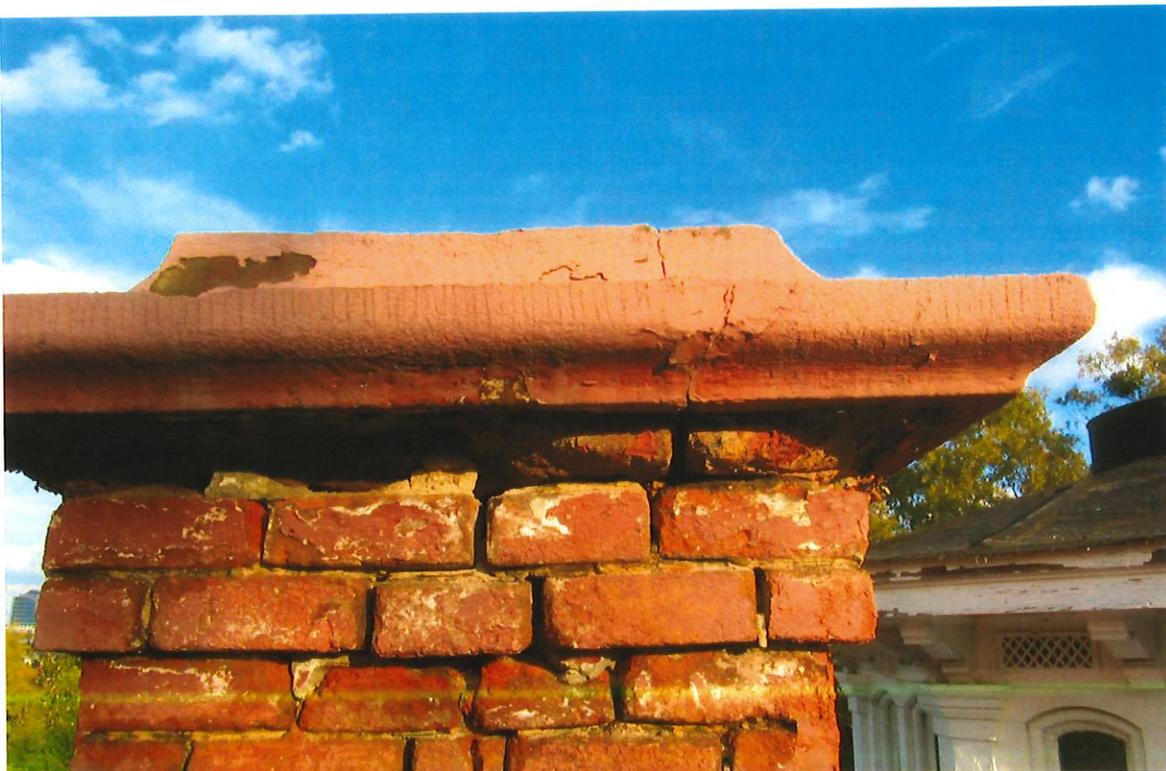
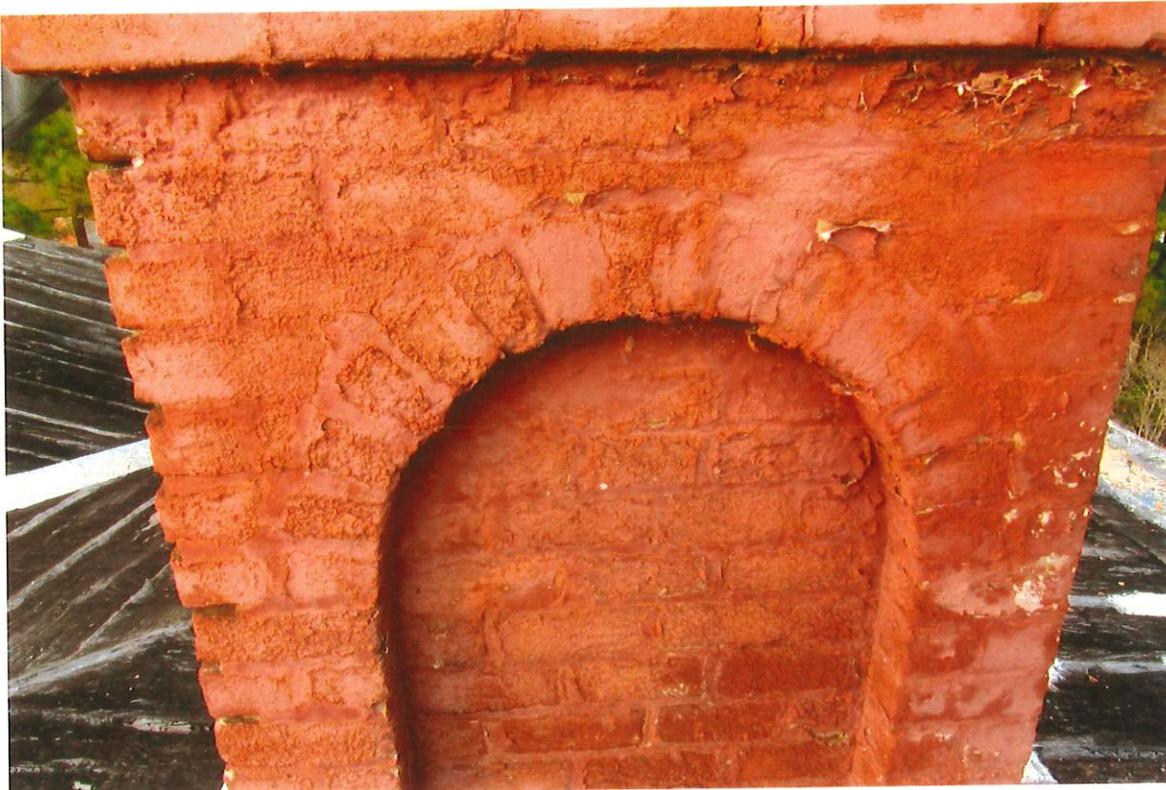
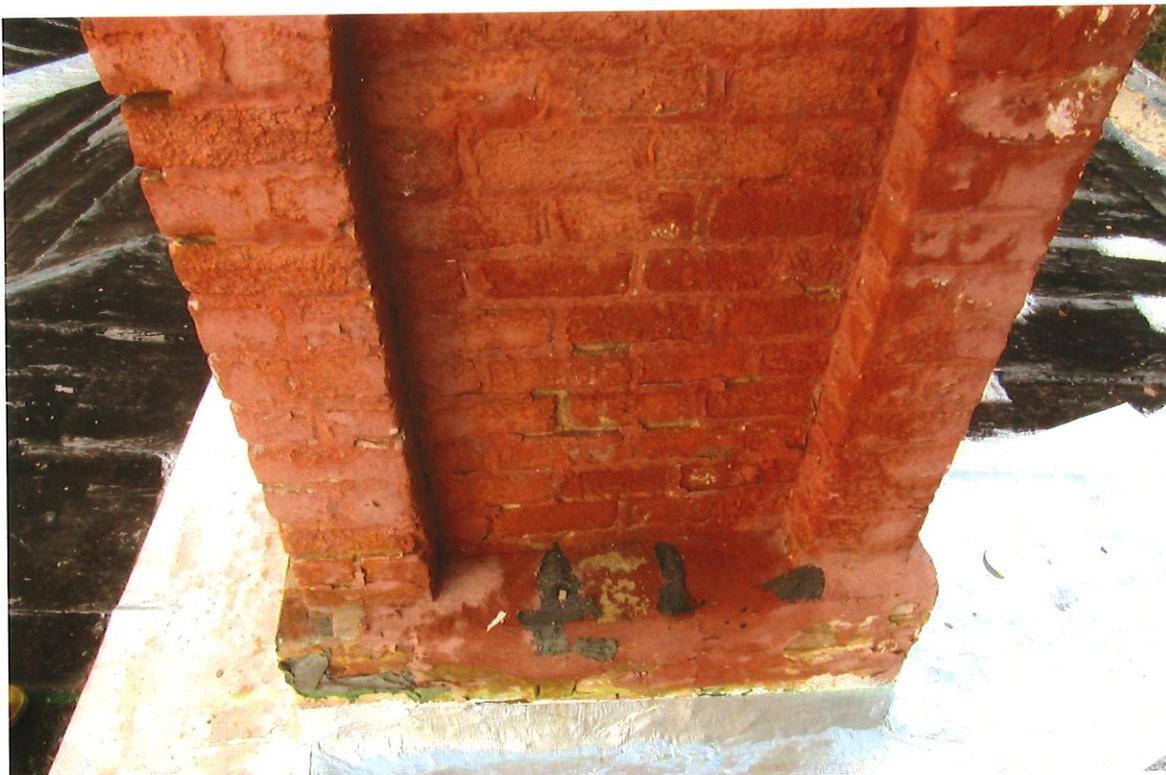
Chimneys 2&3 are believed to be original, and are both topped by a sandstone cap. The chimneys have been painted with the white cement based paint that has trapped moisture in the mortar and bricks, evidenced in the spalling of the brick face. The outer layers of paint making up the surface are blistered, most likely from the trapped moisture evaporating through the surface of the brick over time. The paint has been removed with a hand scraper on the western face of chimney 2 as a test area, with the original intent of repointing and repairing the masonry chimneys. Within the test area, it is clear that the masonry has been significantly compromised.

05 - Chimney 2, west side

06 - Chimney 2, test area on west side

07 - Chimney 2, south side

08 - Chimney 2, south side

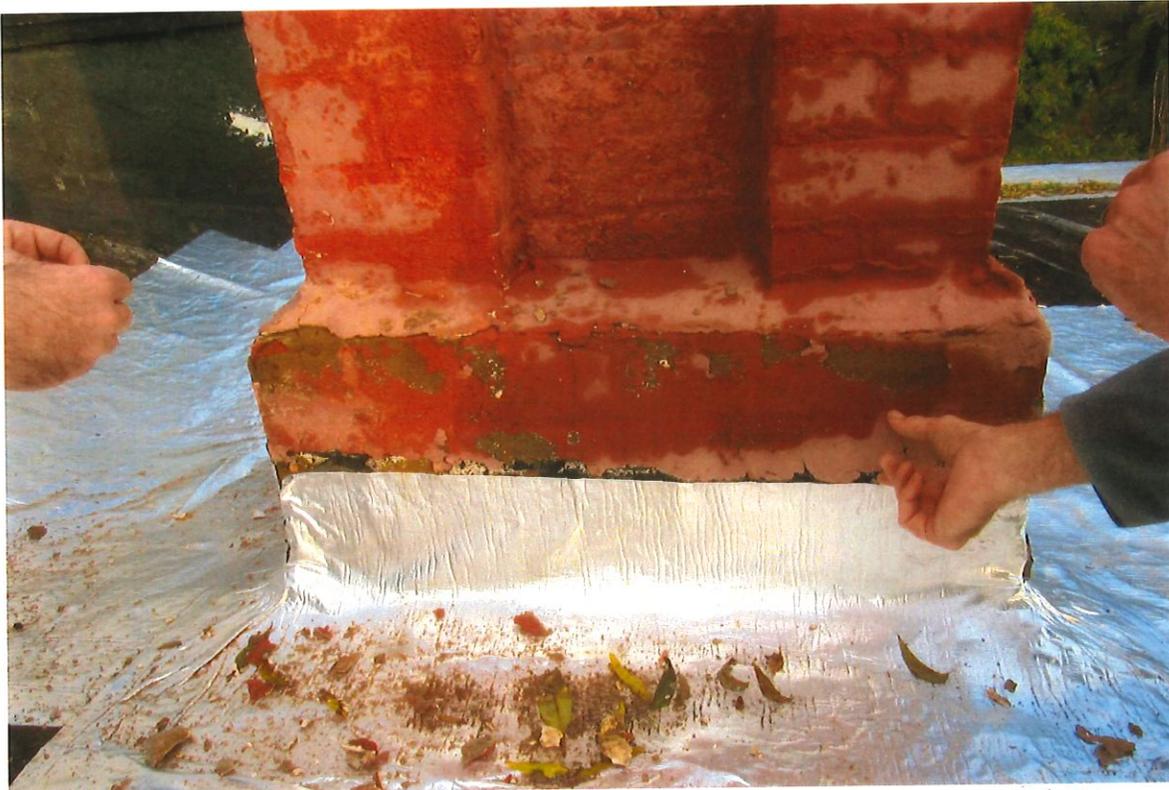
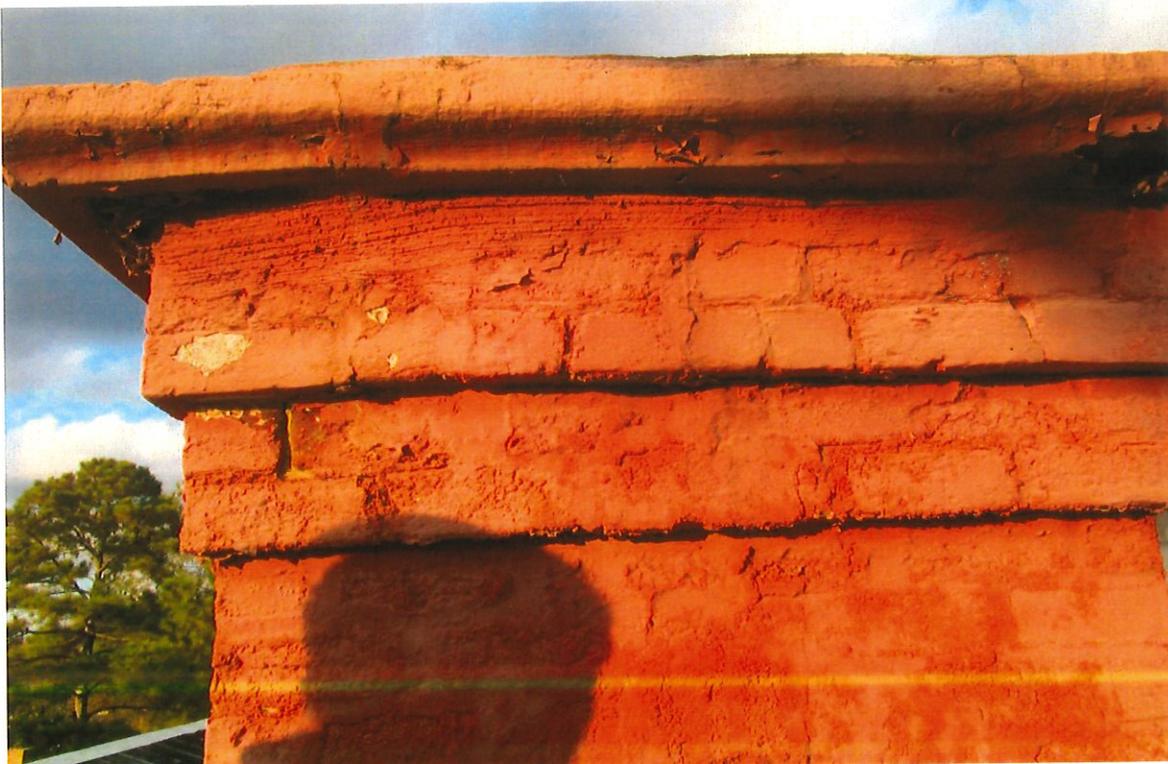
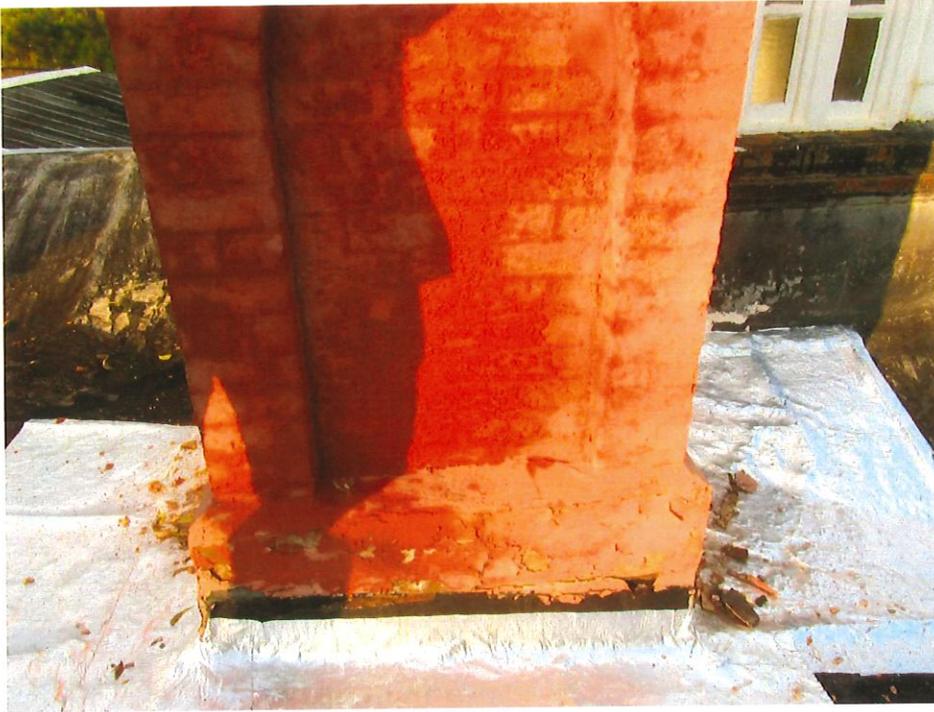
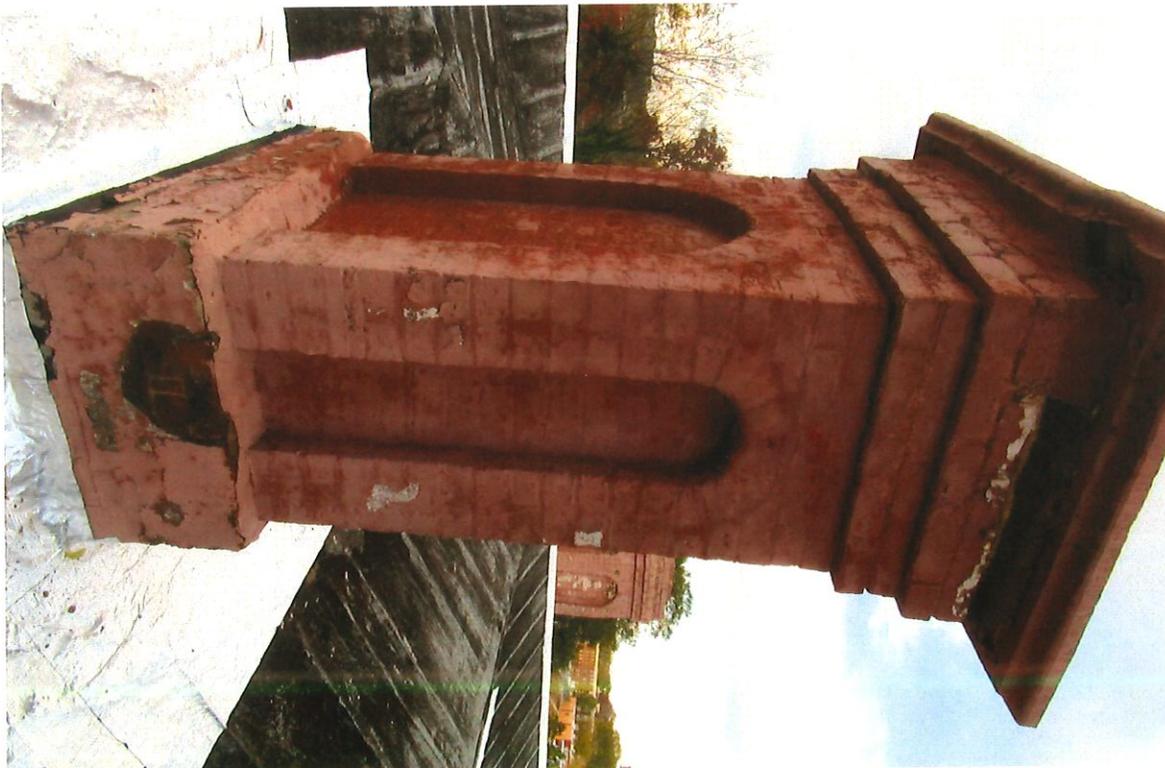
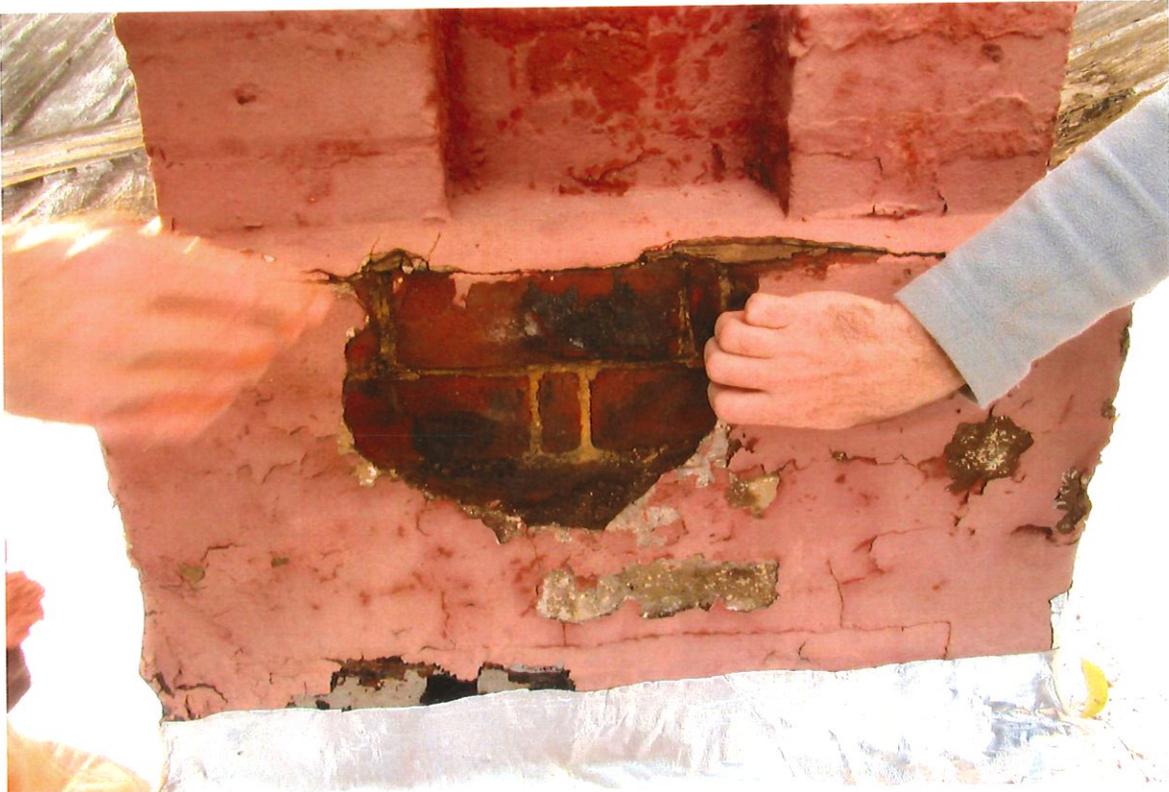
The brick face is in advanced state of deterioration, making the original chimneys poor candidates for repointing and repair. Within the building on the second floor, evidence of moisture intrusion from the masonry chimney can be seen above the fireplace and mantel.

09 - Chimney 1, west side

10 - Chimney 1, south side

11 - Chimney 1, south side

12 - Chimney 1, east side

13 - Chimney 1, east side
