APPLICATION FOR A CERTIFICATE OF APPROPRIATENESS – STAFF REPORT

COA-0013-2019 308 S BOYLAN AVENUE

## **Montfort Hall**

## Montfort Hall Restoration

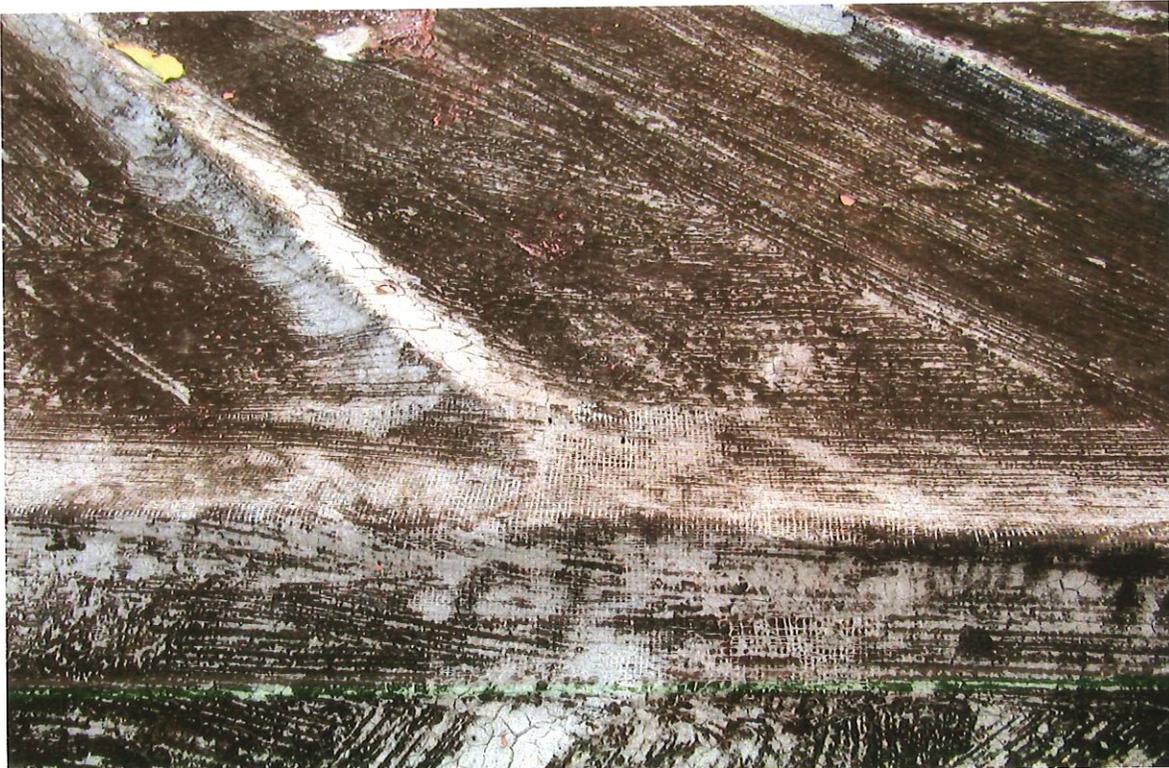
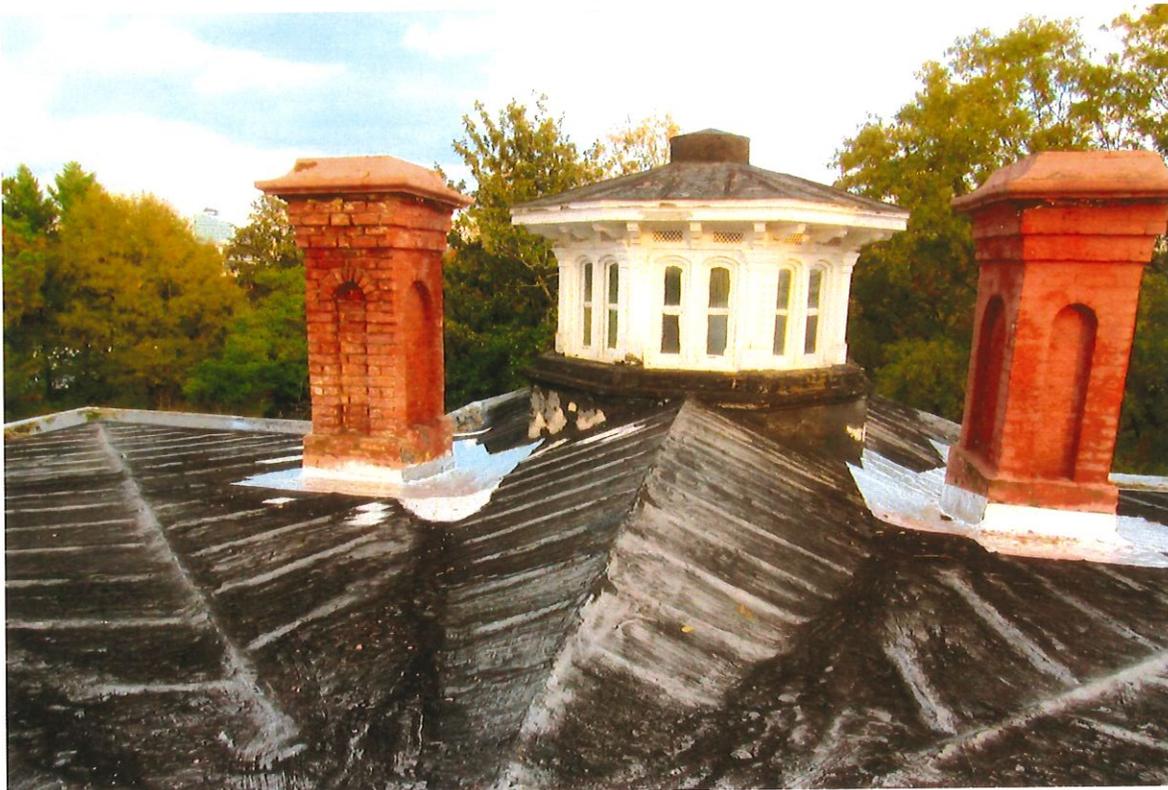
The existing roof at Montfort Hall consists of the following; the main or upper cross gabled roof and cupola roof is terne that is believed to be original. The terne was later repeatedly coated with fiberglass and tar in what appears to be an attempt at repair. The existing surface of the upper roof is blistered and cracking. The terne roof has also been patched in multiple locations with a variety of materials including a self-adhering waterproofing membrane, primarily around the cupola chimneys and the roof valleys. Water damage from the active roof leaks continues to compromise the interior of the building, including decorative plaster work. The back or western slope of the upper roof is a membrane roof, presumably laid over the original terne coated with fiberglass and tar. The lower roof on the western ell of the building is asphalt, as are the porch roofs on the west and east elevations. There are built in gutters on the upper roof that are no longer operational and water is standing at the perimeter of the upper roof in multiple locations. Due to the long term presence of water, there is significant structural damage to the wood members or lookouts supporting the deep overhangs around the roof perimeter. There is also structural damage to primary roof members within the interior of the building due to the water infiltration over a long period. See roof plan and photo documentation for reference.

14 - Existing roof covered in fiberglass and tar

15 - Existing roof looking east

The architect and general contractor recommend removing existing chimneys 1 - 4 and rebuilding from the surface of the roof up, along with replacing the original terne roof with a new metal roof. The new chimneys will match the original chimneys in detail and dimension. Rebuilding the chimneys from the roof up while the roof is being replaced has many advantages over the life of the building. The new masonry chimneys can be properly waterproofed and through wall flashing installed at the base above the roof, ensuring that any moisture in the exposed portion of the chimney will be expelled before being allowed to enter the building envelope. Damaged structural members will be repaired and the new roof will ensure that the building is protected and weather-tight. The roof is approximately forty feet above grade. The only portion of the roof that is visible from the ground is the cupola roof. While two of the four chimneys on the upper roof are believed to be original and can be partially seen from the ground, the chimneys themselves do not significantly contribute to the character of the historic building. Rebuilding the chimneys to match the original and replacing the 160 year old roof will ensure the long term preservation of the structure as a whole.

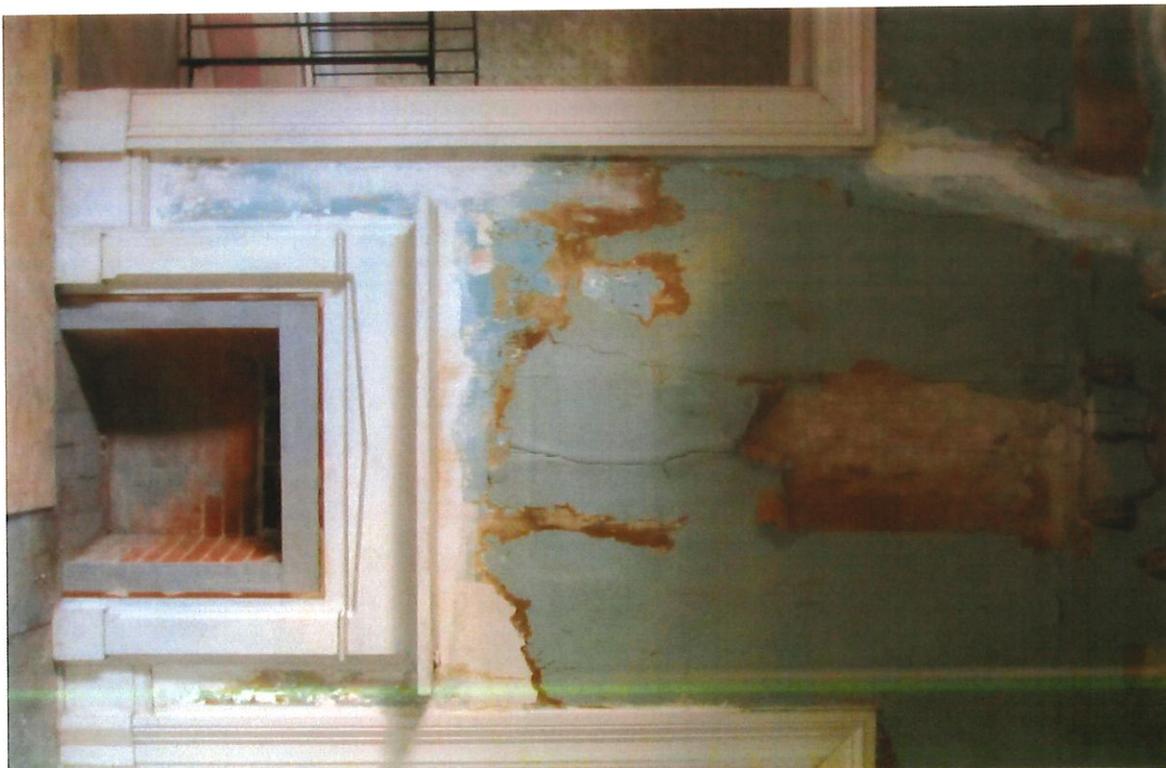
The brick face is in advanced state of deterioration, making the original chimneys poor candidates for repointing and repair. Within the building on the second floor, evidence of moisture intrusion from the masonry chimney can be seen above the fireplace and mantel.

16 - Second floor bedroom below chimney 2 - note water damage above mantel
