Building Energy Audit Report: City of Raleigh
NC Department of Commerce Energy Fellowship
April 2012

Anna Leonard
Sustainability Technician
City of Raleigh
919.996.4258
Anna.Leonard@RaleighNC.gov

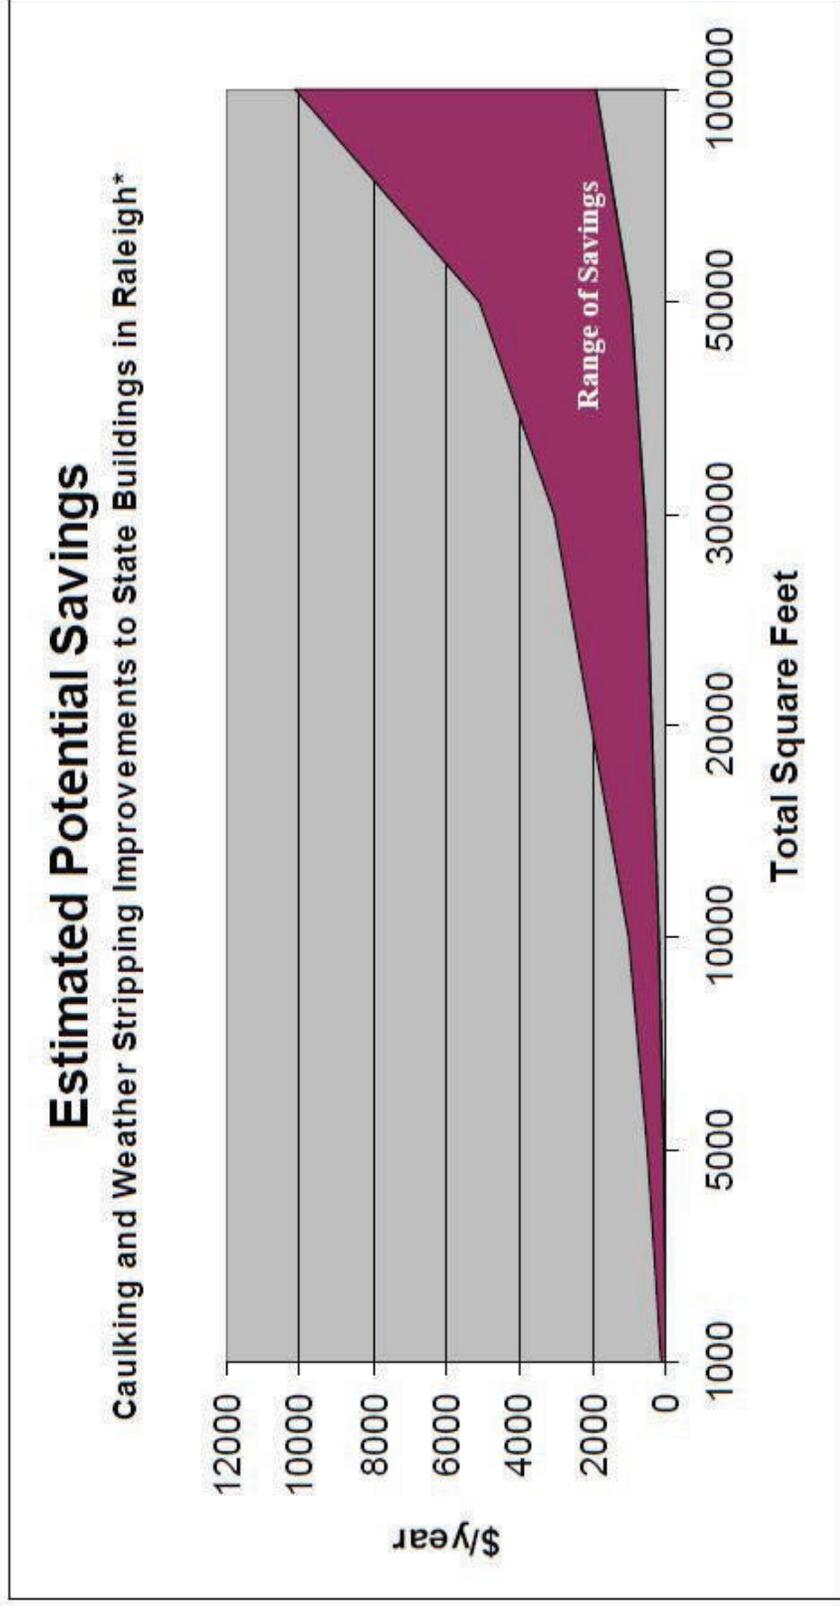
15. Weatherization Savings

*The above estimates are based on a NIST study of air infiltration rates in two buildings using the actual total energy cost of \$1.59/sf for state-owned facilities in Raleigh, NC.
