APPLICATION FOR A CERTIFICATE OF APPROPRIATENESS – STAFF REPORT

COA-0034-2019 517 S BLOUNT STREET

Nature of Project: Construct rear stair and roof deck; construct egress area; install 6’7” fence; construct front ramp; restore storefront; remove bars from windows; install new window and door; install rear garage door; install new mechanical units; change paint colors

517 S BLOUNT ST. RALEIGH
HISTORIC REVIEW DOCUMENT
TOMA | FARREN ARCHITECTS

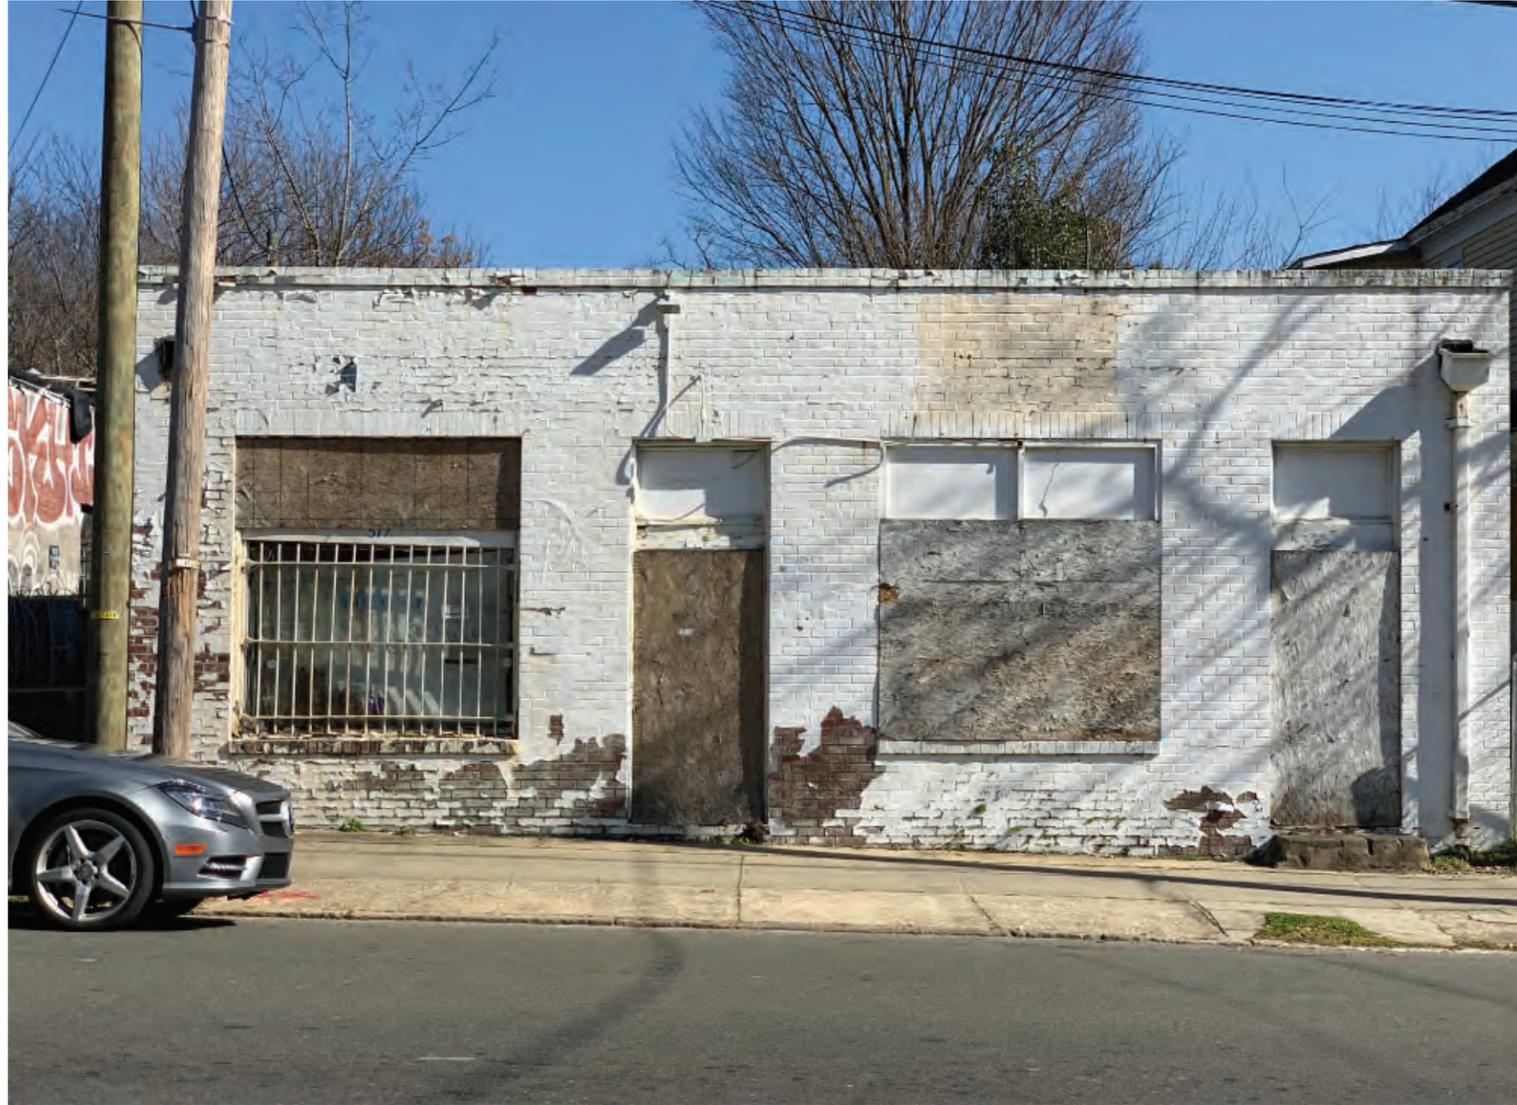
WEST FACADE - RESTORE PAINTED WOOD STOREFRONT AND DOORS. SALVAGE GLASS AND CHECK CASHING SIGNAGE ON LEFT WINDOW, PROVIDE ADA ENTRY RAMP UP TO LEFT ENTRY DOOR.

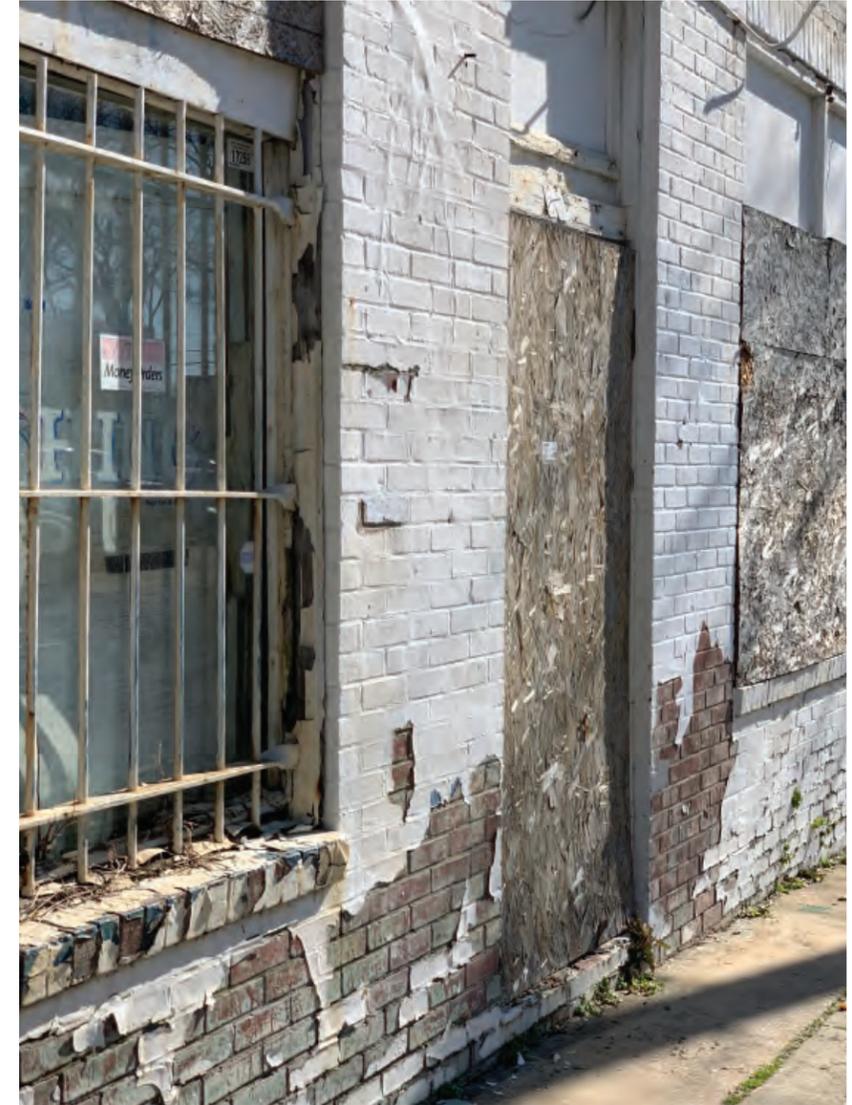
WEST FACADE - REMOVE WINDOW BARS, RESTORE EXISTING WOOD STOREFRONT WINDOWS AND DOORS

- 4* The application proposes the removal of the bars in front of the windows.

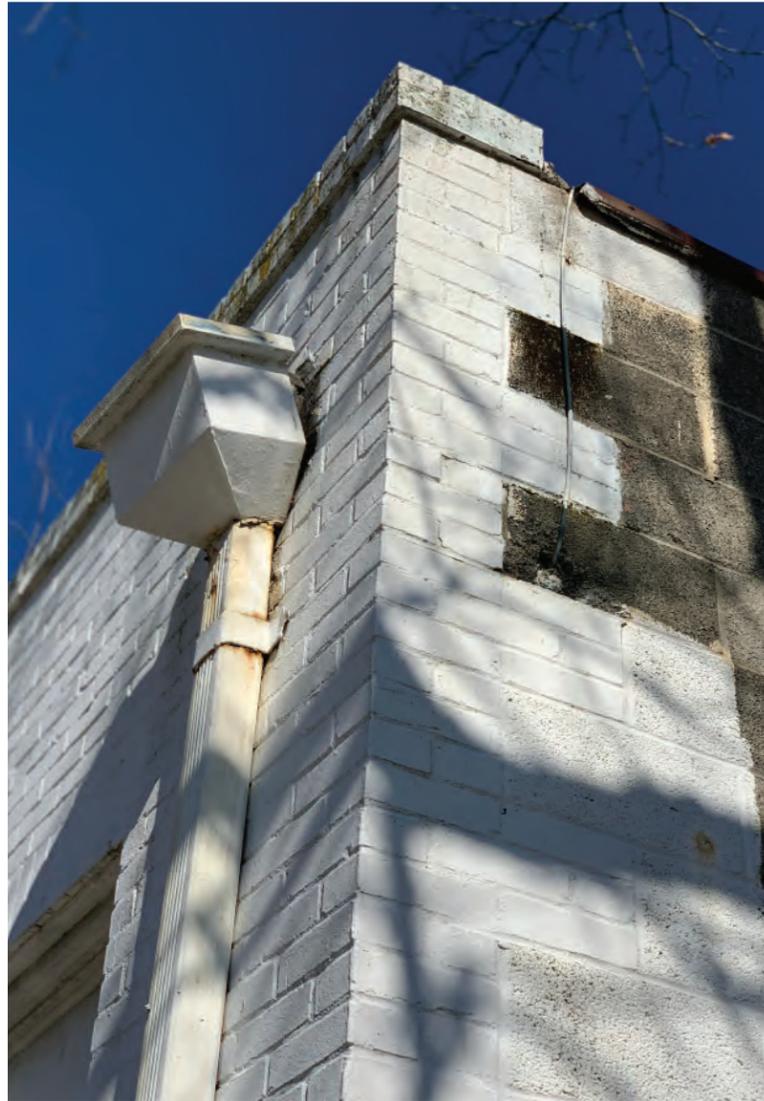
WEST + SOUTH FACADE - RESTORE BRICK DETAILING, REMOVE PAINT, REPLACE EXISTING DOWNSPOUT

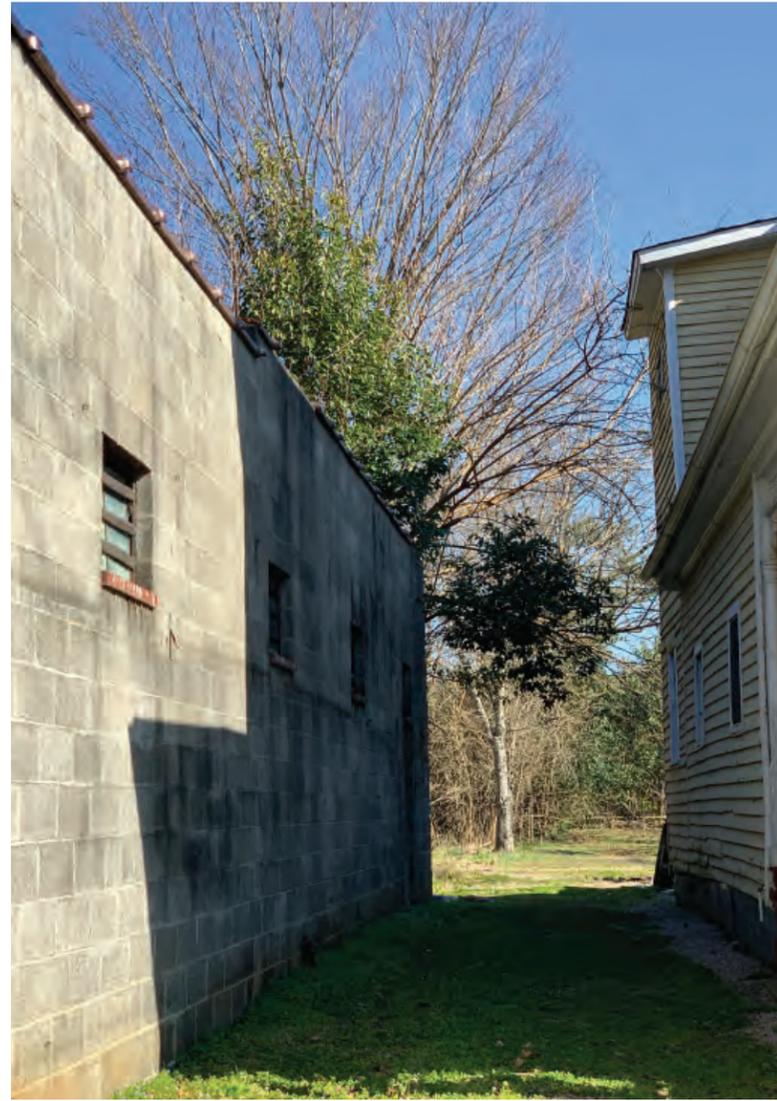
SOUTH FACADE - REPLACE GLASS IN EXISTING WINDOWS WHERE NEEDED, REMOVE WINDOW BARS

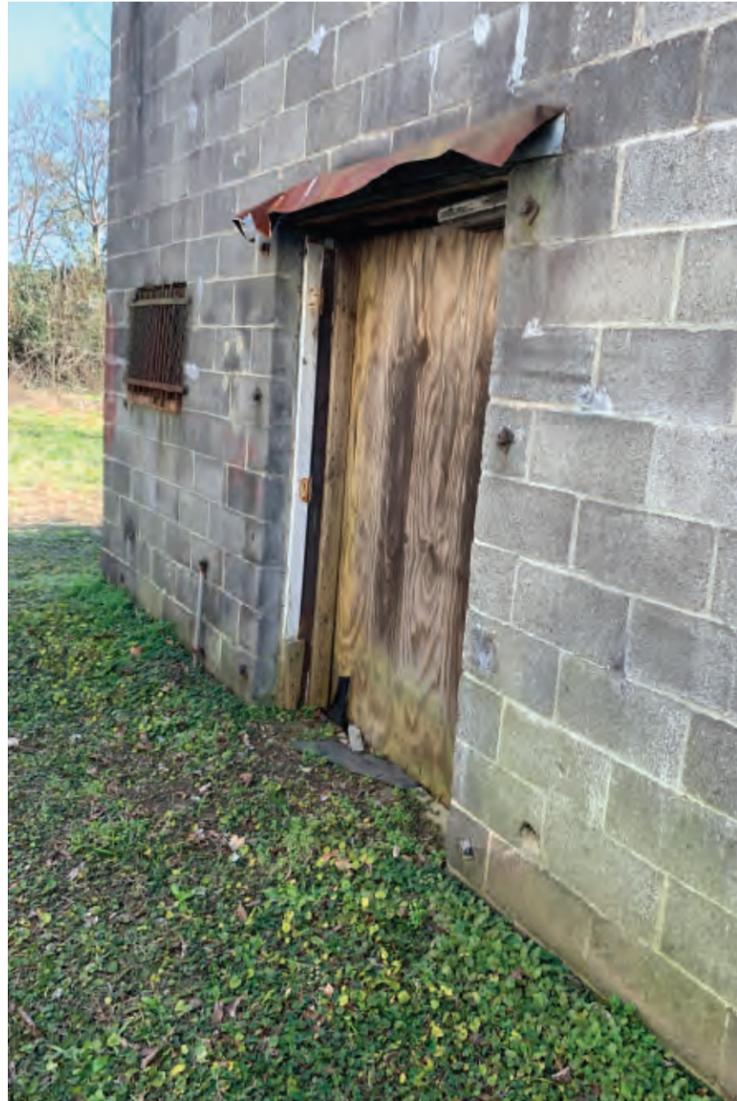
NORTH FACADE- REPLACE DOOR WITH WINDOW, REMOVE BARS FROM WINDOW REMOVE METAL OVERHANG,

- 5* A door opening that has been blocked off with wood is proposed to be converted into a window. The proposed picture window fills the existing opening. The width of the opening is comparable to the existing windows; however, the location of the opening results in a window that is not in harmony with the existing windows. The proximity of the window to the ground is incongruous and atypical to a historic commercial structure. Window specifications were not provided.

- 6* The remains of a small metal roof located over the door opening are proposed to be removed.
- 7* The application includes paint details for the wood windows on the front facade, the masonry, and the new front doors. Paint specifications were provided, but samples were not.

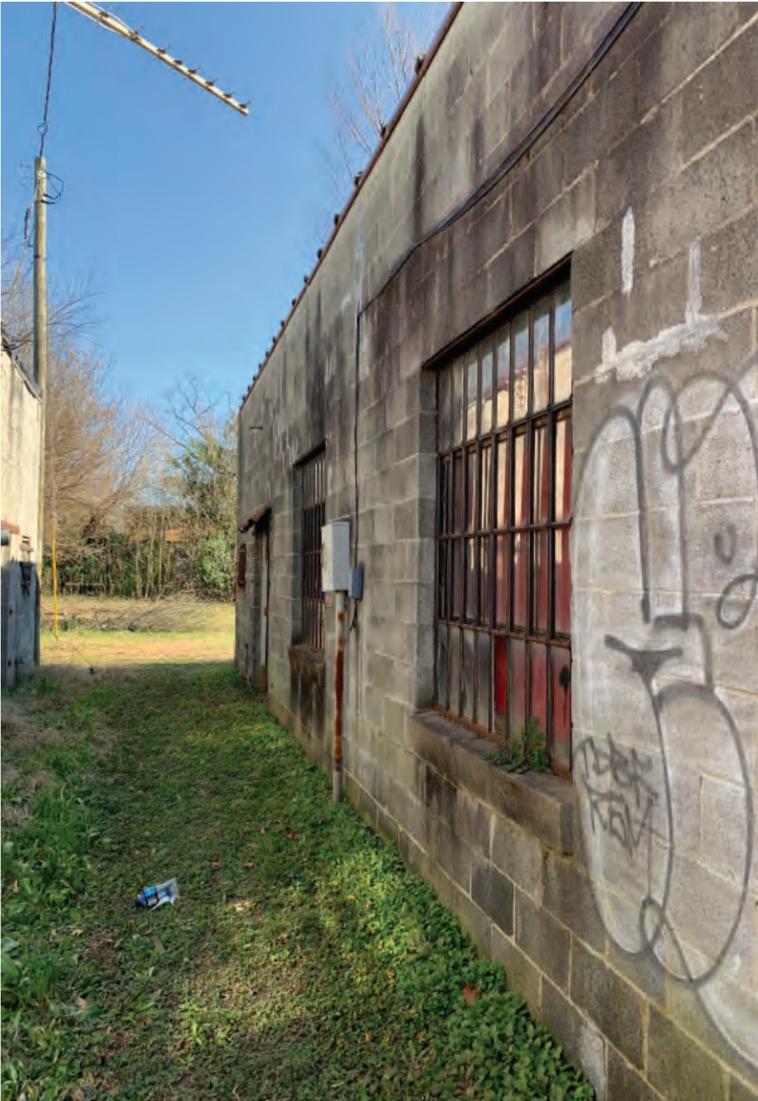
NORTH FACADE - EXISTING WINDOWS - REPLACE GLASS WHERE NEEDED, REAPPLY TERRACOTTA COPING

- 2* Terracotta coping is proposed to be repaired and reinstalled. The application does not state that the coping will be replaced in kind where deteriorated or missing.

2. That the proposed window on the north façade match the sill height and dimensions of the existing windows.
3. That the terracotta coping be replaced in kind where it is deteriorated or missing.

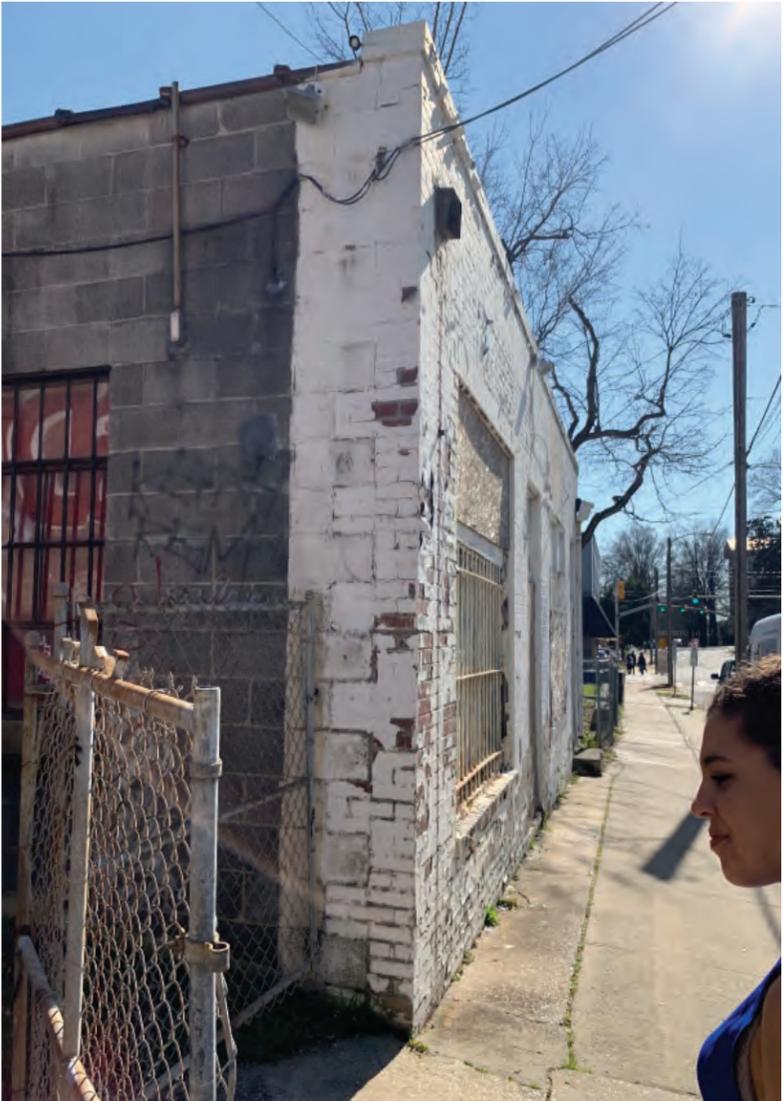
STREET + NORTH FACADE - RESTORE BRICK DETAILING, REMOVE PAINT FROM CMU - REMOVE PAINT FROM BIRCK , REPOINT AS NEEDED,

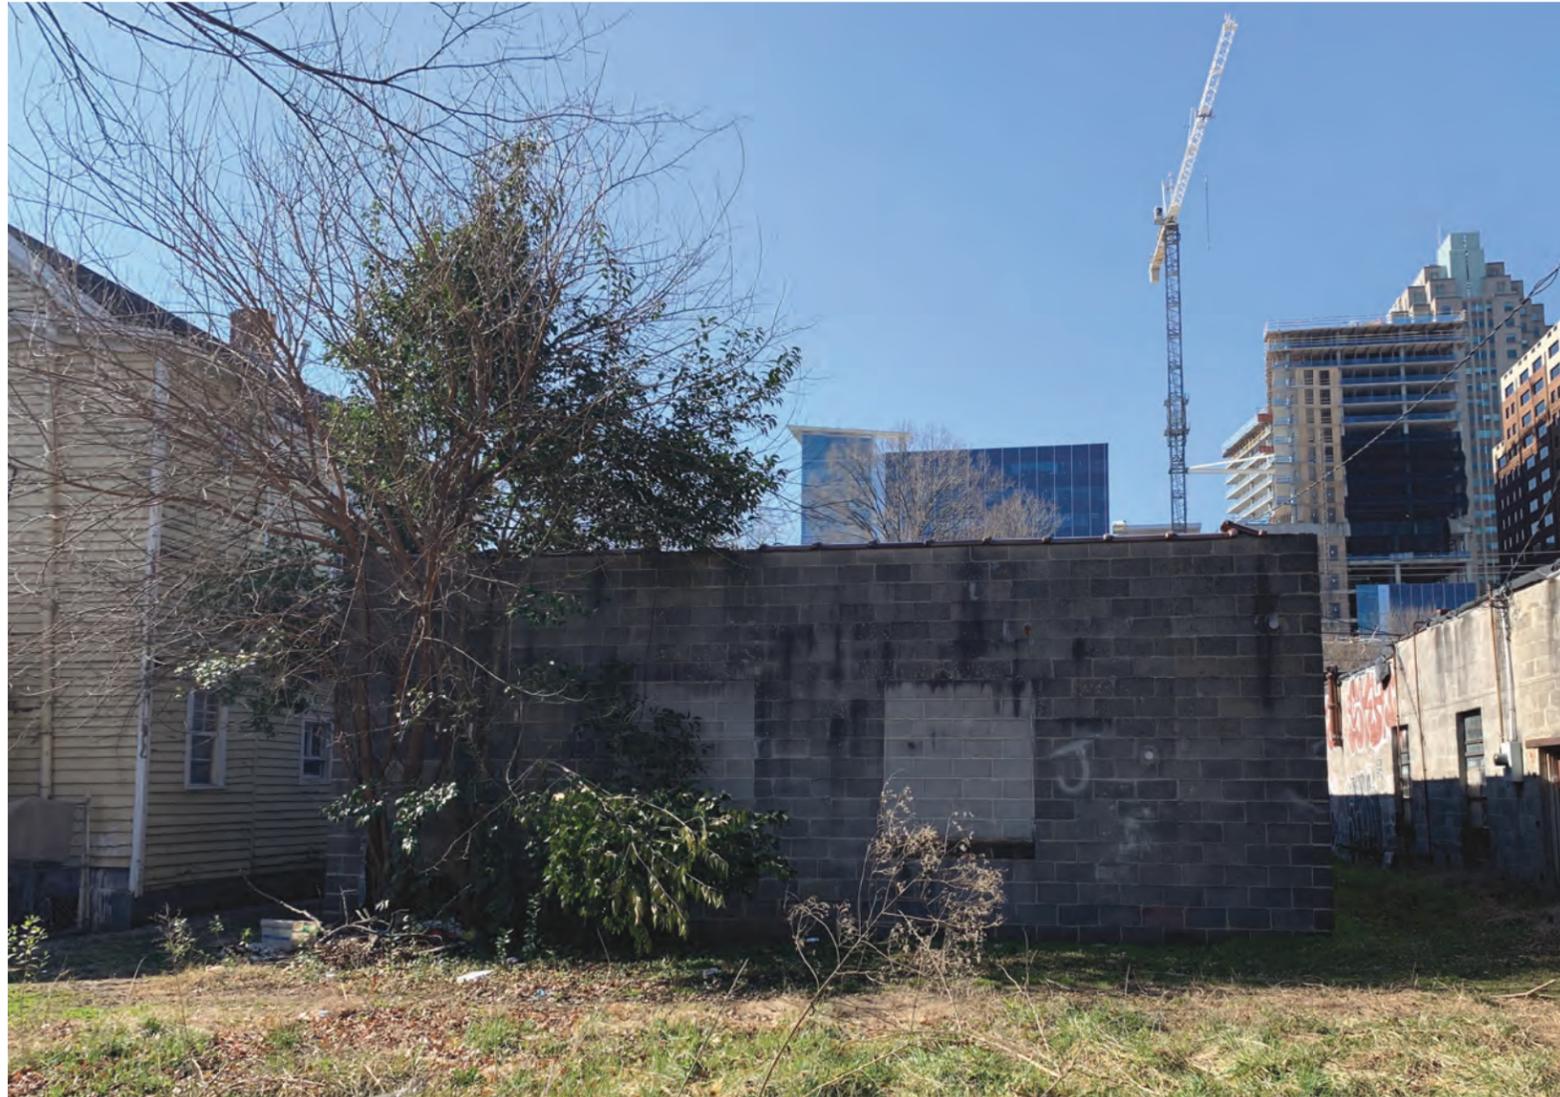
NEW OPENING WHERE EXISTING PUNCHED WINDOWS WERE INFILLED

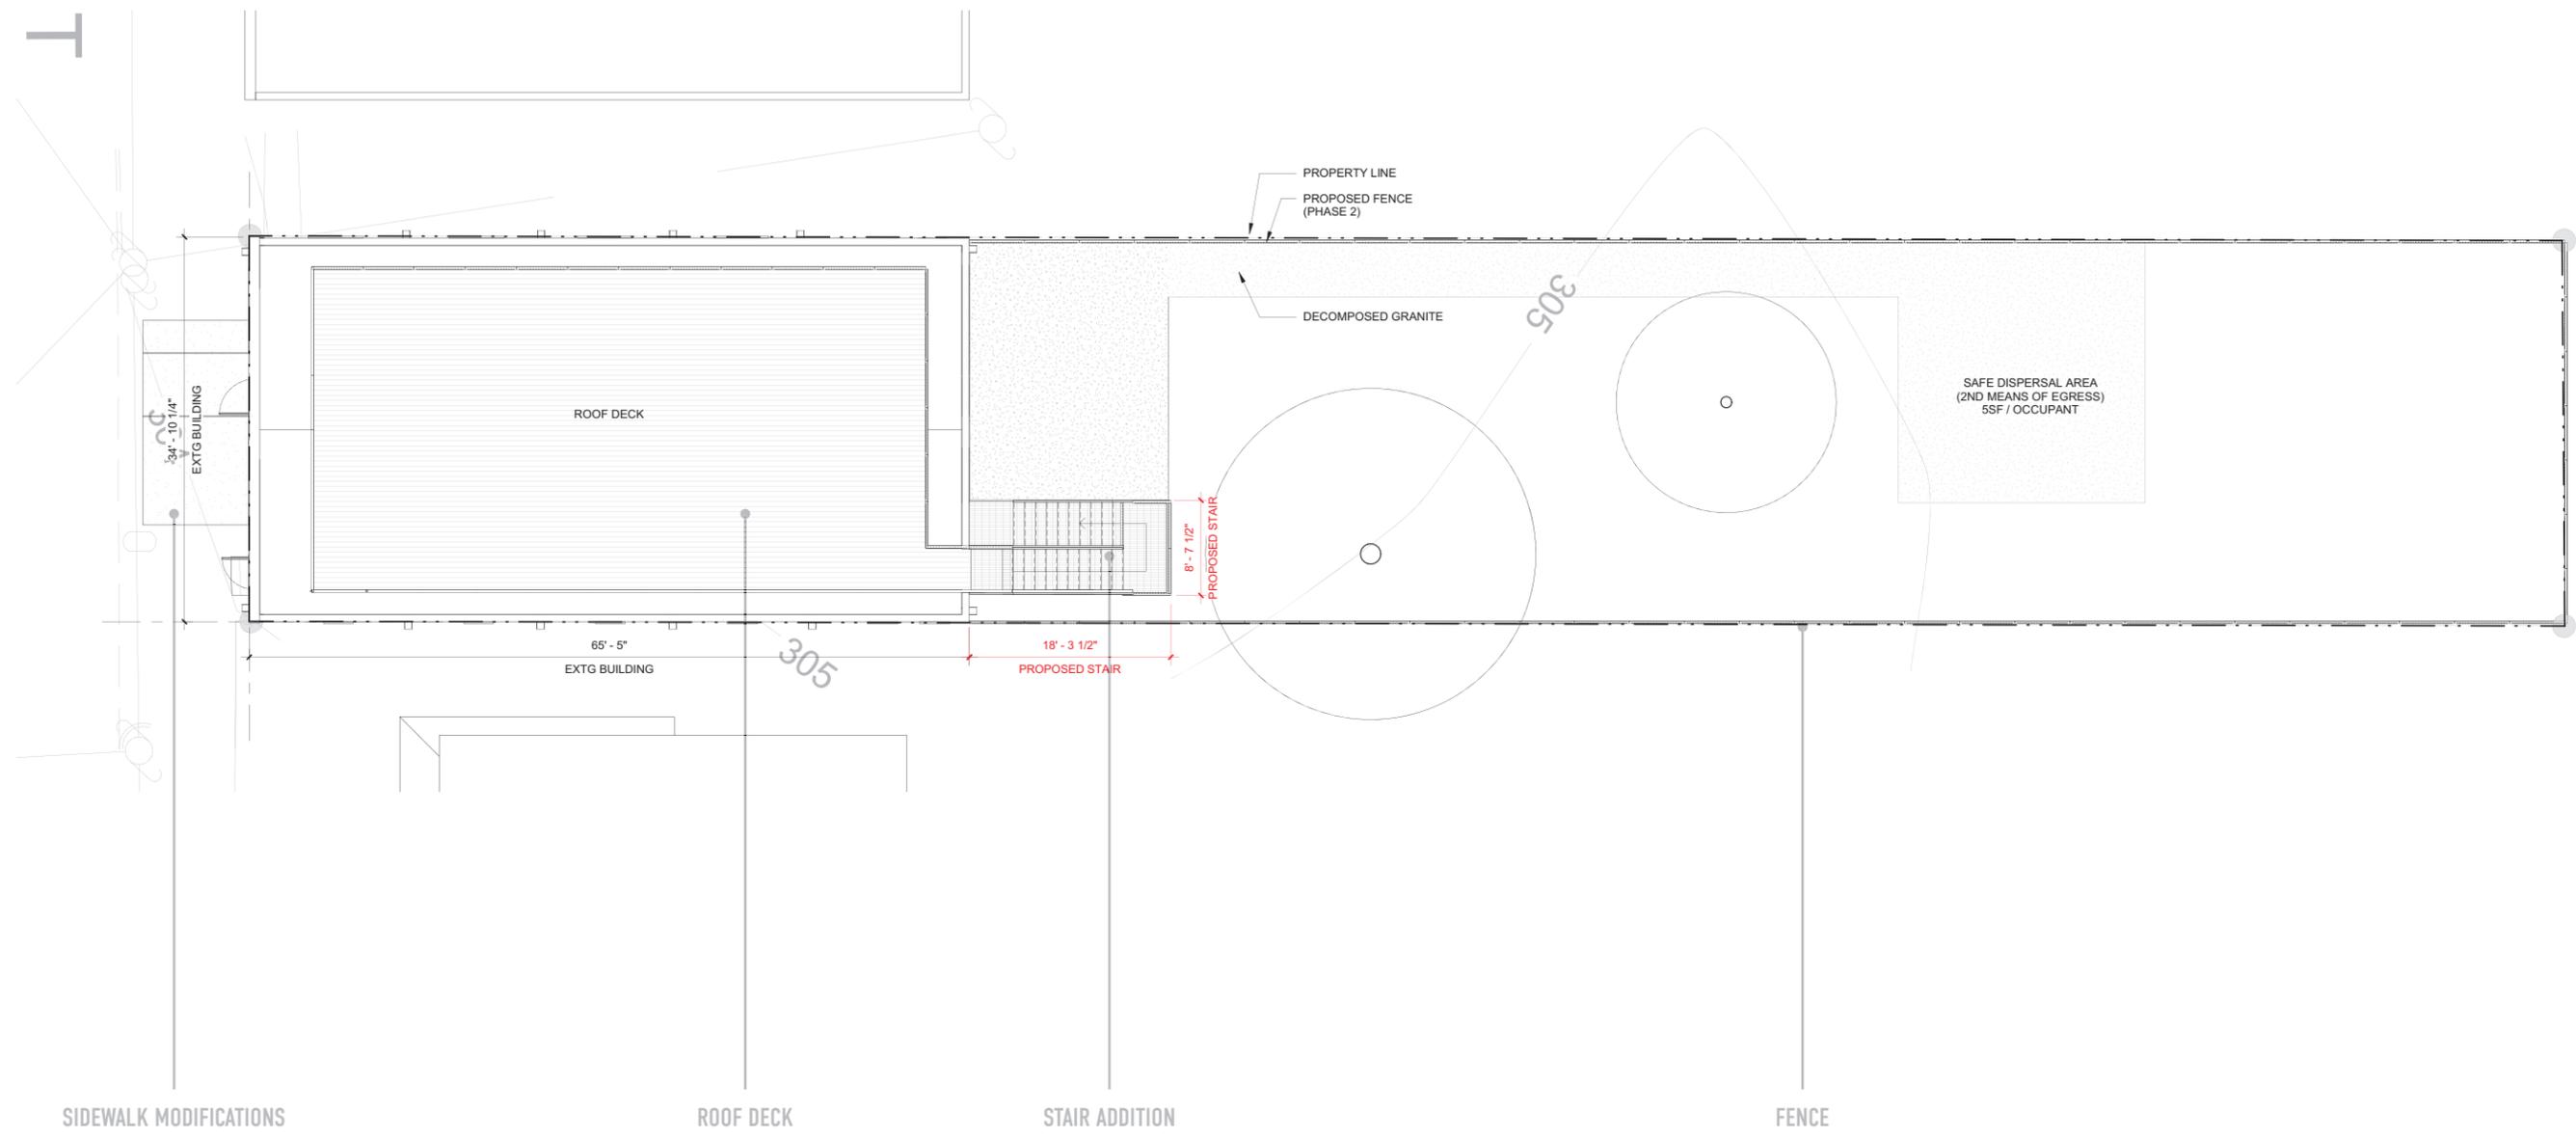
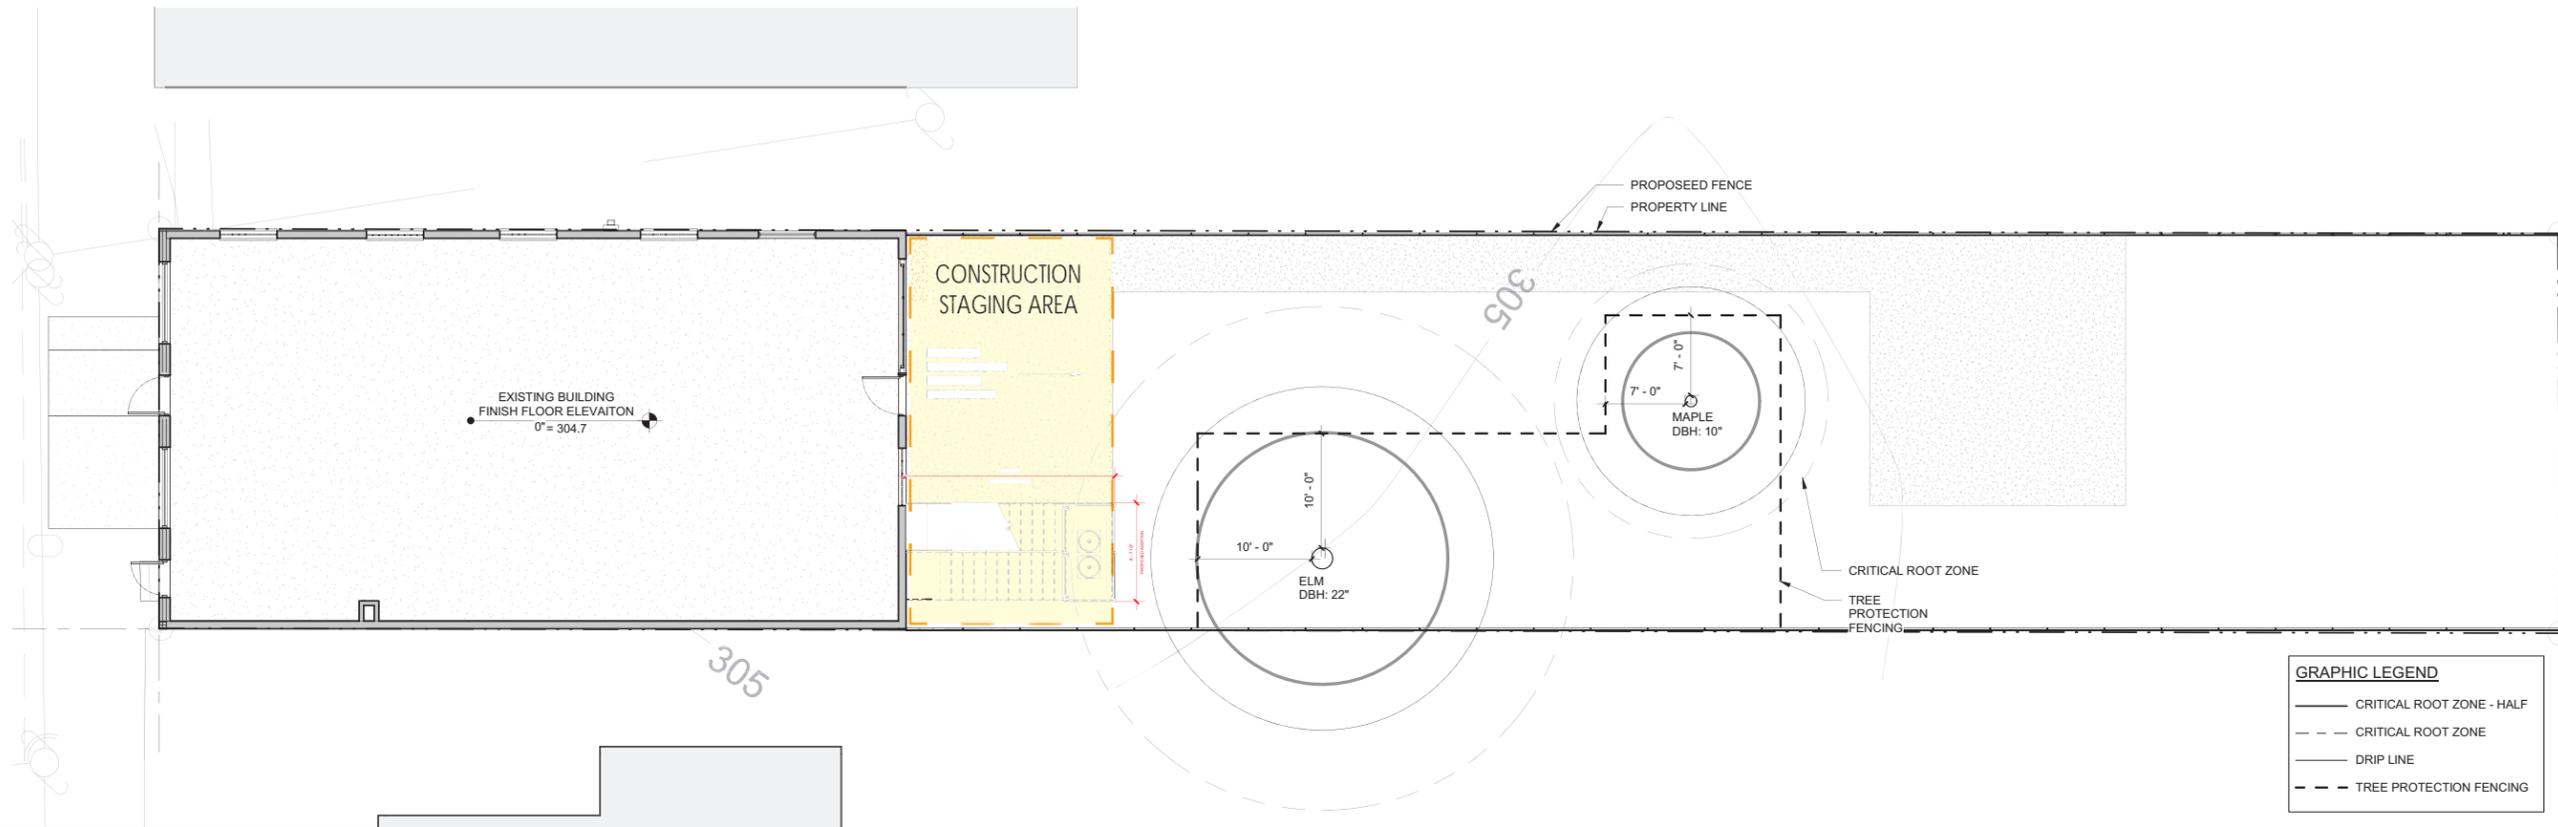
GRAPHIC LEGEND	
	CRITICAL ROOT ZONE - HALF
	CRITICAL ROOT ZONE
	DRIP LINE
	TREE PROTECTION FENCING

Inspection date: 3/11/2019
 Type of inspection: Visual
 Tree Species: Elm
 Tree location: 517 S. Blount St, Raleigh NC
 Elm is located approximately 25' behind building.
 Tree diameter at chest height 22".

Prior to construction I recommend spreading wood chips around the base of the elm a minimum of 8' from the trunk, no more than 4" thick and install tree protection fencing around tree 8-10' from base.

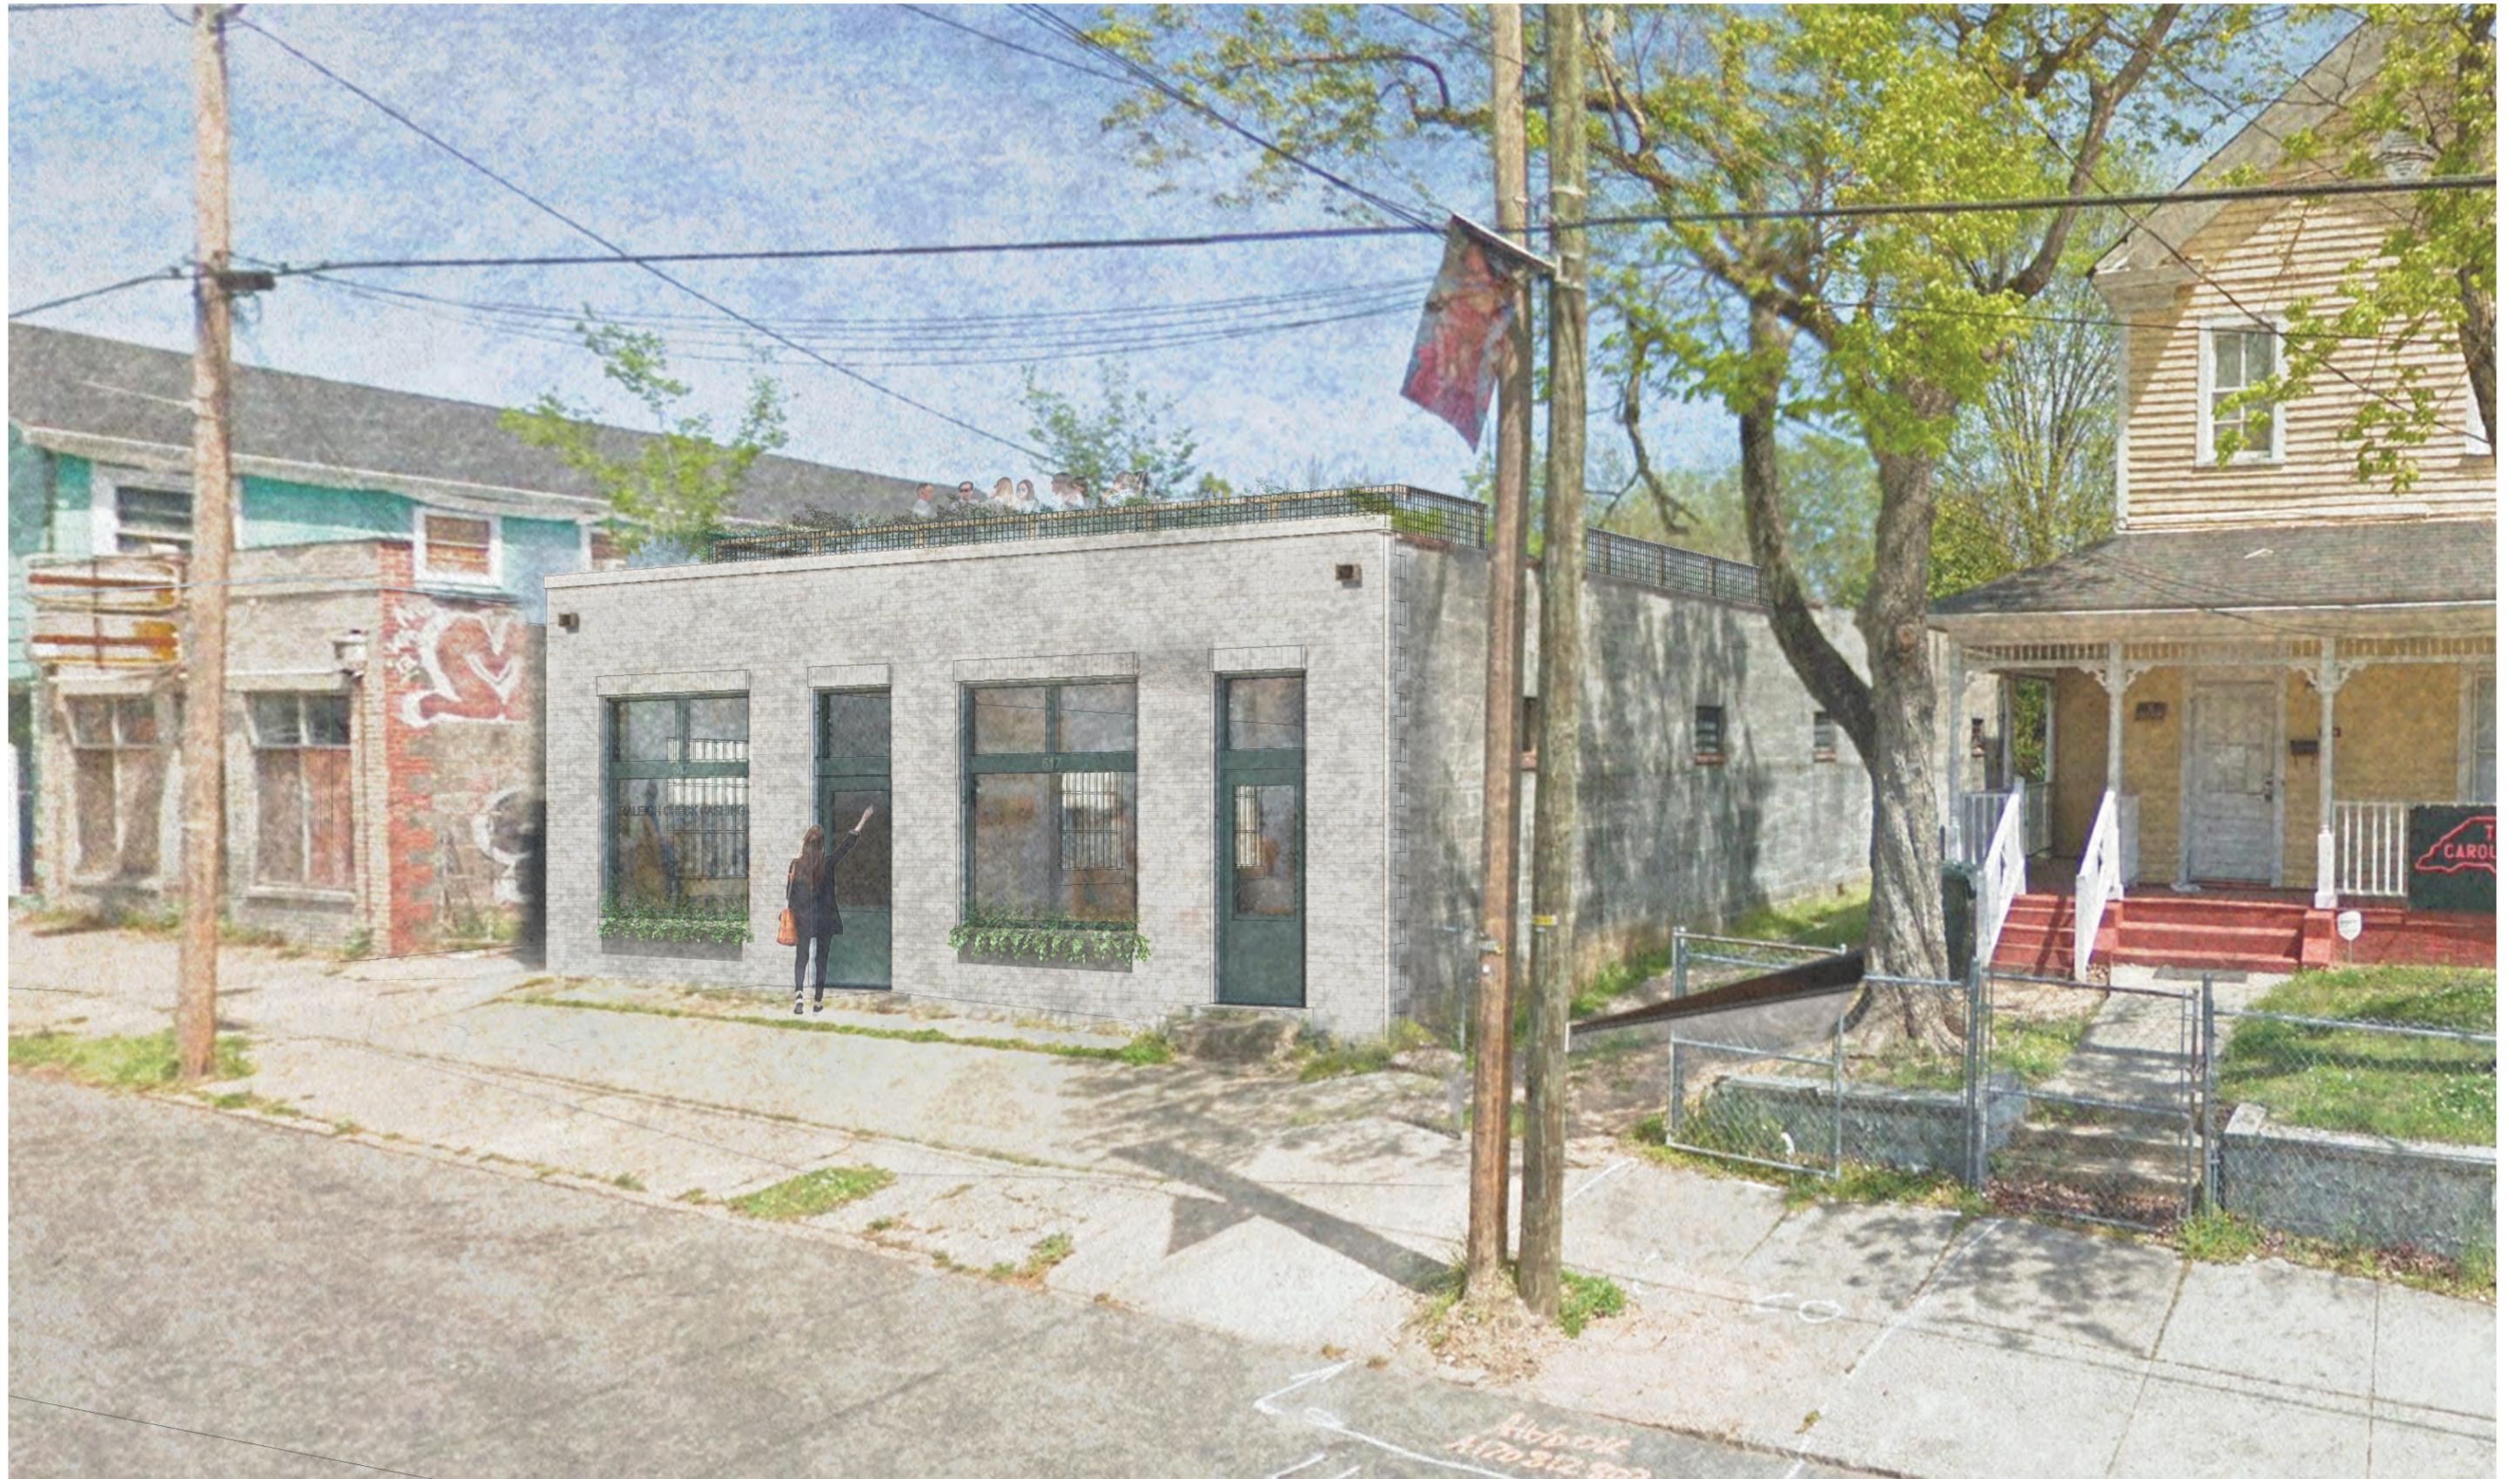
PROPOSED RENDERING - STREET
517 S. BLOUNT STREET | HISTORIC REVIEW

- 11* The deck and railing are located on the roof – about 4’8” from the front and 2’ from both the north and south facades. A perspective drawing was provided to show the visibility of the railing; however, a sight line illustration was not provided.

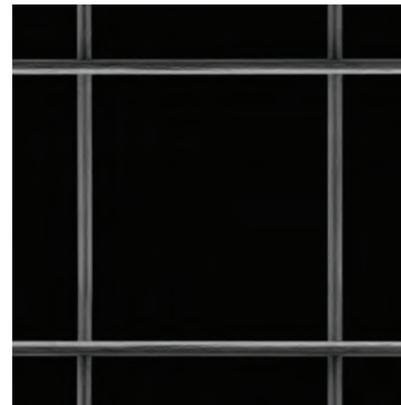
McNICHOLS® WIRE MESH

Square, Carbon Steel, Cold Rolled, Welded - Trimmed, 4" x 4" Mesh (Square), 3.7500" x 3.7500" Opening (Square), 0.250" Thick (2-3/4 Gauge) Wire Diameter, 90% Open Area

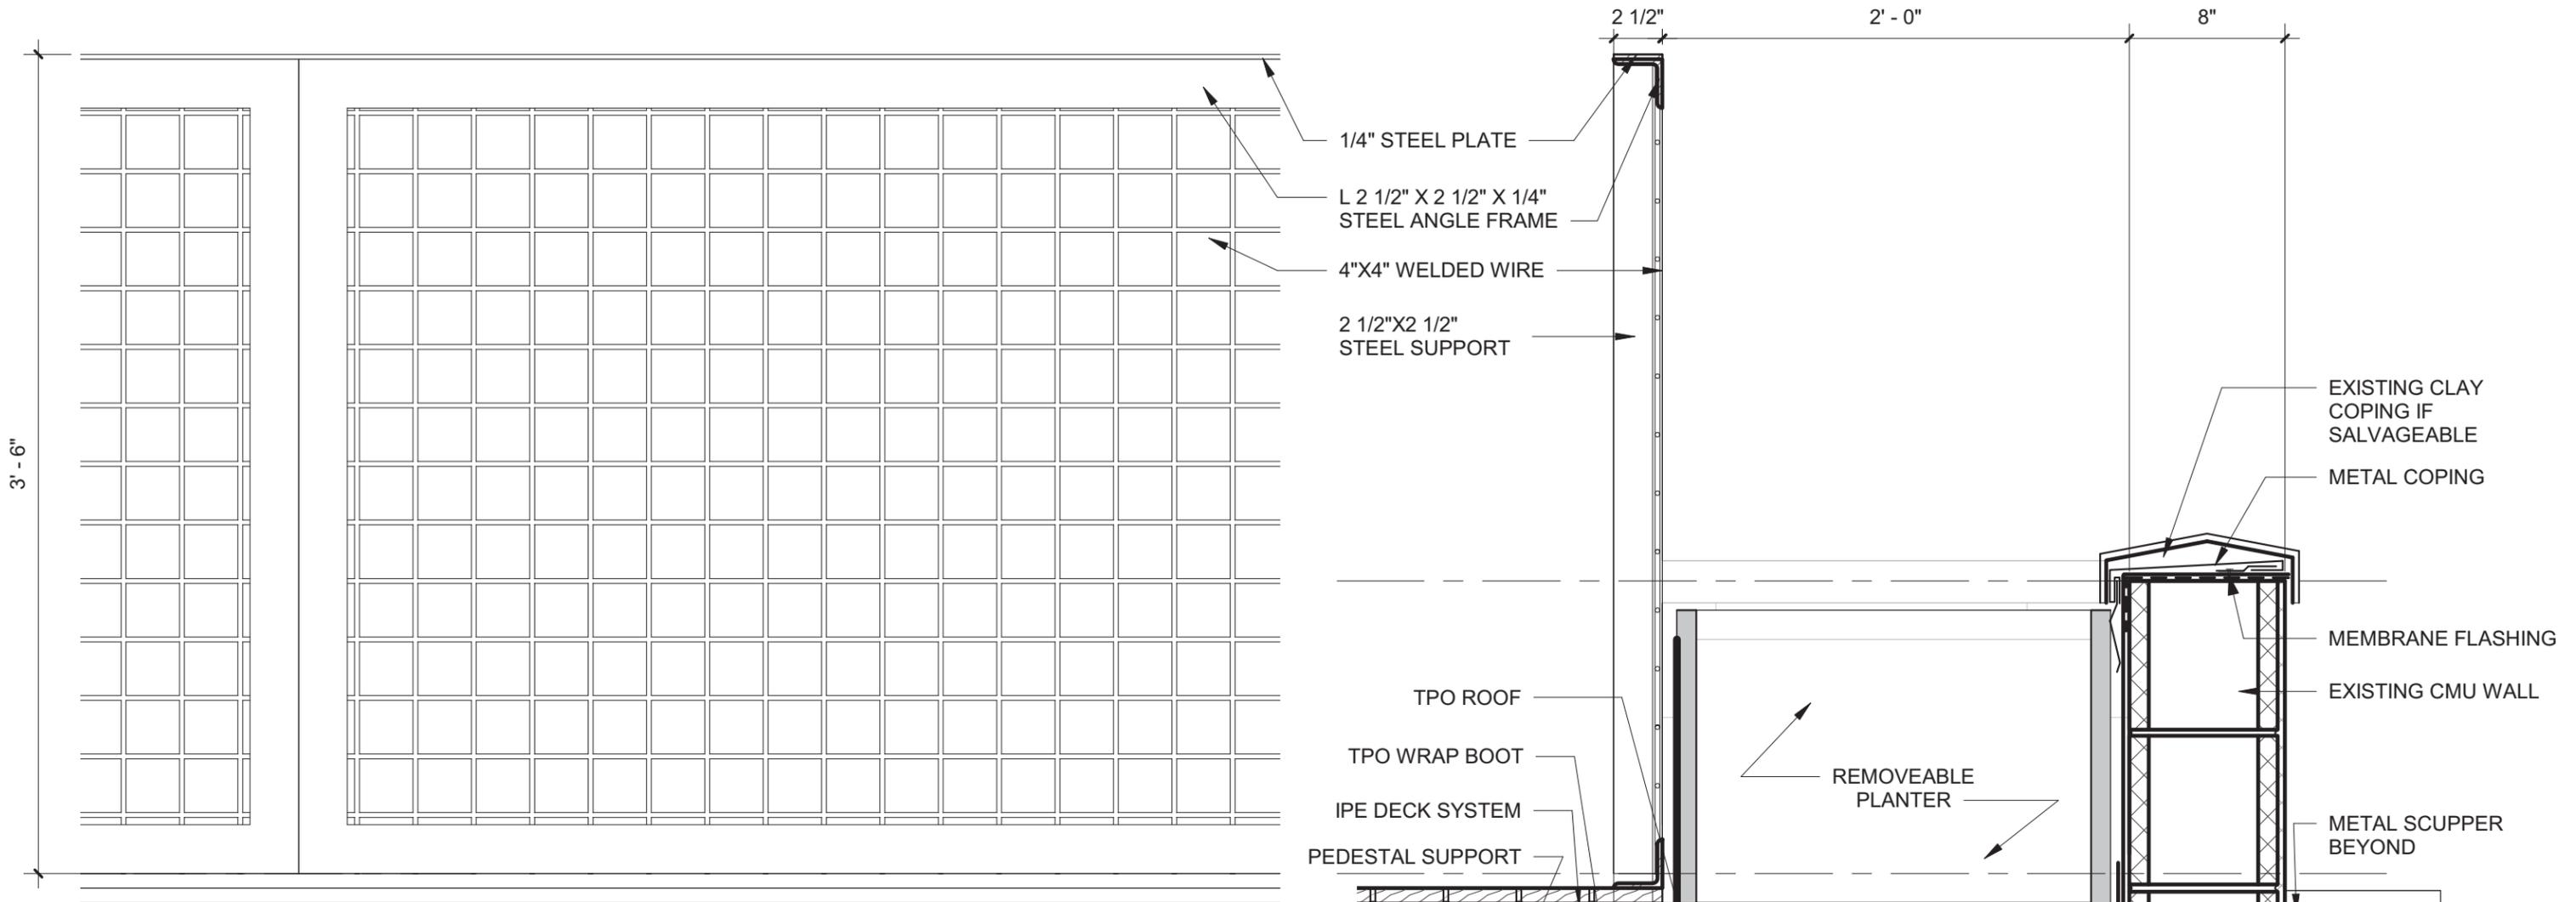
1 TYP ELEVATION DTL - GUARDRAIL + FENCE
SCALE: 1 1/2" = 1'-0"

- 9* The proposed railing is a dark grey/black metal frame with metal wire mesh panels similar to the railing at 20 E Hargett Street (081-12-CA). Specifications and detail drawings were provided.

- 10* The railing detail drawing also shows an entity between the railing and the parapet labeled “removable planter;” however, the planter base appears to be mounted to the roof decking using the pedestal system. Unmounted planters are considered furniture and not subject to COA review.

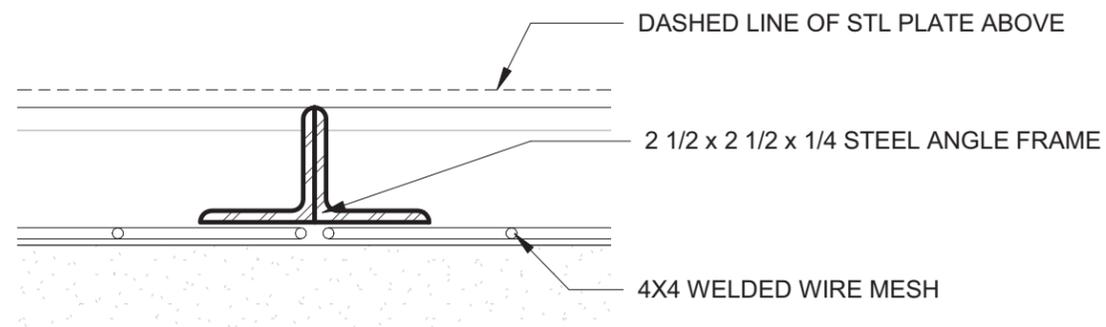
3 TYP PLAN DTL - GUARDRAIL + FENCE BALUSTER
SCALE: 3" = 1'-0"
