APPLICATION FOR A CERTIFICATE OF APPROPRIATENESS – STAFF REPORT

COA-0034-2019 517 S BLOUNT STREET

Nature of Project: Construct rear stair and roof deck; construct egress area; install 6’7” fence; construct front ramp; restore storefront; remove bars from windows; install new window and door; install rear garage door; install new mechanical units; change paint colors

517 S BLOUNT ST. RALEIGH
HISTORIC REVIEW DOCUMENT
TOMA | FARREN ARCHITECTS

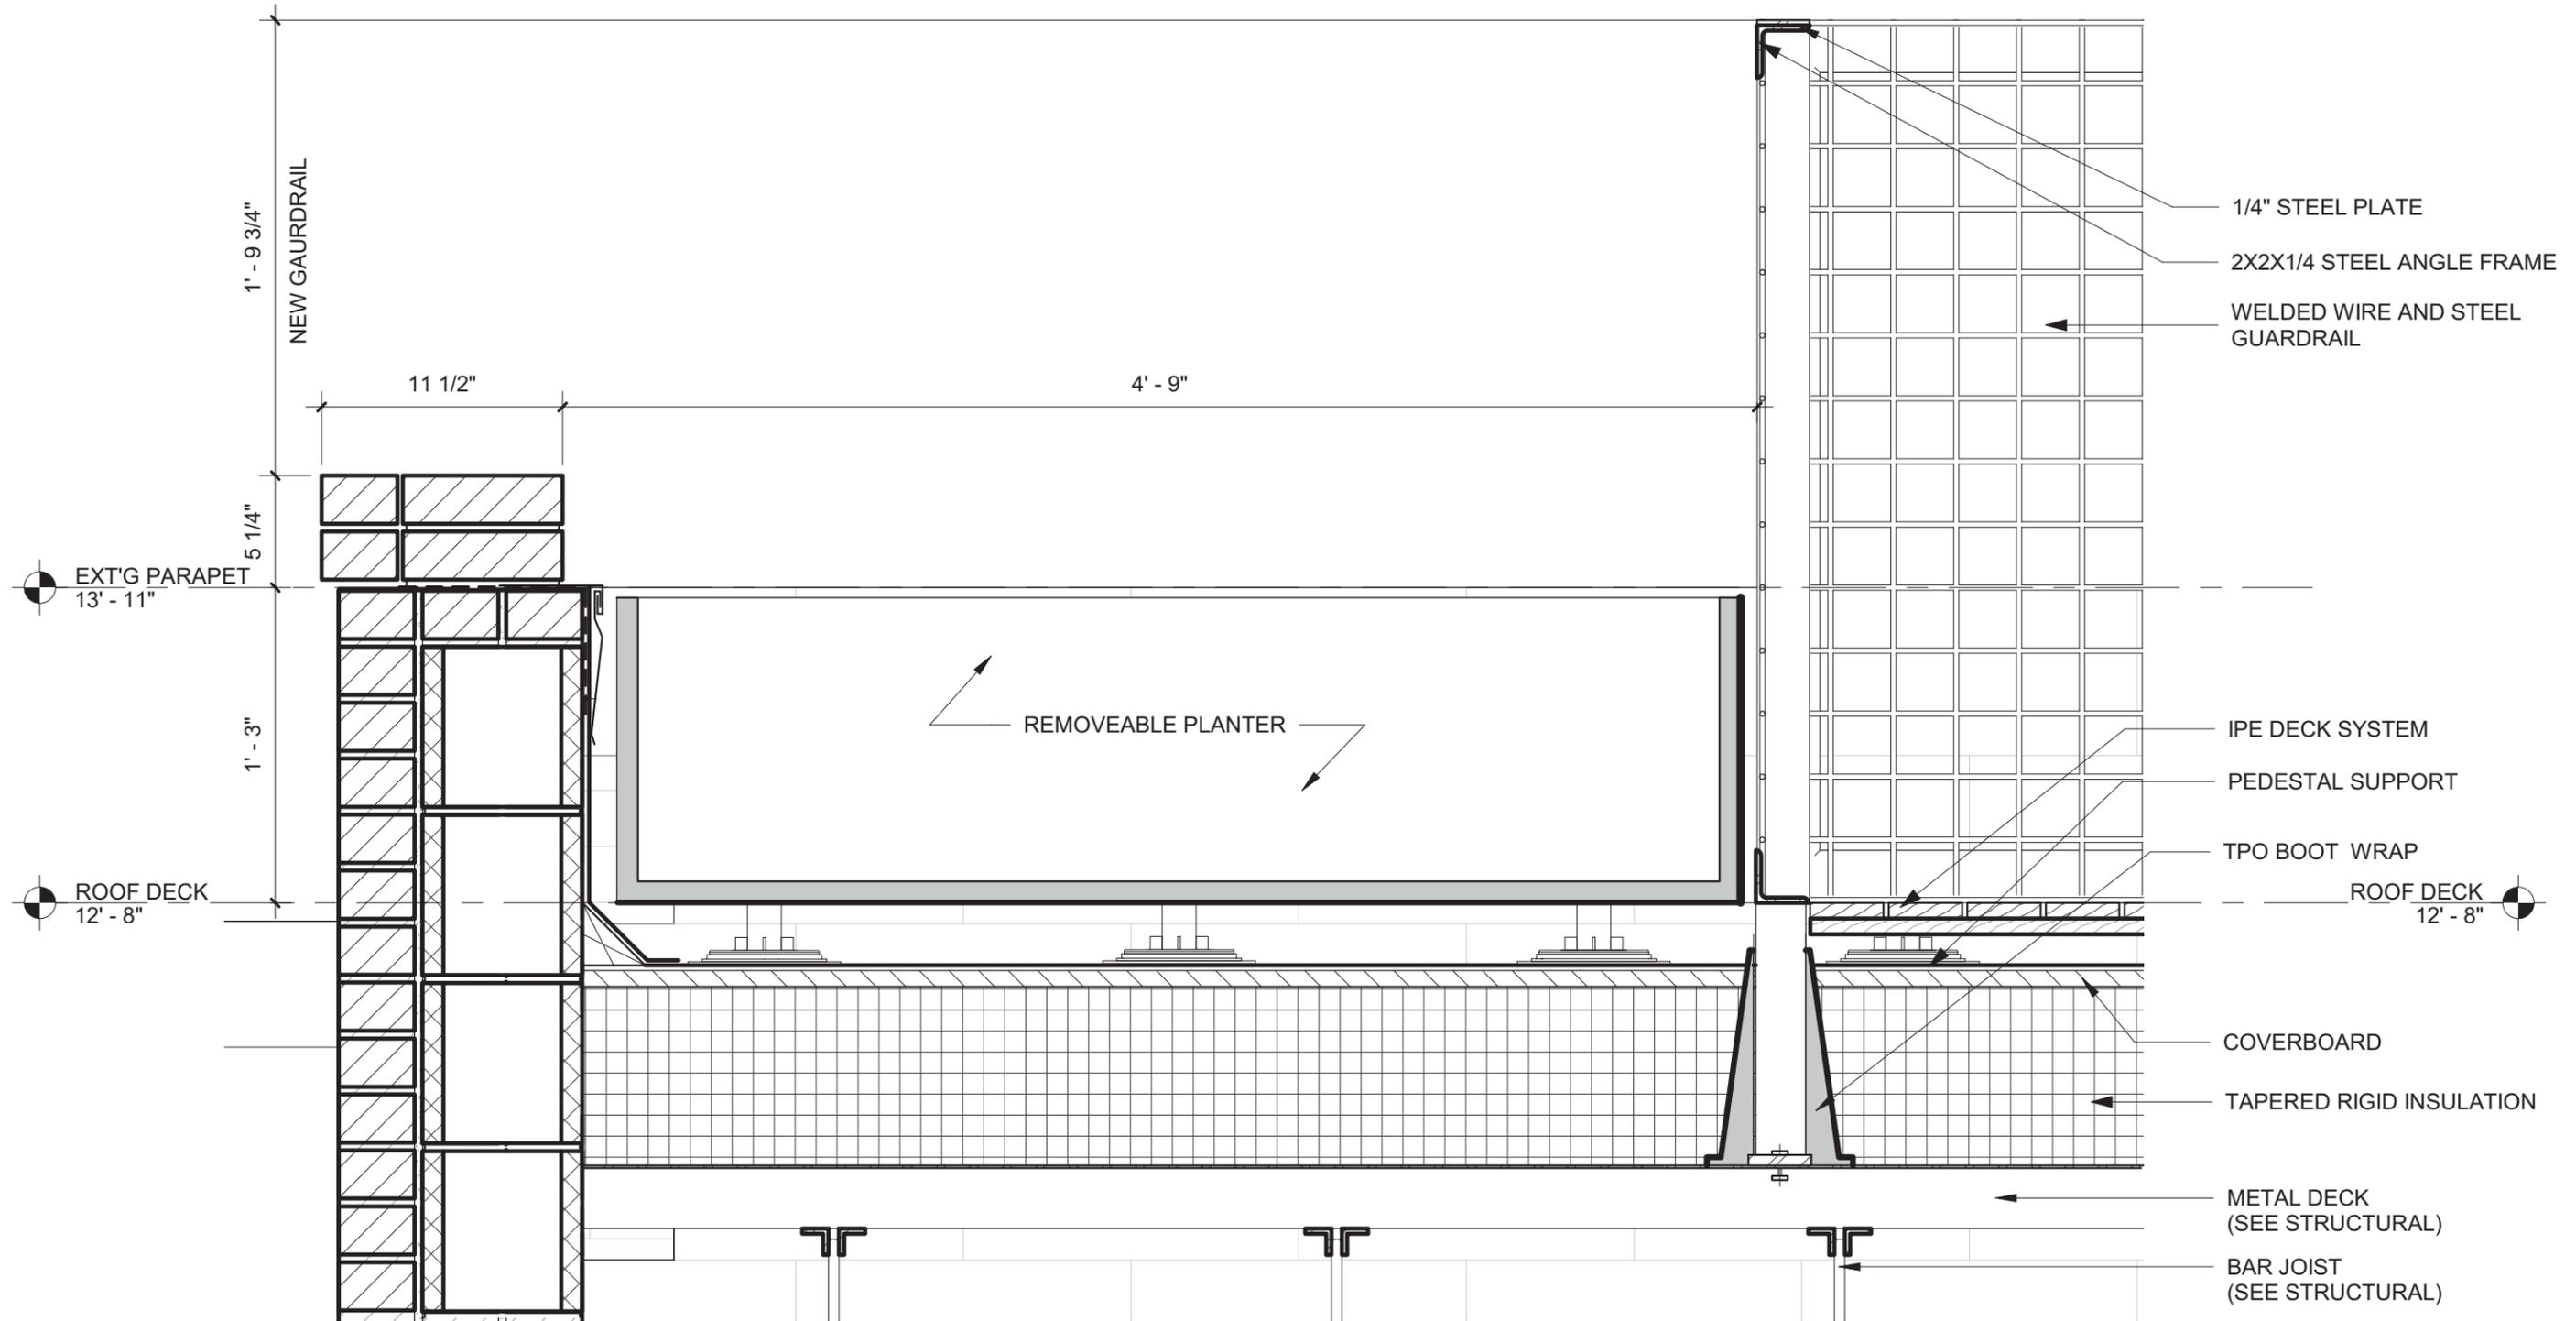
1 SECT DTL AT BRICK PARAPET + GUARDRAIL
 SCALE: 1 1/2" = 1'-0"

- 6* The historic building is approximately 14’4” tall to the top of the parapet.
- 7* The roof deck railing is not attached to the historic parapet and will extend approximately 2’3” above the parapet.

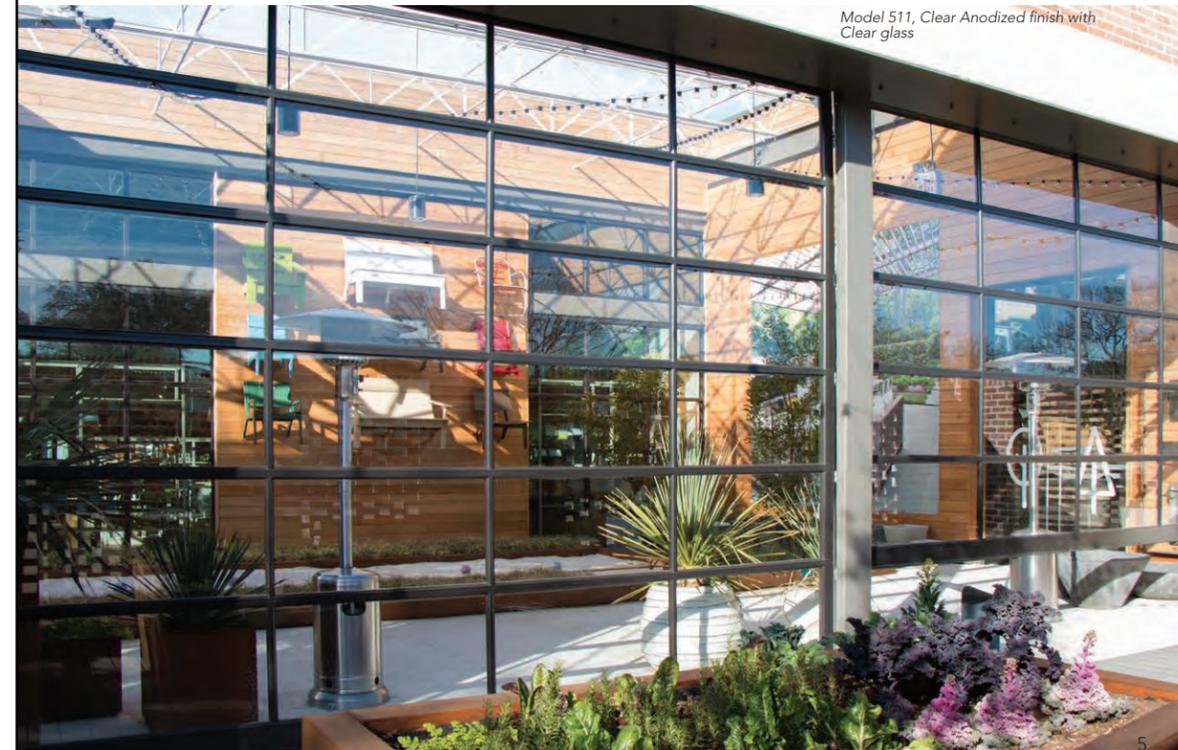
Model 511, Clear Anodized finish with
Clear glass

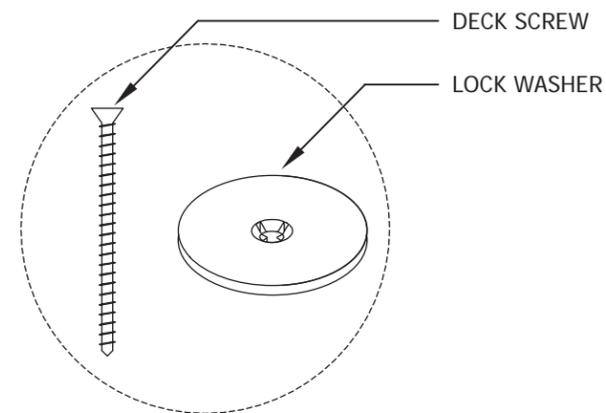
INSERT THE LOCK WASHER IN TO THE KURF CUT BETWEEN THE UPPER SLAT AND BOTTOM RAIL OF 3 WOOD PAVERS. INSERT THE 4th PAVER IN TO THE 4TH CORNER. ONCE ALL 4 PAVERS ARE TIGHTLY IN PLACE INSERT SCREW THROUGH LOCK WASHER AND HAND TIGHTEN IN TO PEDESTAL TOP UNTIL ALL 4 PAVERS ARE SECURELY FASTENED TO THE PEDESTAL. DO NOT OVER TIGHTEN.

- 5* The application notes that the roof deck utilizes a pedestal system to float over the roof structure. An unlabeled diagram of the pedestals was included. The diagram appears to indicate that each pedestal is screwed into the roof through the pedestal base.
