City of Raleigh Parks and Recreation

Chapter 6 | Appendices

City of Raleigh Parks Observation Site Analysis

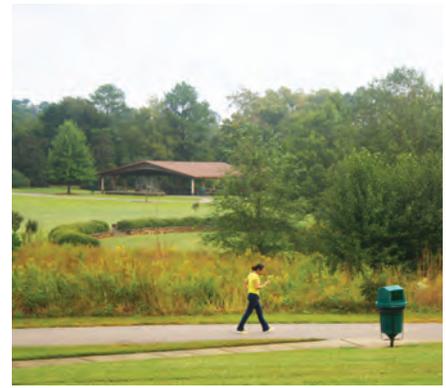
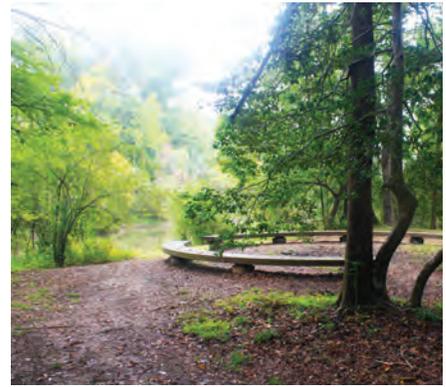
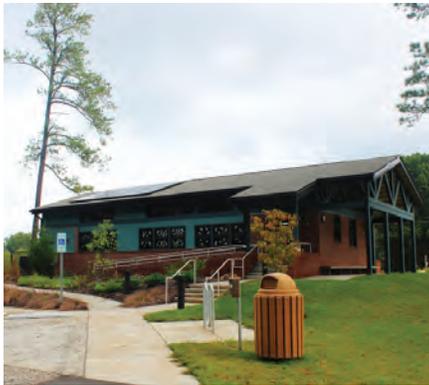
Anderson Point is limited on stormwater management techniques utilized throughout the site. Due to limited access points, site is not complementary of multi-modal uses, limited to vehicle and pedestrian/cyclist access. Existing structures are limited in energy efficiency techniques.

- Accessibility to confluence area of park is limited
- Canoe launch and associated parking drains directly into Neuse River
- Programming opportunities such as yoga classes, walking clubs

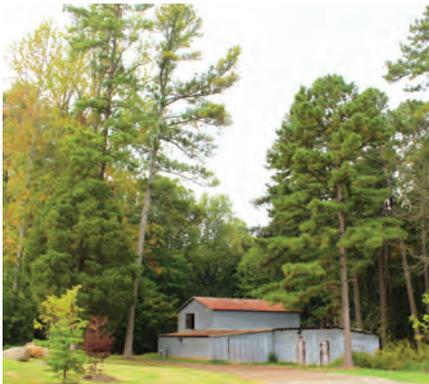
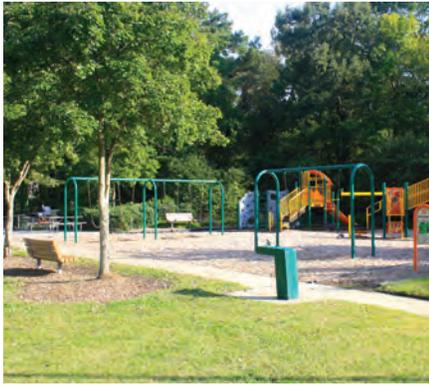
6.1.2 - Annie Louise Wilkerson M.D. Nature Preserve

Stormwater management is well handled on-site. Existing facilities are energy efficient. Site is limited in multi-modal choices to vehicles only due to a lack of sidewalks into the park.

- Accessibility may be improved into park with sidewalk connections
- Future Nature Center will increase activities at site
- Future trails should offer accessible hard surfaces where appropriate

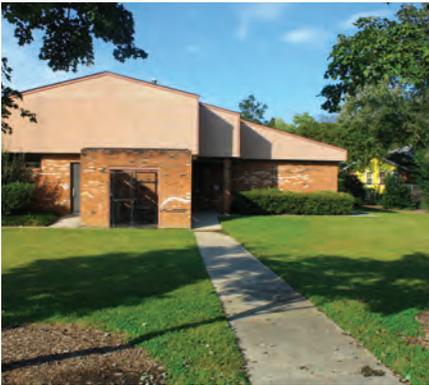
6.1.3 - Apollo Heights Size: 4.26 acres

Site is a model for multi-modal access for small parks. Energy efficiency is limited to upgrades at neighborhood center. Direct stormwater drains into Walnut Creek system.

- Site may improve direct stormwater runoff
- Highlight trail connectivity through park into adjacent neighborhood
- Playground has drainage problem and may lack accessibility if not maintained

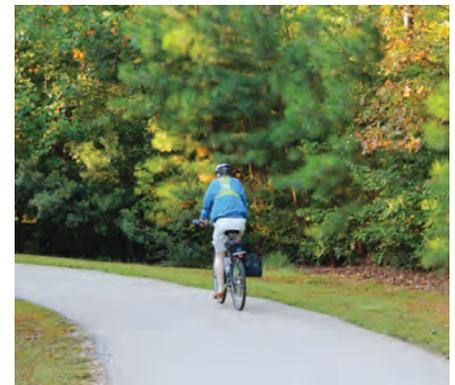
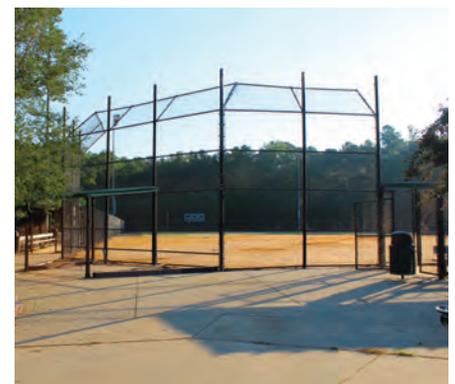
Existing facilities lack sustainable design and techniques. Direct stormwater runoff impacts surrounding properties. Limited multi-modal options for users.

- Direct sidewalk access to park is needed
- Lighting in parking and fields is not energy efficient
- Accessibility in playground may need to be improved

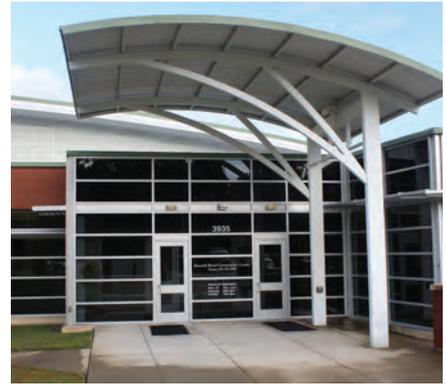
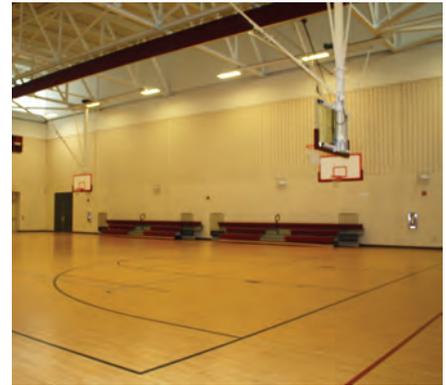
Closed stormwater system limits opportunities to treat run-off on site or near building. Site is only accessible to vehicle traffic, limiting multi-modal choices. Utilities are managed by school district. Most of site is floodplain and streams.

- Accessibility to park from adjacent roadways with sidewalks is limited
- Programming choices for elderly and adults lacks due to available hours
- Stormwater management on site may be improved

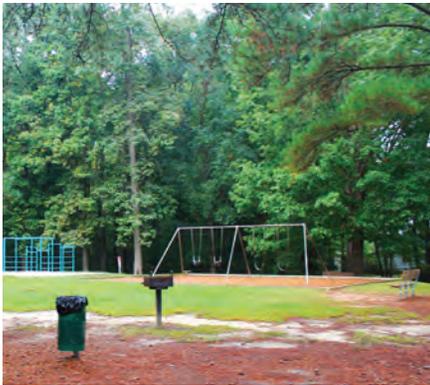
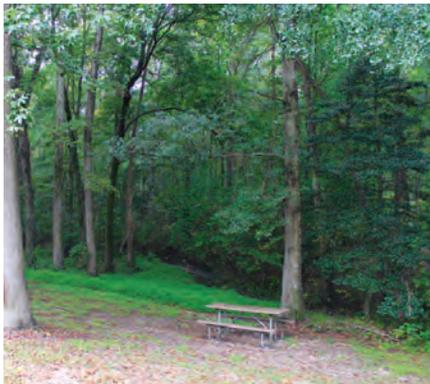
6.1.6 - Berkshire Downs West

Direct stormwater runoff from site demonstrates a lack of water management on-site. Multi-modal choices offered include on-street parking and pedestrian/ cyclist access.

- Accessibility into park lacks clearly defined routes
- Stormwater treatment may be available on site
- Crosswalks lack to WRAL Soccer Fields

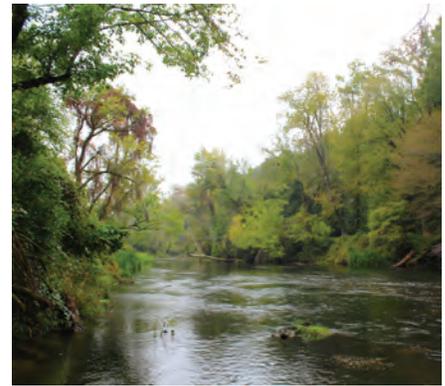
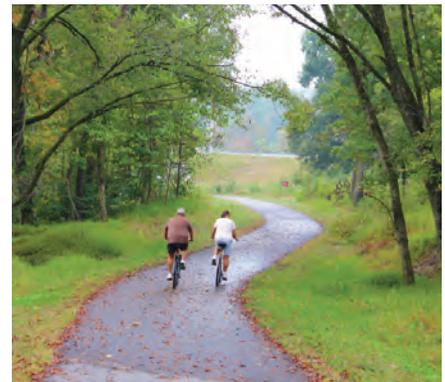
6.1.13 - Canoe Launch at Falls Lake Size: 9.13 acres

Site is energy efficient with solar lighting and limited infrastructure. Stormwater is mostly direct runoff and limited multi-modal capacity is available given the site size and location.

- Direct sidewalk access lacks
- Protection from weather with shelters lacks
- Programming at site may encourage use by multiple age groups

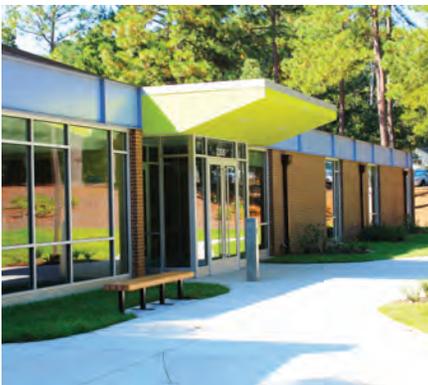
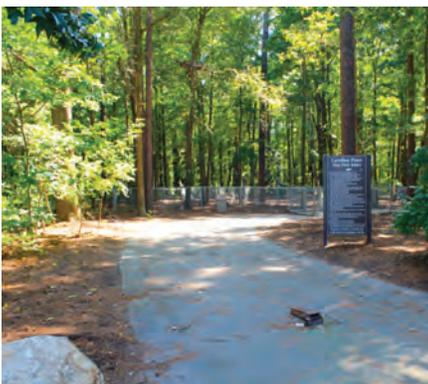
6.1.14 - Carolina Pines Size: 38.71 acres

Renovations at Community Center are examples of sustainable techniques with rain garden and energy efficiency. Transit access encourages multi-modal uses with an option for a park and ride facility. Most of site has direct runoff of stormwater.

- Park could be used as Park and Ride if routing and land uses permit
- Shelters for rentals lack in key locations
- Dog park lacks shelter with accessible hard surface access

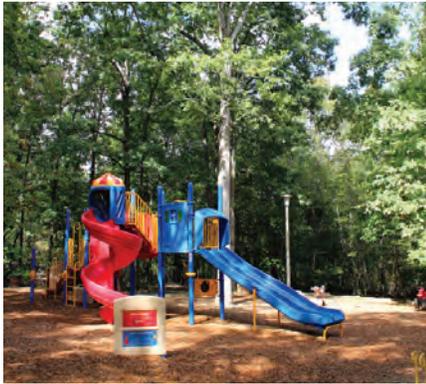
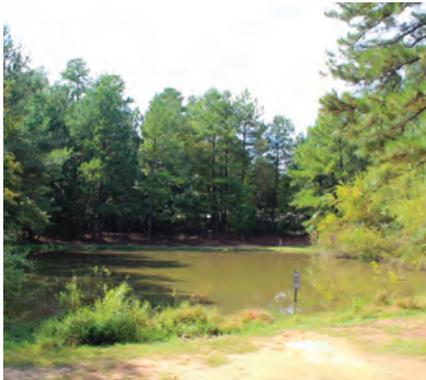
6.1.15 - Cedar Hills Size: 38.49 acres

Existing utility corridor is used for parking which promotes a good integration of infrastructure. Multi-modal capacity is not utilized to its full potential and energy efficiency for restrooms and fields could be improved.

- Appropriate signage around disc golf course is lacking
- Lighted baseball field could be more flexible for multi-purpose use
- Energy efficiency may be improved at facilities

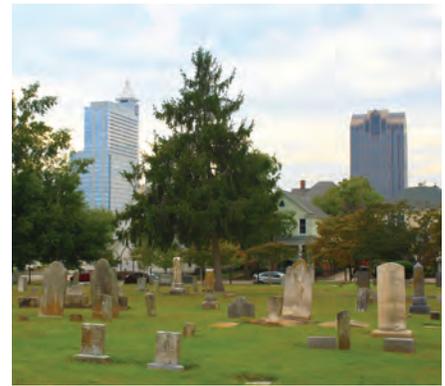
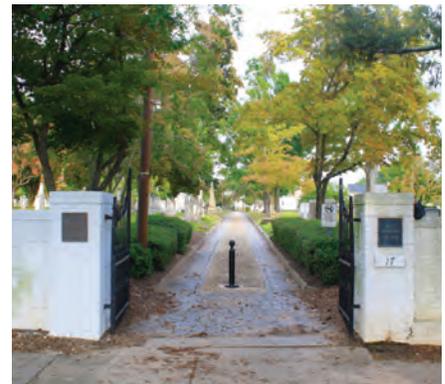
6.1.17 - City Cemetery

Cemetery is extremely well maintained and clean. Existing facility is maintenance only with no protection from weather and no shaded seating options. Some tombstones need repair due to age.

All stormwater is treated on site with limited direct run-off. Multi-modal connectivity and incorporation of a fire station next door creates a civic node.

- Educational signage could be added
- Promote sustainability with energy efficient lighting
- Site offers historic tours to public

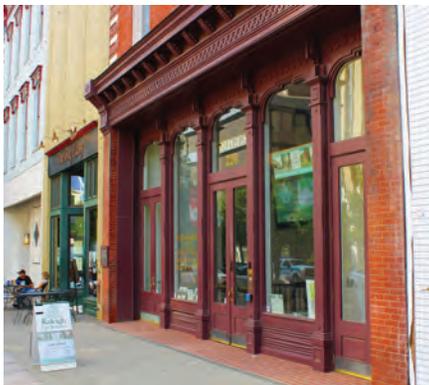
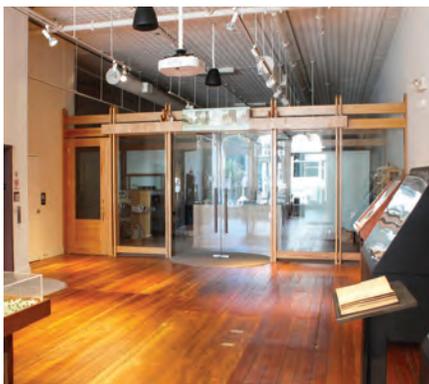
6.1.18 - Raleigh City Museum

Stormwater drains into closed system with no treatment. Multi-modal access is promoted within museum with a strong integration of non-profits within building.

- Energy efficiency within museum could be promoted
- Indoor seating for patrons of museum is lacking
- Roof stormwater could be treated on site

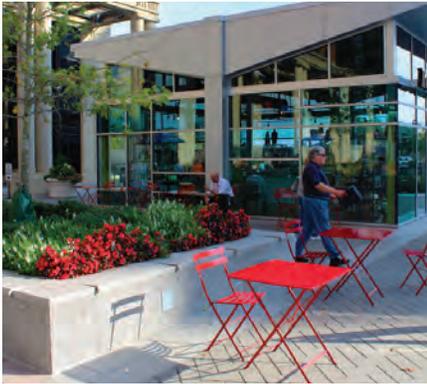
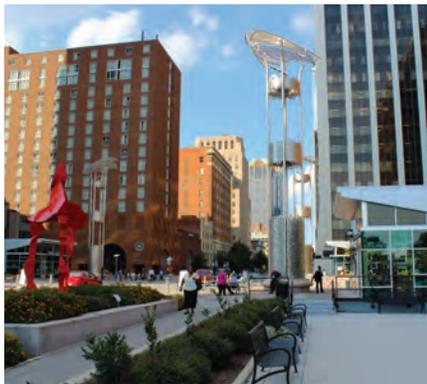
6.1.19 - City Plaza Size: 1.11 acres

Pavement consists of semi-permeable pavers, however, entire plaza is located on top of parking garage with limit opportunities for treatment of stormwater. Site promotes multi-modal access and lighting used is energy efficient.

- Shaded seating choices could be improved
- Better signage of space could promote area as community plaza

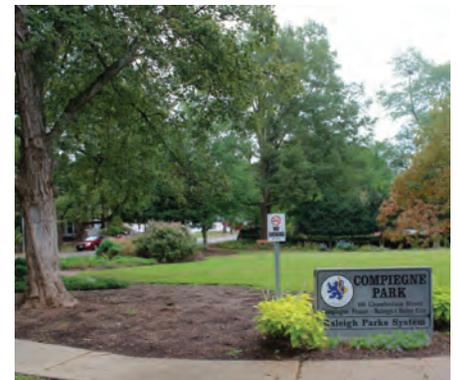
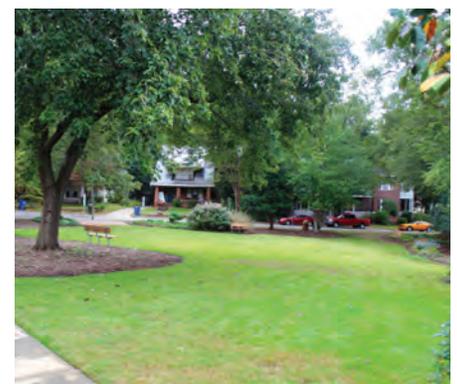
Direct stormwater runoff drains into closed system. Site uses adjacent street lighting. Integration of business activities could increase use of site.

- Nearby businesses close to park could provide surveillance
- Picnic tables and moveable chairs would increase seating choices
- Utilize sustainable techniques to promote stewardship around park

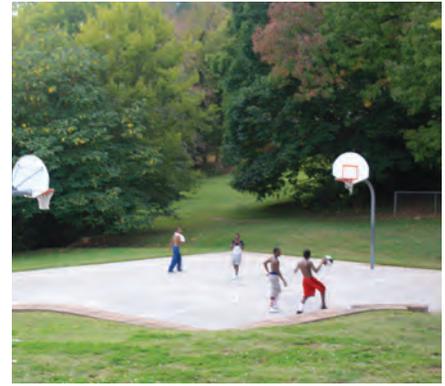
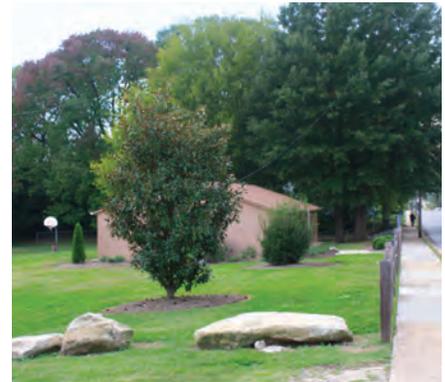
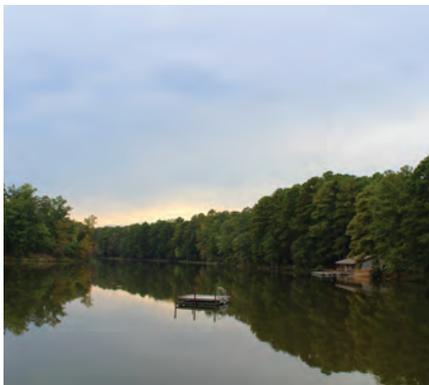
Site is maintained, however, shelter's roof needs maintenance. Restrooms at shelter were not maintained well and do not provide a sense of pride or ownership in current condition.

Direct stormwater runoff onto adjacent properties has negative impact. Multi-modal choices promote transit and walking to site. Energy efficiency is lacking on site.

- Energy efficiency at shelter could be improved
- Increase treatment of on-site stormwater
- Promote better use of limited open space through landscape

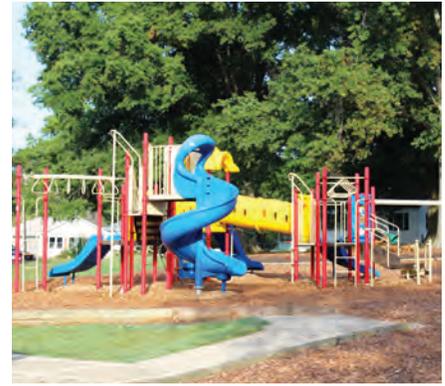
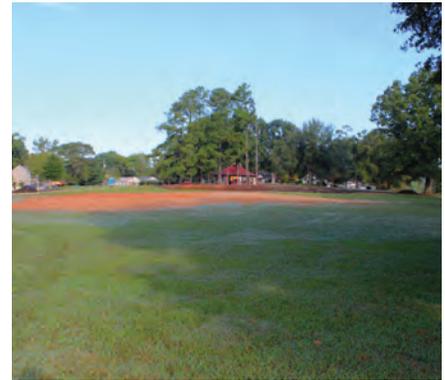
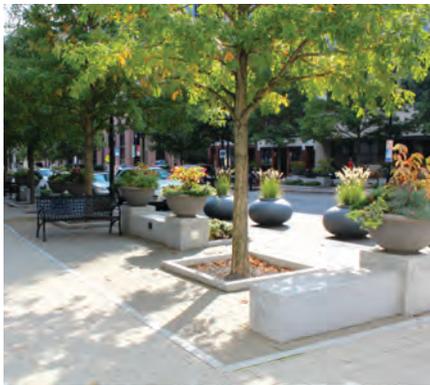
Some stormwater runoff is channeled directly to streets. Parking is limited, but could be increased on-street. Impact of future use of Water Works site could change needs for park. Energy efficient lighting could be provided around park. Remove portable restrooms.

- Accessible crosswalks to park from adjacent roads is lacking
- Erosion and sod issues on multi-purpose field and temporary restrooms
- Consider opportunities of future plans for Water Works site

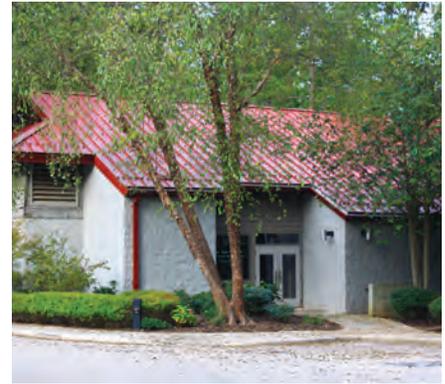
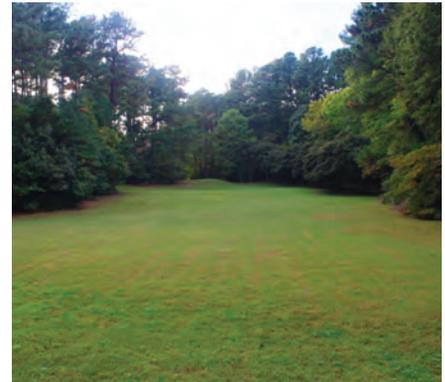
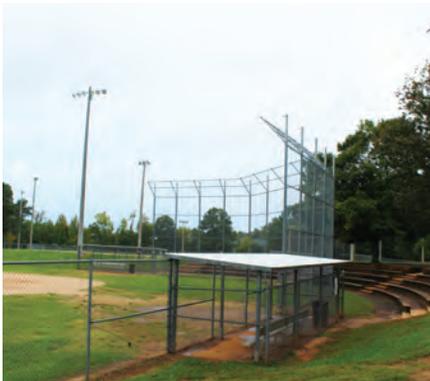
Park is in overall good condition with good maintenance of facilities. Restroom interior may need improvements. A good choice in seating options and protections from weather, along with open views provides a feeling of safety.

- Encourage reduction in parking lot pavement with permeable surface
- Seamlessness with library infrastructure and parking is minimum
- Flexibility of baseball fields for multi-purpose use is minimum

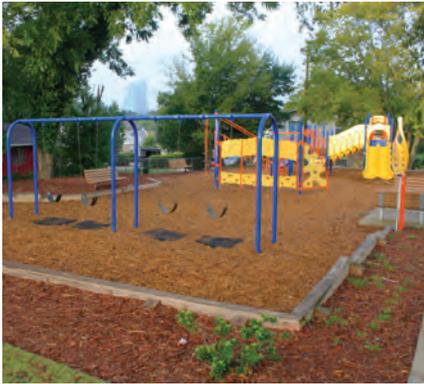
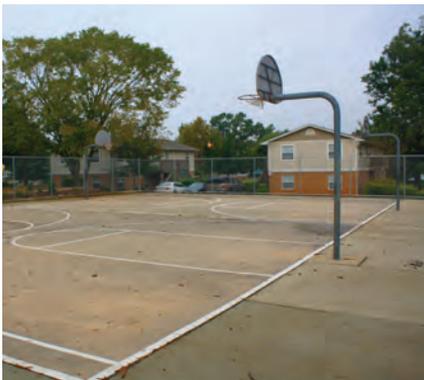
6.1.43 - Lane Street Size: 0.57 acres

Located at a street intersection, the park offers great visibility with clear views into entire space. Park is accessible from three points with two transit stops nearby. Clear accessible routes within park are noted. Lighting is provided by existing street lights.

Park's stormwater runoff is directly into adjacent street system. Small site size limits opportunities for water treatment on-site. Multi-modal access with accessible parking spaces on site and nearby transit with sidewalk access is excellent.

- Protection from weather is minimum in park
- Energy efficient security lighting is lacking in park

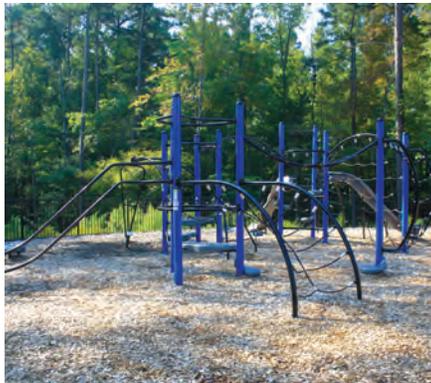
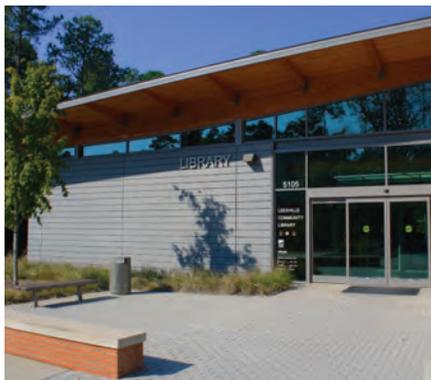
6.1.46 - Leesville

Library and playground have two-stage stormwater retention. Lack of transit access limits multi-modal choices. Library within park promotes co-location of civic facilities.

- Balance natural resources while developing site
- Temporary uses of overall park site could be provided
- Promote interaction with library with outdoor reading areas/ patios

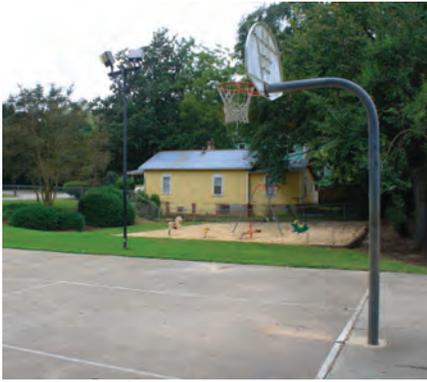
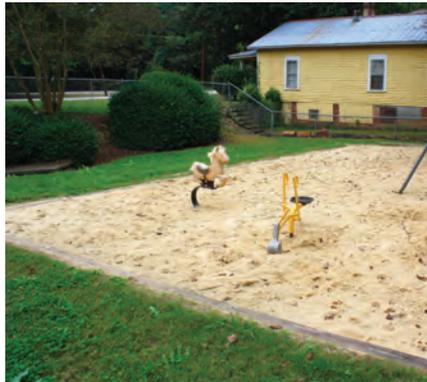
6.1.47 - Lenoir Street Size: 0.32 acres

Park stormwater runoff is closed system which runs underneath park. Nearby daylighting of stream is fenced and dangerous area of park. Park is accessible by multi-modal means.

- Flexibility for open space, seating and protection from weather lacking
- Energy efficient lighting for court and security lighting is needed
- Promote treatment of stormwater

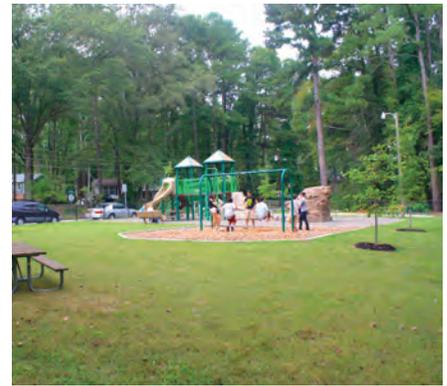
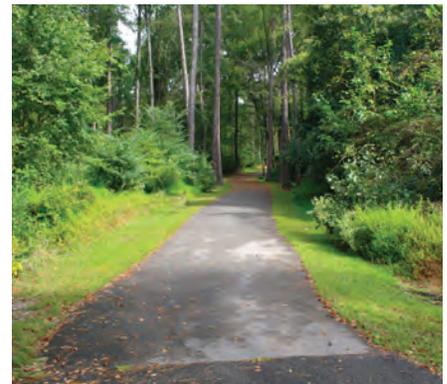
6.1.49 - Lockwood

Park is adjacent to stream, however, playground has direct stormwater runoff. Transit is possible, but not for scale of park. Pedestrian routes and bike racks promote access. Lighting for security is not energy efficient.

- Promote retention of water on site where possible
- Solar security lighting could provide better energy efficiency
- Crosswalk markings or traffic calming signage is lacking near park

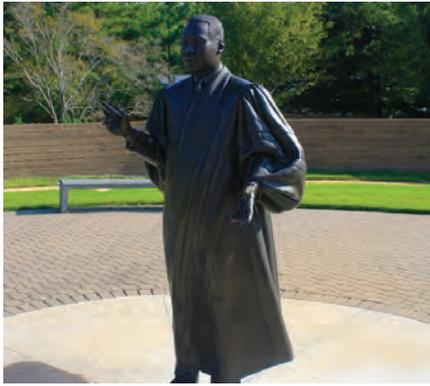
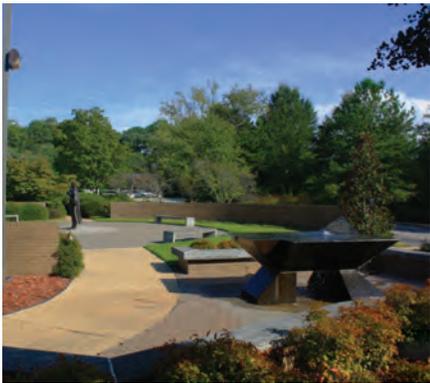
6.1.51 - Martin Luther King Jr., Memorial Size: 2.38 acres

Memorial is well maintained and very clean. Some wall damage due to construction and materials. Seating choices are provided near memorial. Protection from weather is not provided.

Multi-modal access to site is benefit for users with options such as transit, vehicle, cycling and pedestrian. Direct stormwater drains onto adjacent site. Parking areas and entrances are being replanned currently.

- Treatment of stormwater on site could be improved
- New masterplan proposes elimination of one entrance and re-configuration of parking area

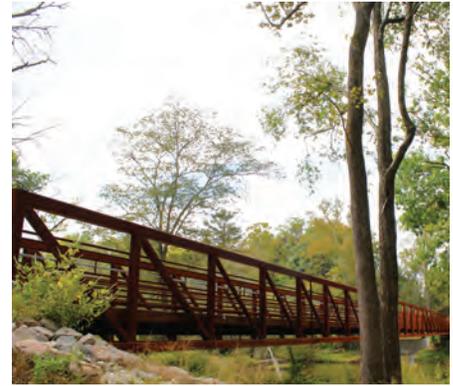
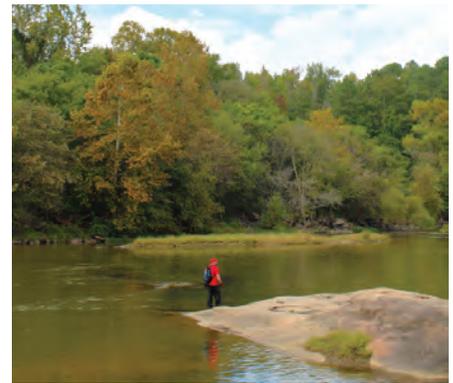
6.1.53 - Milburnie

Site includes amenities and access within a sewer easement highlighting co-location of infrastructure. Multi-modal access is extremely limited with only vehicle access currently provided.

- Limited amenities such as restrooms and/or shelters
- Link park to future sidewalk access and on-road bicycle routes

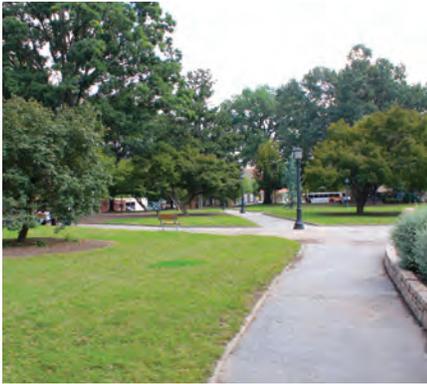
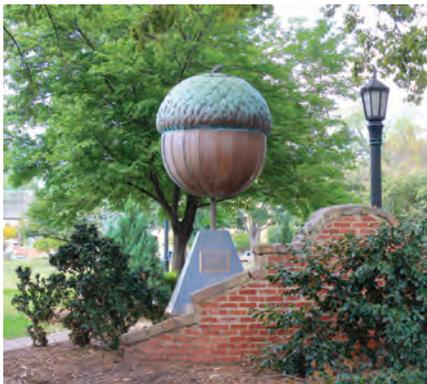
6.1.55 - Moore Square Size: 4.09 acres

Plans are currently approved for a complete renovation of the square as current conditions of hardscape and landscape are outdated and overly used. Current signage of square is limited. Loitering is significant issue for square.

Park relies solely on closed system for stormwater runoff. Multi-modal access is exceptionally high around park with a co-location of magnet school and transportation hub nearby.

- Concessions could promote daily use of square for typical users
- Moveable chairs and tables for would provide flexible use of spaces
- Balance intense special events with rest periods for tree health

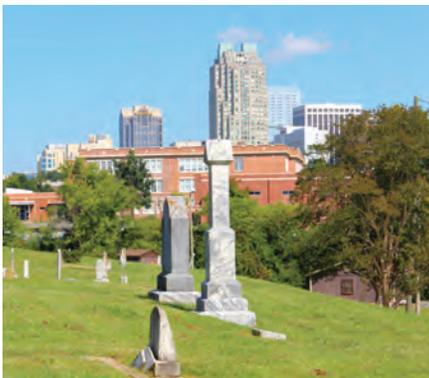
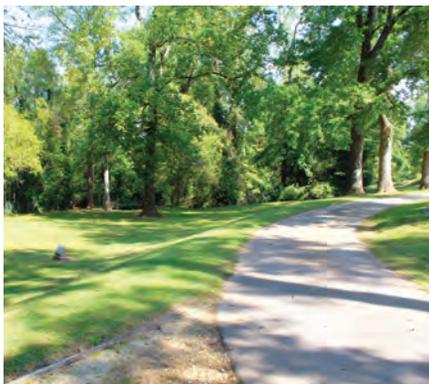
6.1.58 - Mount Hope Cemetery

Multi-modal access is provided to site, however, few parking spaces and no bike racks limit access. Co-location and stormwater treatment on site is extremely limited due to site's single-use as a cemetery.

- Use of cemetery for peaceful passive uses, such as seating, would have to comply with City of Raleigh code
- Bike racks near trail and on-street parking options are minimum

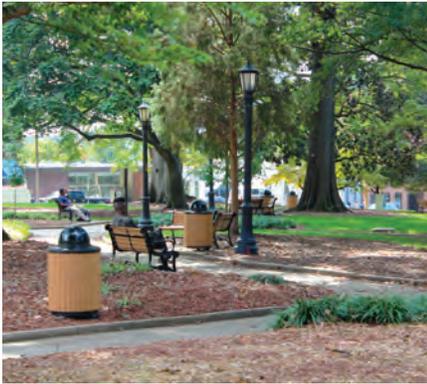
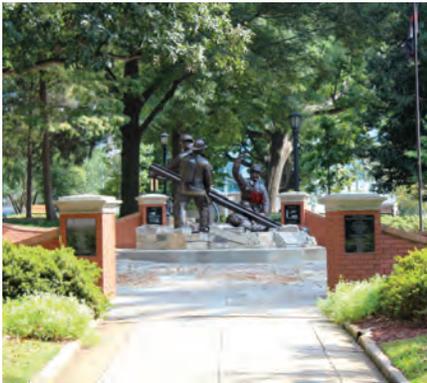
6.1.59 - Nash Square Size: 4.08 acres

Multi-modal access is accommodated near site. Co-location of public art and memorials in square promotes space as a center civic square for downtown. Stormwater is handled by a close system.

The square is well maintained and very clean. Benches are provided throughout and protection from weather is provided by the nearby municipal building.

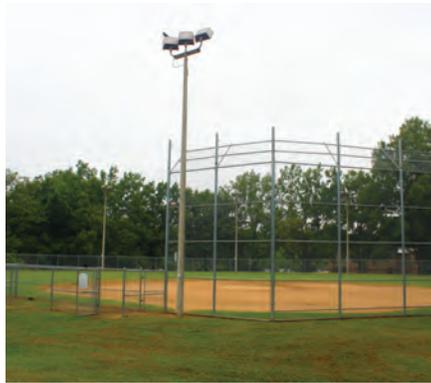
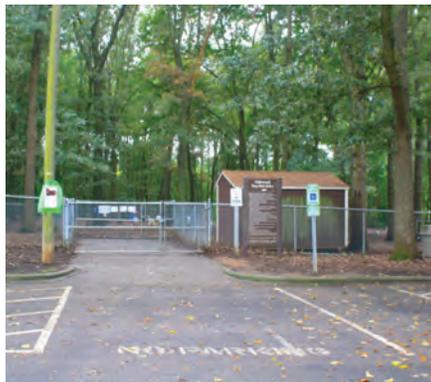
6.1.62 - Oakwood

Site lacks treatment of stormwater runoff on-site and taxes surrounding streets closed system. On-street parking could reduce needs for parking within site. Site needs to promote energy efficiency and water management for neighborhood.

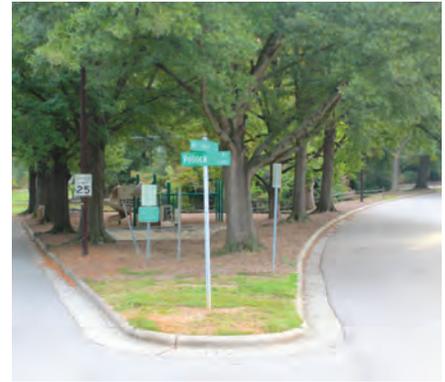
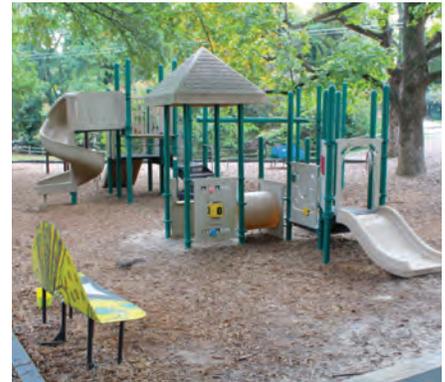
6.1.65 - Pollock Place

Multi-modal access with bicycle sharrows, parking and transit promotes access. Water management, though limited, can be accommodated on-site and enhanced.

- Activities for a mix of age groups is minimum
- Water management and quality on site could be enhanced
- Crosswalk and direct sidewalk access with accessible playground lacking

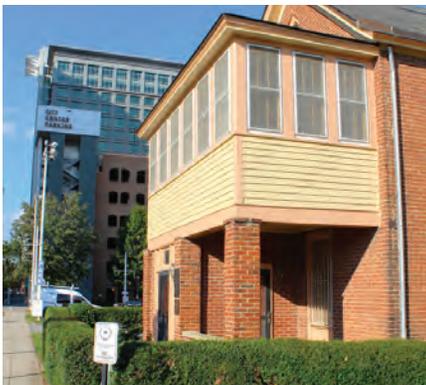
6.1.66 - Pope House

- Energy efficiency through site could be provided where appropriate
- Water harvesting could be utilized where appropriate
- Bike racks are lacking on site

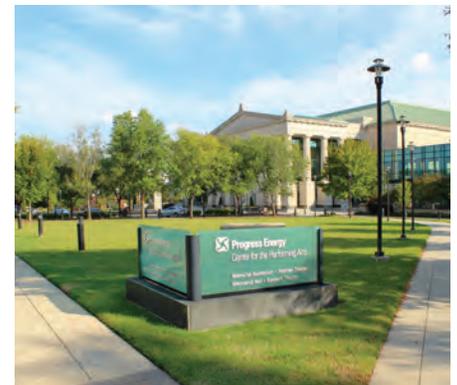
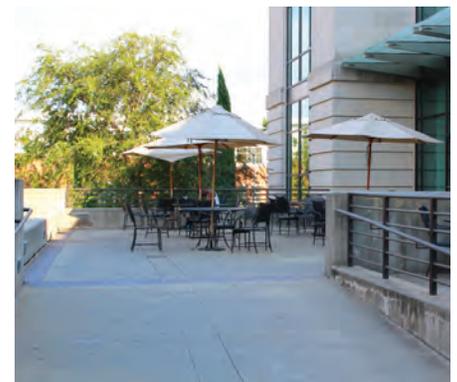
Site is primarily used for special events at the Performing Arts Center. Limited activities are offered outdoors in site for multiple age groups. Arts Center occupies most of site.

Space is very well maintained and clean. Parking areas are secluded to prevent unwanted views, however, this may impact safety. Seating options are lacking in southern area of site.

Stormwater is handled mostly with a closed system. Drainage problems exist in lawn areas in northern side of site. Multi-modal access is promoted through programming and use of site for civic events and facilities promotes co-location of infrastructure.

- Programming for outdoor spaces is minimum
- Drainage within lawn areas in northern area of site is insufficient
- Temporary and staff parking areas adjacent to arts center is unsightly

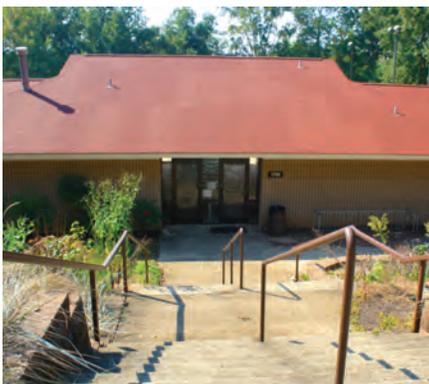
6.1.70 - Ridge Road

Ridge Road Park is set back from nearby streets with very limited visibility into the park. Connectivity via sidewalk is provided, however, transit and signage is minimum. Some pavement cracking and maintenance may impact accessibility.

Stormwater is direct runoff from site to adjacent properties. Multi-modal is provided by vehicle, bicycle and pedestrian access. Located adjacent to a middle school, the area promotes co-location of facilities.

- Year-round activities at facility and/or site are minimum
- Multi-modal access to park and school facilities is lacking
- Seating and external shelters for protection from weather are not provided

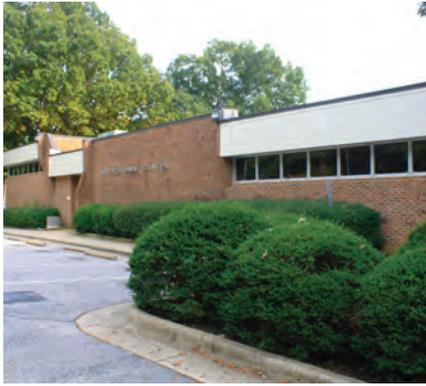
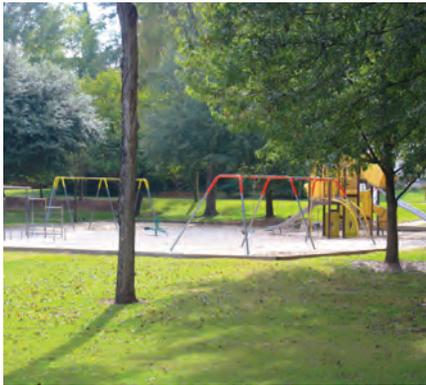
6.1.71 - Roberts Size: 7.20 acres

Stormwater is minimally treated on-site and could be improved. Multi-modal access is provided by vehicle, bicycle and pedestrian access. Lighting for fields and courts throughout park is out-dated and may not be energy efficient.

Park is well maintained. Nearby residences provide natural surveillance of the park, while neighborhood center and shelters provide protection from weather.

- On-site stormwater management is minimum
- Accessible routes to facilities such as playground and courts are missing
- Crosswalks to park and energy efficient lighting for courts and fields missing

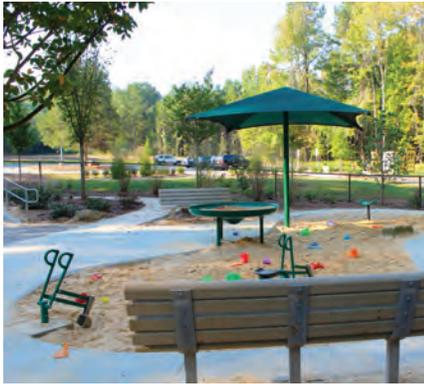
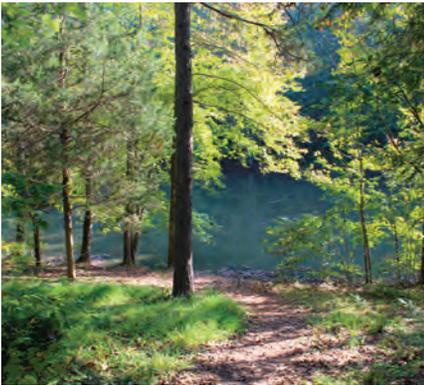
6.1.75 - Strickland Size: 36.10 acres

Site includes bio-swales and retention with treatment of stormwater runoff. Solar lighting promotes energy efficiency. Multi-modal access is lacking without direct and safe sidewalk access.

Park is new and very clean. Within park open views to active areas provides safety, however, seating is limited to playground and no protection from weather is currently provided.

- Sidewalk access into park is missing
- Balance natural appeal of site with future development
- Continue energy efficiency and sustainable design for future development

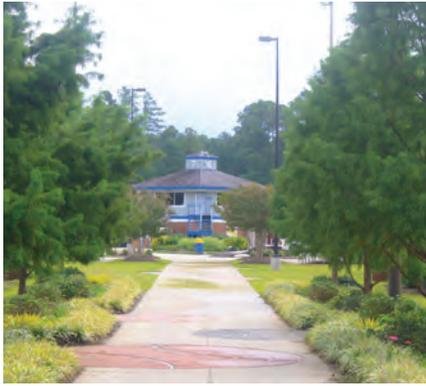
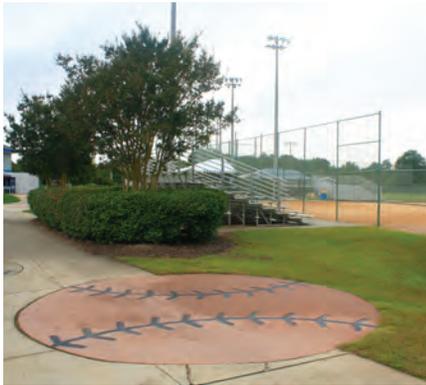
6.1.79 - Walnut Creek Softball Complex Size: 104.84 acres

Field stormwater run-off is typically untreated. Vehicle parking areas are mostly gravel which reduces runoff. Multi-modal access is extremely limited with only safe vehicle access into park. Lighting is high intensity due to complex needs.

- Activities and programming for additional age groups, such as playgrounds, wi-fi, additional seating, walking trails, food trucks, etc., are limited
- Stormwater treatment to reduce runoff from fields is minimum

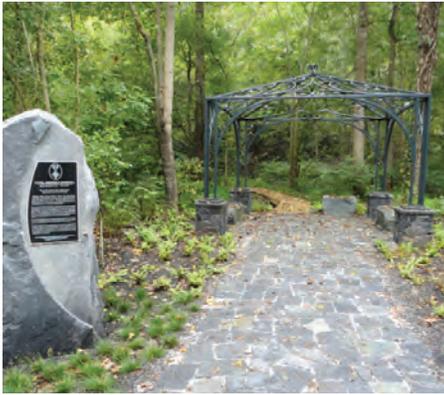
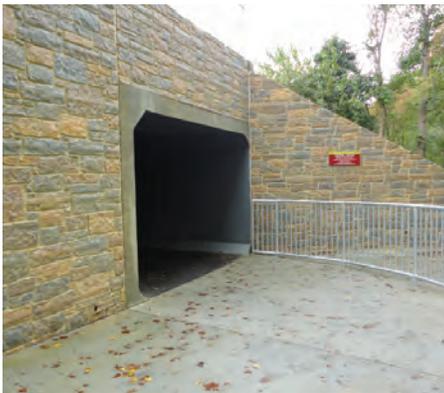
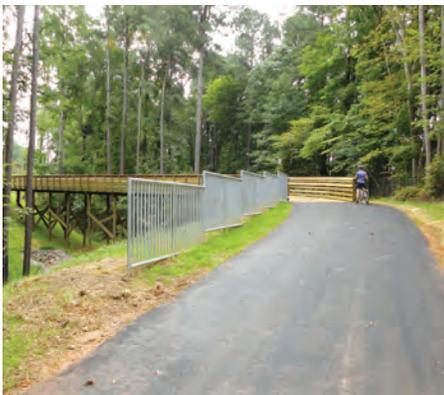
6.2.1 - House Creek Trail

- Underpasses are not lit
- There is potential for user conflict at underpass entrances

Trail striping is missing on most curves and centerlines of the trails. Spur along Horton St. connects to park amenities. Crosswalks are needed along the driveways for safety. The trailhead provides parking for approximately 15 vehicles and includes accessible parking. South of Horton, centerline striping is needed to warn bicyclists of the limited sightlines and steep grades.

- Some ponding near underpass
- Trail tread is aging, cracking

House Creek Trail does not have centerline striping. Centerline striping is recommended for transportation trails, and at a minimum, should be installed at

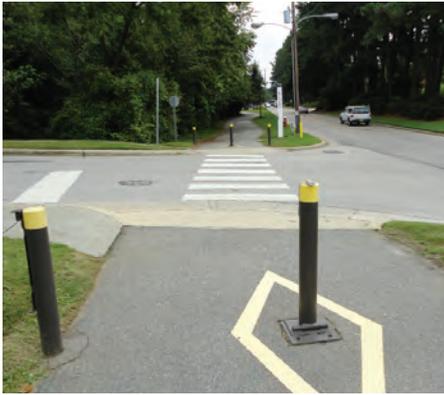
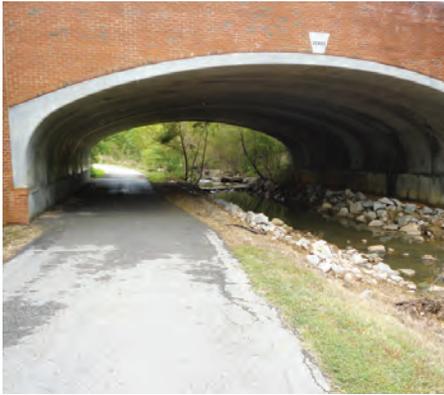
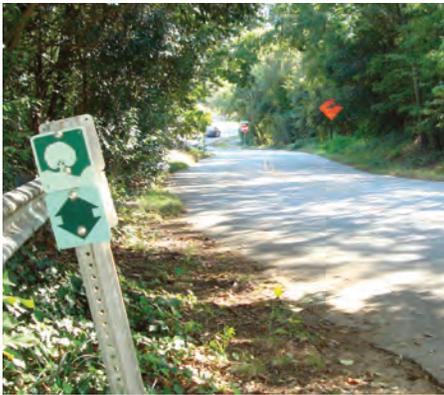
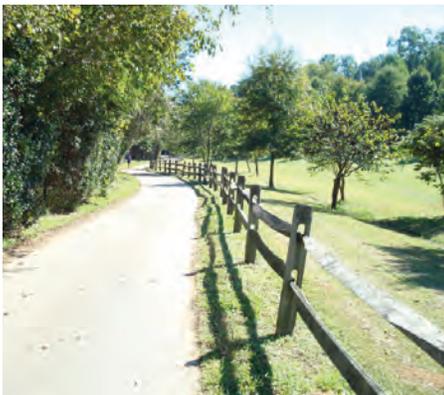
6.2.3 - Rocky Branch Trail

- Railings on Western Blvd. are in poor condition
- Asphalt is aging, cracked
- Update wayfinding, kiosks with current signage
- A 10-foot minimum trail width could handle high levels of traffic
- A mural underpass at McDowell would provide a better safety perception
- Pedestrian level lighting at strategic locations would increase hours of operation beyond current dawn to dusk

- Trail cracking in some areas
- Sediment and ponding along some shoulders
- Timber boardwalk is deteriorating in some areas

A study is recommended at the intersection of Jamaica and Saunders. The underpass at Dawson/Western/McDowell is lit, however the inside would benefit from a mural or other inviting element.

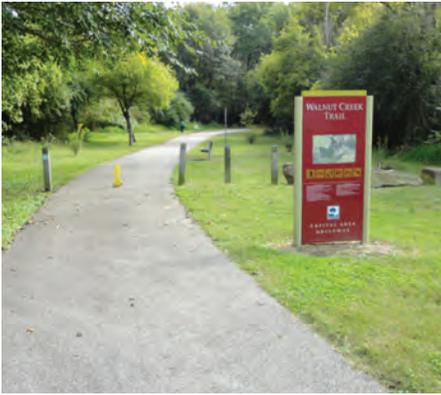
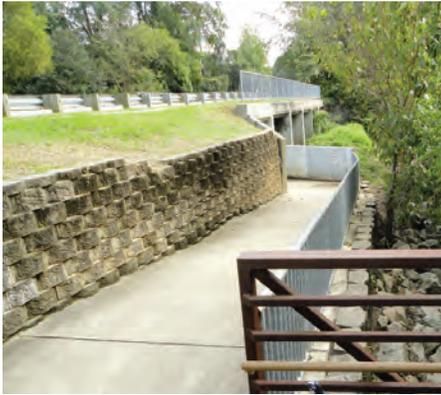
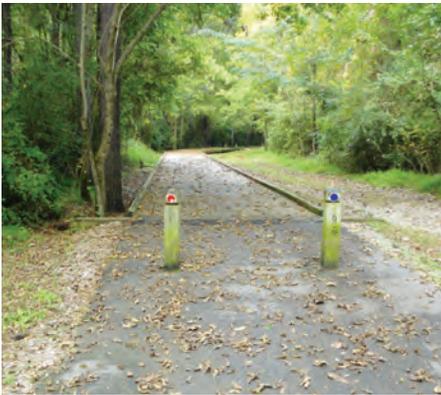
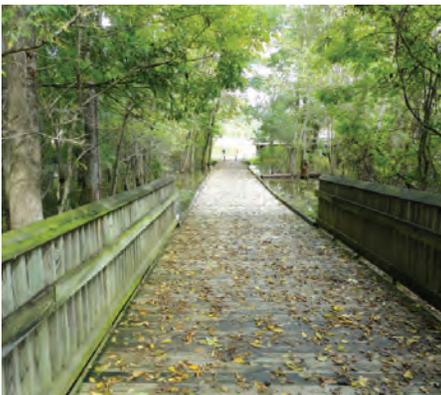
6.2.5 - Walnut Creek Trail - WCT-A

- Underpasses are not lit and lacks regulatory signage, vertical/horizontal clearance is limited
- Poor site lines at underpass
- Trail tread in very poor condition
- Areas in need of maintenance
- Vandalism of mile markers, littering

The underpass at Rock Quarry Rd. has very low clearance, no lighting, sediment and moisture, and inadequate signage

and striping at entrance. Sections of the tread along this segment are in poor condition with slippery conditions, sediment deposits, and litter. There is vandalism of several mile markers and some areas in need of railing.

The tread is in very poor condition. There are sediment deposits, mud, downed limbs, and slippery conditions on the tread. Boardwalk areas are in disrepair. At Rose Ln, a better transition is needed for safety and user clarity. Where the trail becomes an on-road facility, sharrows or other bike route signage is needed.

- Reconstruct/reroute areas in disrepair
- Raised tread and surface damage present
- Maintenance may be lacking with litter present
- Wayfinding signage along corridor is minimum
- Safety issues at underpasses present
- Signage is vandalized
- Railing is lacking in some areas where appropriate

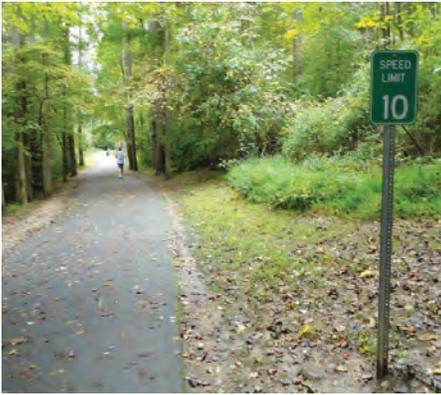
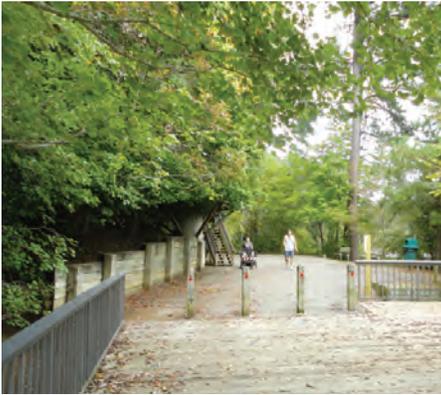
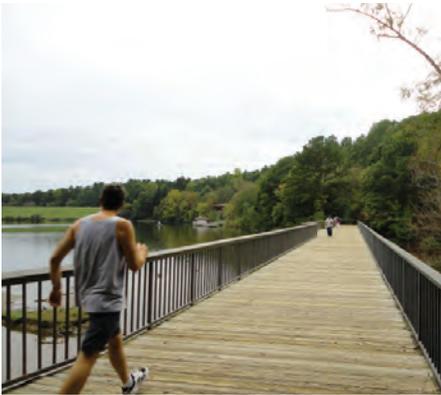
6.2.7 - Shelley Lake Trail

- Trail surface is aging, cracking, tree roots (esp. at lake)
- Some ponding/sediment
- Timber boardwalk is deteriorating

- Trail may be too narrow to support such high level of use
- Slopes are steep on south side of trail
- Cross slopes are steep in some areas (not ADA compliant)

- Trail width is minimum for high level and variety of uses
- Asphalt is aged and needs repair
- Wayfinding and regulatory signage at intersections and parking area is lacking
- Trail etiquette signage are not provided
- Existing boardwalk is in poor condition
- Recycling receptacles are not provided
- Fitness stations are aging/deteriorating

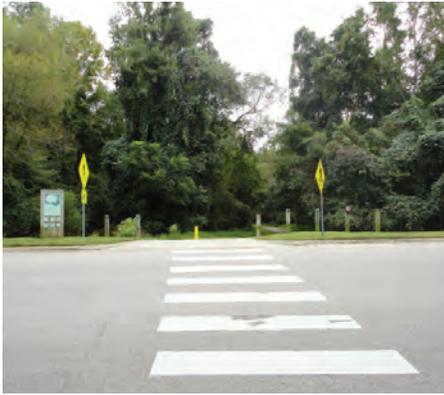
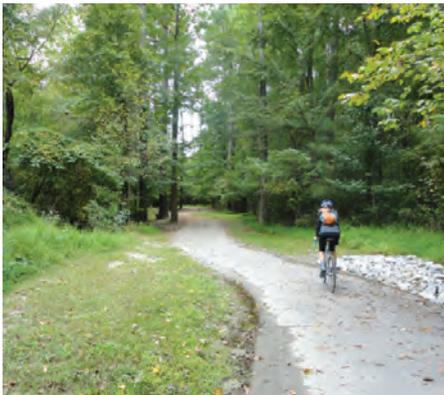
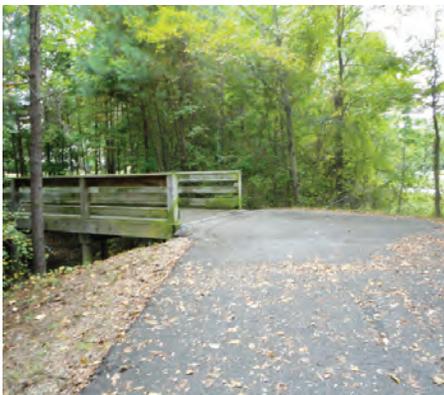
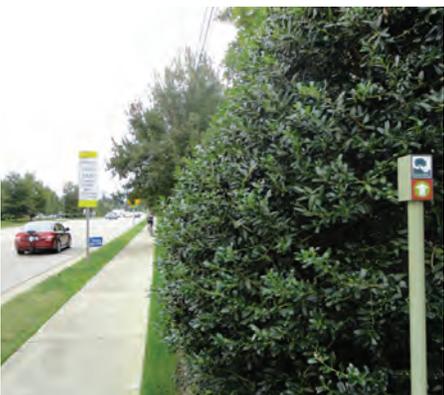
6.2.9 - Simms Branch Trail

- Drainage issues are being addressed, but some ponding is still occurring
- Tread is aging, cracking in some areas

Trail is aged and cracking in places due to roots. Resurfacing needed areas. Some locations areas contain ponding issues but are being address. Cross slopes on some sections are steep

- Some areas of asphalt are crack and aged due to root damage
- Wayfinding/mile markers in to be updated

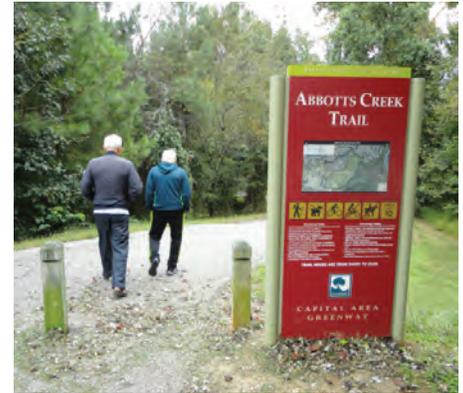
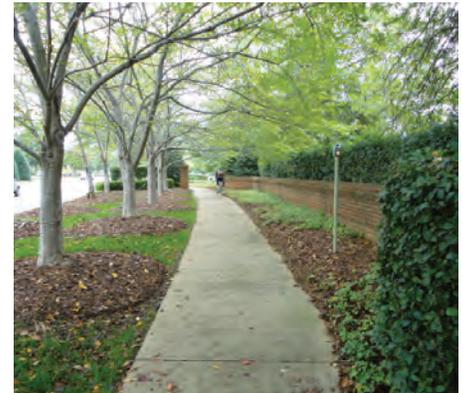
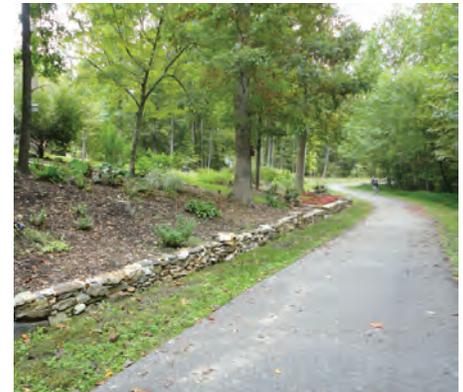
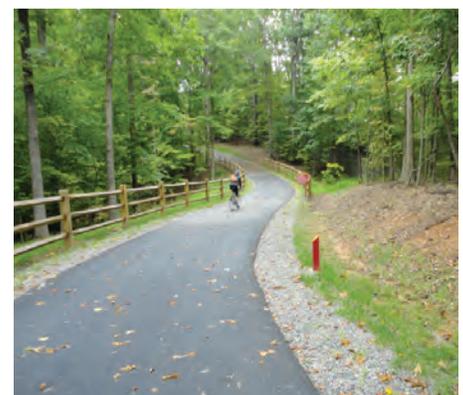
Pruning is necessary for facility to be functional transportation corridor and keep path of travel clear. Along Falls River Ave., there are multiple driveways that need signage and crosswalks to warn motorists and trail users. At the intersection of Durant Rd., a study is recommended with high visibility crosswalk and wayfinding signage. Along Durant Rd., the wayfinding signage is difficult to see.

- Trail entrances at Falls River Ave. and Durant Rd. lacks high visibility crosswalks
- Traffic calming and driveway crossing facilities on Falls River Ave. missing
- Centerline striping at Falls River Ave. entrance missing
- Sidewalk travel area not clear along Falls River Ave. due to vegetation
- Sidewalk and bike lane facilities are minimum
- Wayfinding signage could more visible when connecting on-road facilities to off-road facilities

The trail entrance at Falls River Ave. should be improved by extending the brick and repairing the sidewalk. Along Falls River Ave. there is a need for traffic calming such as speed tables or other controls. At the south entrance to Abbotts Creek Trail from Falls River Ave., striping and regulatory signage is needed for the poor site lines.

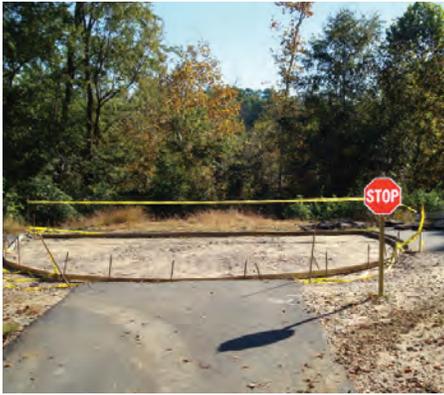
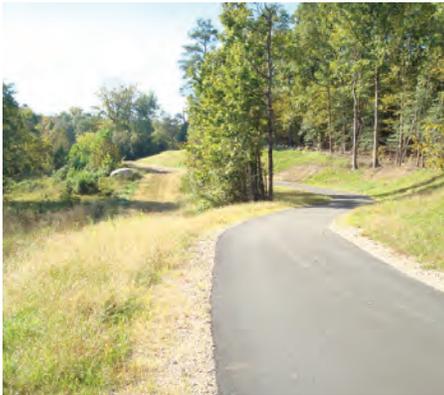
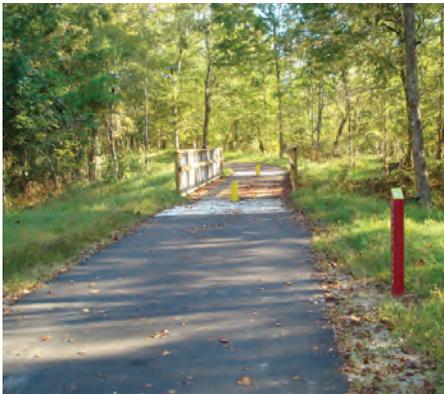
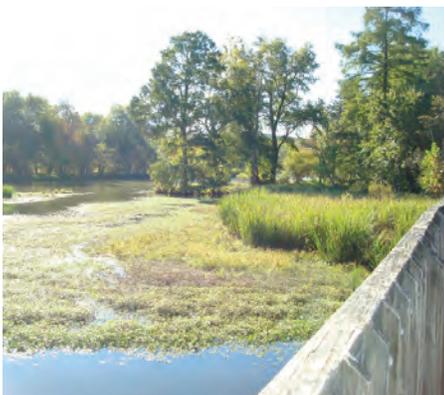
6.2.11 - Neuse River Trail

- Bollards at bridges are unnecessary and a safety hazard

With the wetlands surrounding this segment, there are scenic views to the Neuse River and natural areas for observation. The boardwalk is a nice amenity but will need replacement in short time. The tread is weathering and hand rails are deteriorating. At the spur to Allen Dr, a paving feature was under construction. Segments of this corridor were not paved.

- Wayfinding signage within Anderson Point Park and Milburnie Park are minimum
- Existing boardwalk south of Crag Burn Lane is in poor condition
- Bollards at bridges could be relocated to trail entrances if needed
