PULLEN ARTS CENTER AND NORTH PULLEN PARK IMPROVEMENTS PROJECT

EXISTING CONDITIONS REPORT

September 2015

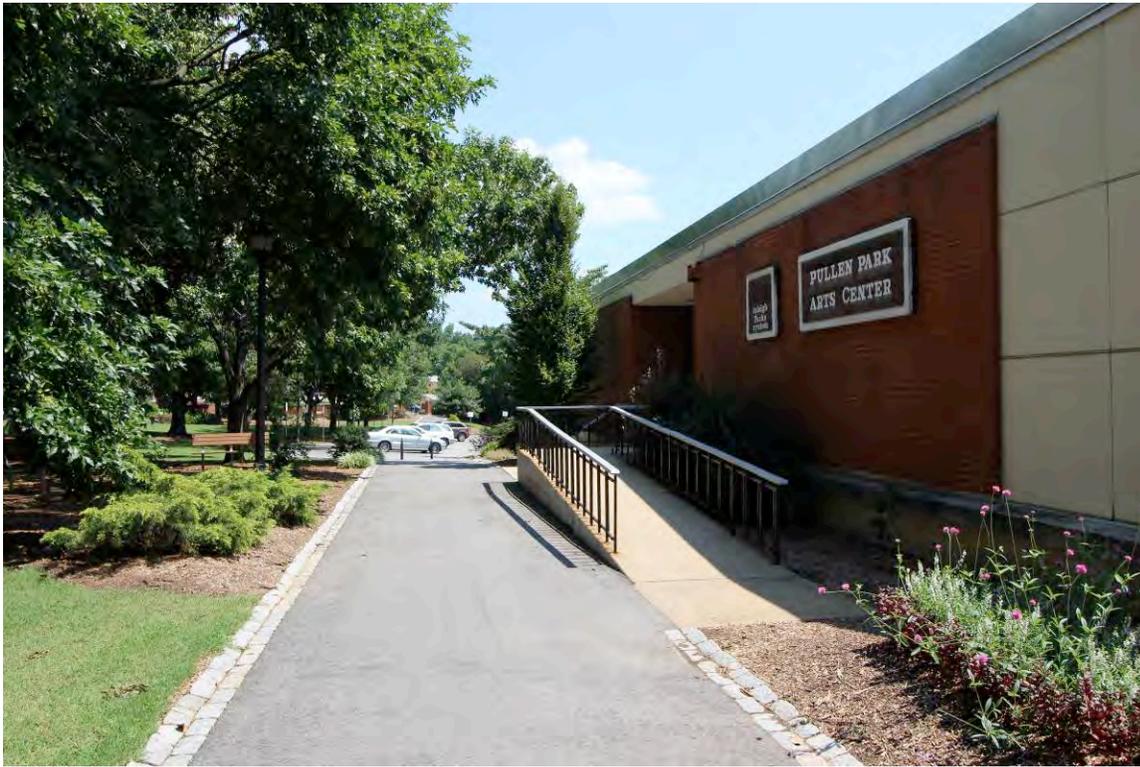
Finding the arts building can prove challenging for first time users. The existing building is located behind a large established grove of trees. While, these trees are part of the historical character of the park and define its cultural significance, the center is only visible through brief glances between the trees along Pullen Road. Opportunities for enhancing user wayfinding may be possible through the expansion of building uses to the exterior, whether through outdoor teaching environments or long-term display spaces for artwork. Once entering the site from the traffic circle on Pullen Road, visitors have a brief view of the building to the north by way of the sculpture lawn before entering the second traffic rotary interior to the park. However this view is very brief and is quickly overwhelmed by the traffic circle and the need for focus as users work to decipher where they should drive to park and enter the desired location. Signage for the theater building is hidden behind the garden, a temporary vinyl banner has been installed to help rectify. The signage for the art building is only present on the Pullen Road façade, which is not visible from Pullen Road or from the access drives. See **Figure 2 depicting the building sign**

Figure 2 View of building signage

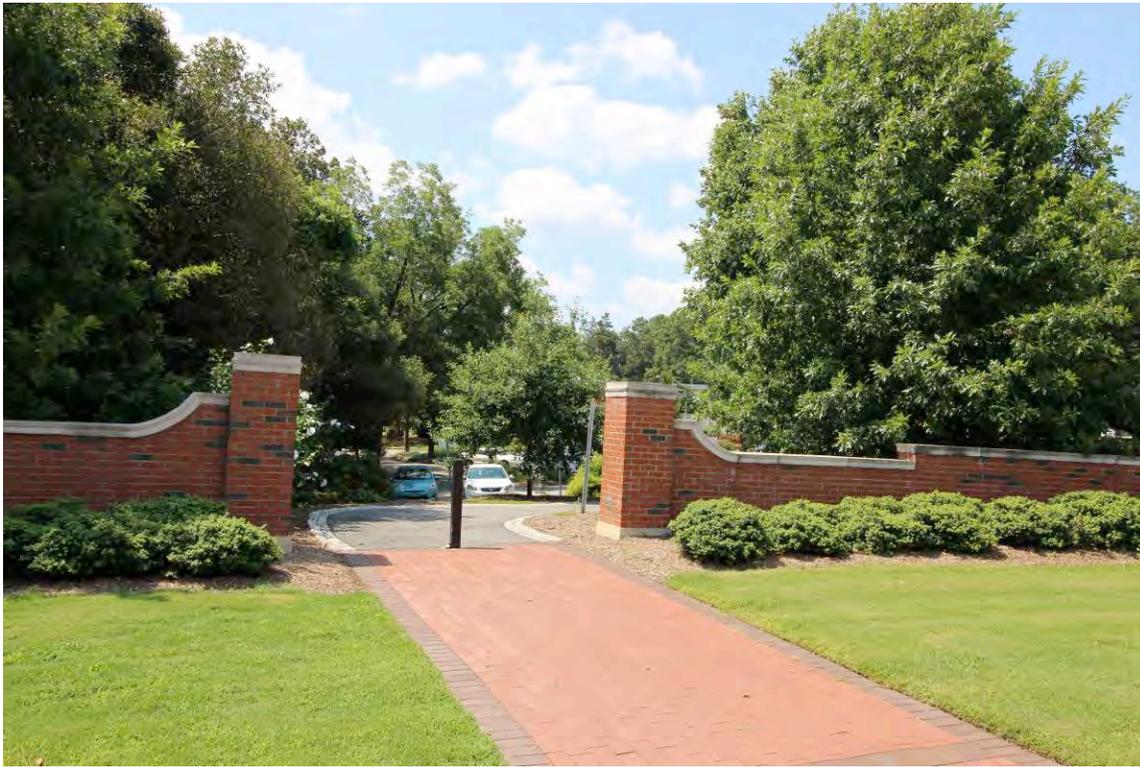
North Pullen Park is framed by a large formal brick entry sign that was constructed as part of the Hillsborough Street traffic circle. From Hillsborough Street, the arts center is visible through a brick archway, but only as a glancing view. Once users have entered the park via this gateway, the building is more visible, but a clear demarcation towards the entry is not apparent. See **Figure 3**.

Figure 3 View of gateway at Hillsborough Street, Pullen Arts Center is barely visible to left of the entryway

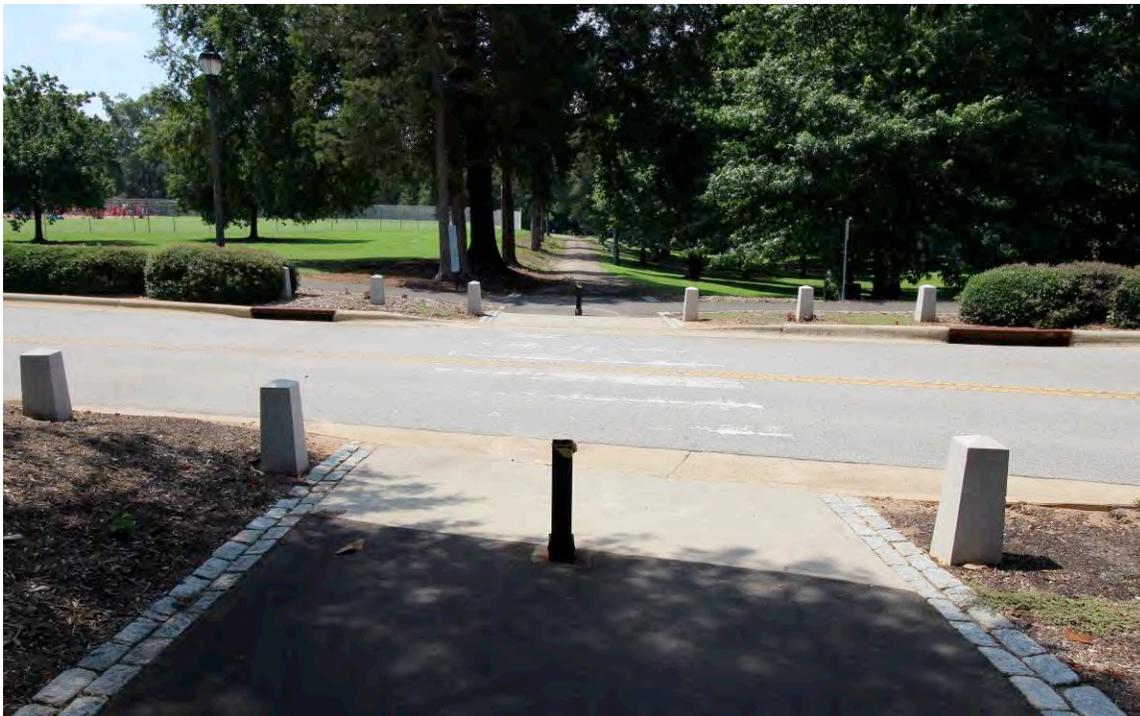
Within the park, the existing sidewalk network provides pedestrian circulation around the arts center building to the main entries from the parking areas. How these networks cross and interact with vehicular circulation routes should be examined for further improvement, specifically in the areas between the Gregg Museum, Theater, and Arts Center. See Figure 6 for a typical pathway crossroad.

Figure 6 View of crossing at main entry drive, pedestrian traffic is secondary to vehicular

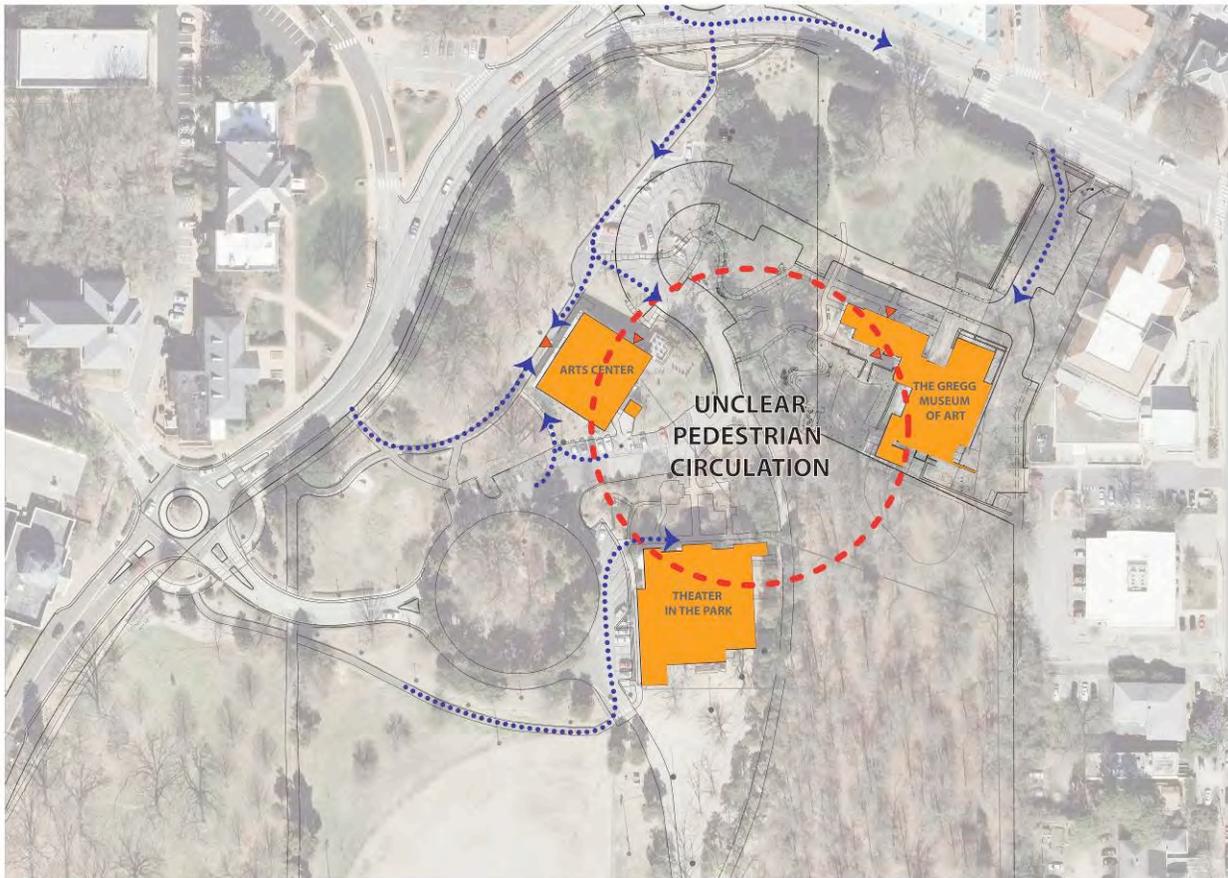
Figure 7 Pedestrian circulation diagram, central court is not pedestrian centric, pathways are focused around perimeter spaces.

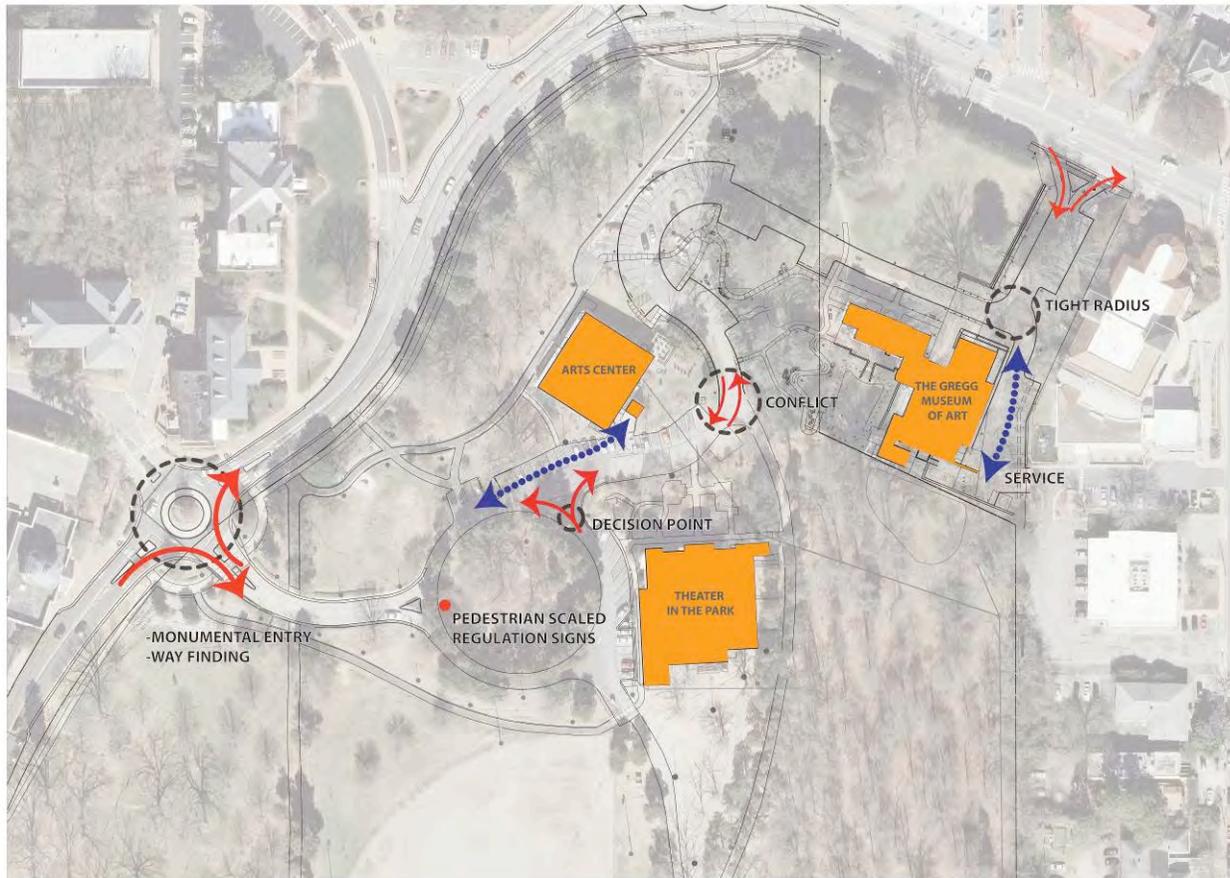
Figure 10 depicts the vehicular circulation of North Pullen Park, documenting service areas and where conflicts in circulation occur.

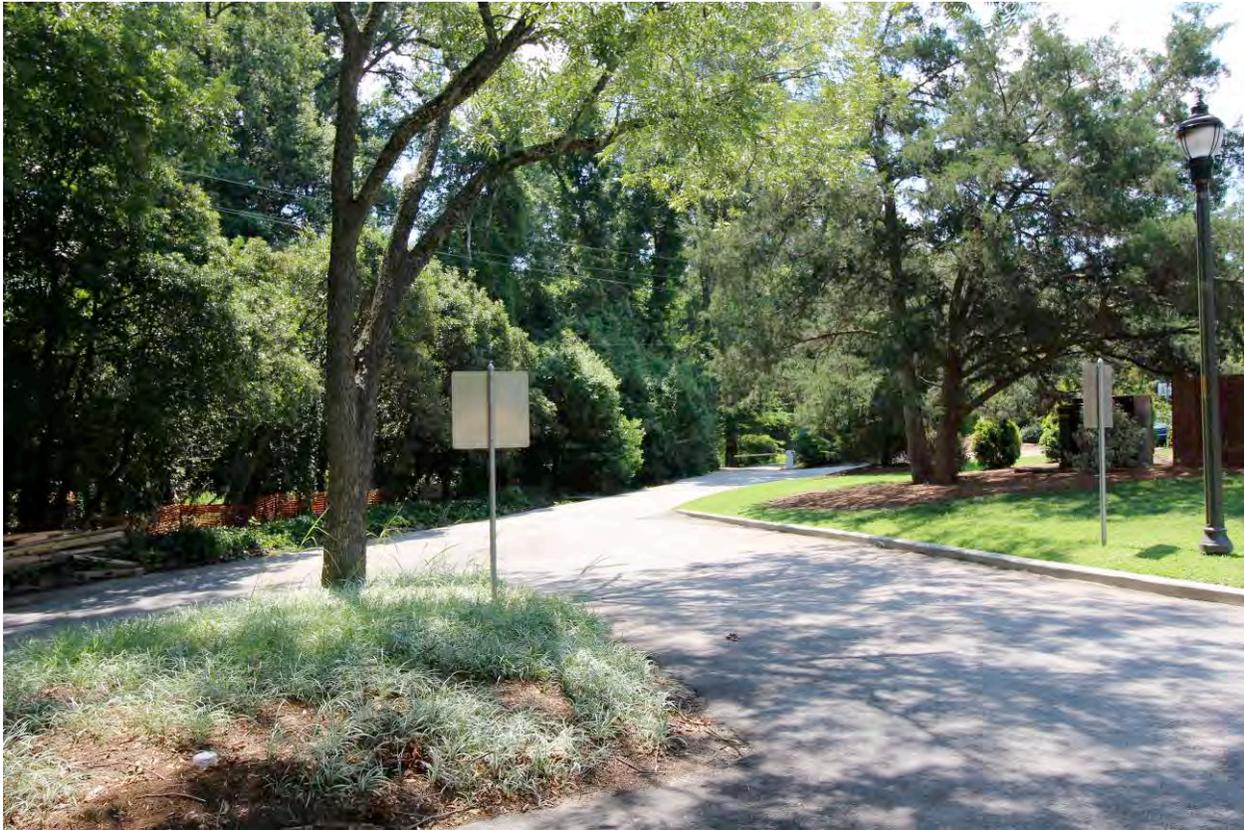
Figure 12 View of the existing parking at the northeast corner of the art center building. This is a storm collection point in the proposed design.

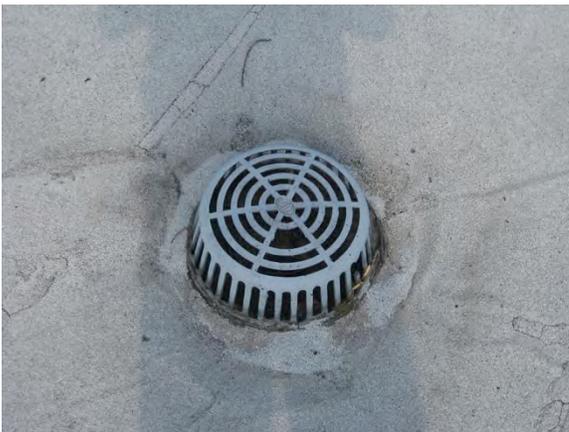
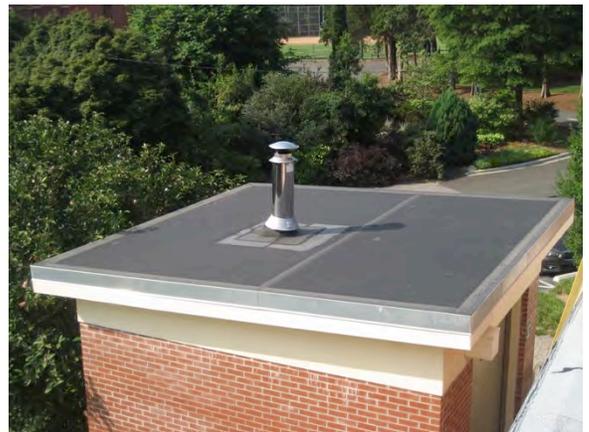
d. Roof Drainage

The main roof is drained by a series of internal roof drains – all of which appear to be installed and functioning properly. We did not note an overflow drain system since none were required when this building was built. Given the modest vertical dimension of the edge flashing, the lack of overflow drainage is not serious in that any buildup of water on the roof would easily drain off the perimeter. There is no roof drain on the small freestanding structure and all water from that roof simply flows across the edge flashing.

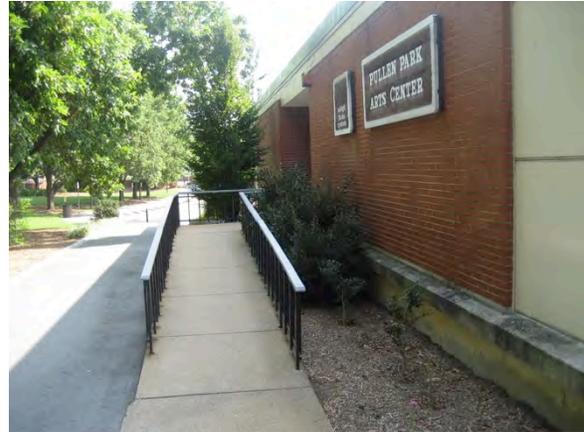
b. Ramp

A concrete ramp was added at the main front entry to provide handicap accessibility. This ramp has a painted metal rail. This access meets current accessibility codes, but does communicate visually that it was a later built accommodation.

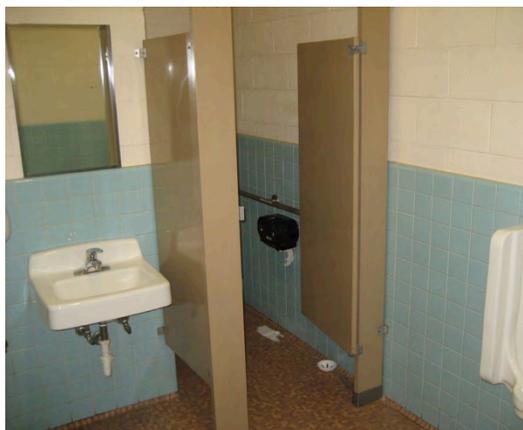
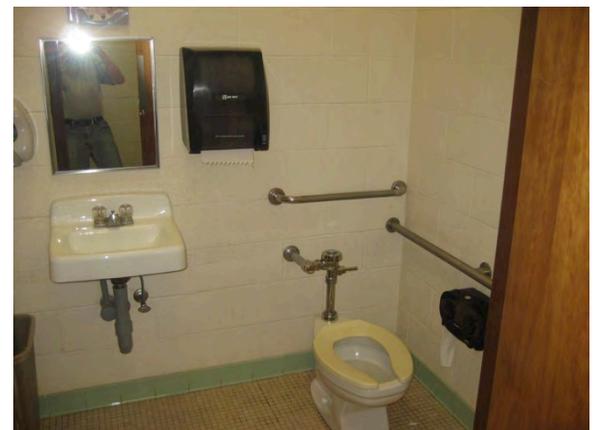
b. Restrooms

- i. The lower level restrooms have been renovated to meet the contemporary ADA Accessibility Guidelines. They appear to be fully compliant except for the recently required vertical grab bar in the toilet partitions. The main floor men and women's restrooms are not accessible. However, there is a single-occupant restroom on this level which is accessible.

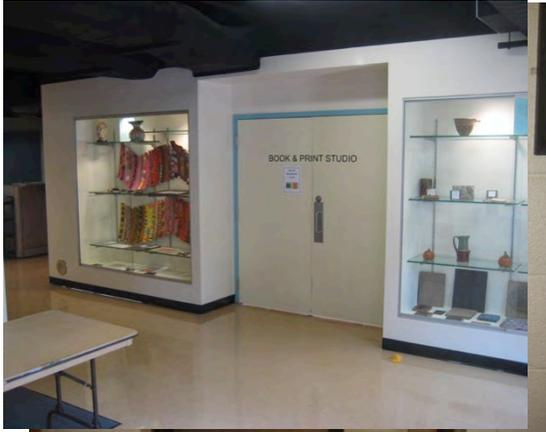
c. Doors

- i. The majority of the doors within the facility meet the required minimum width. However, many of them do not have the required clearance on the door handle side.

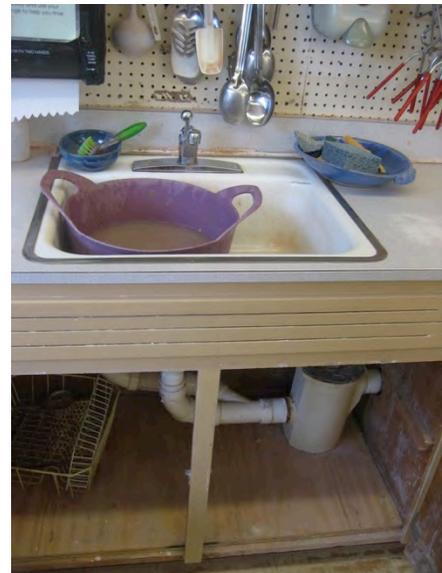
d. Sinks and Counters

- i. None of the sinks in the classrooms, nor the counter space, have the required legroom or dimensional limitations to meet accessibility requirements.

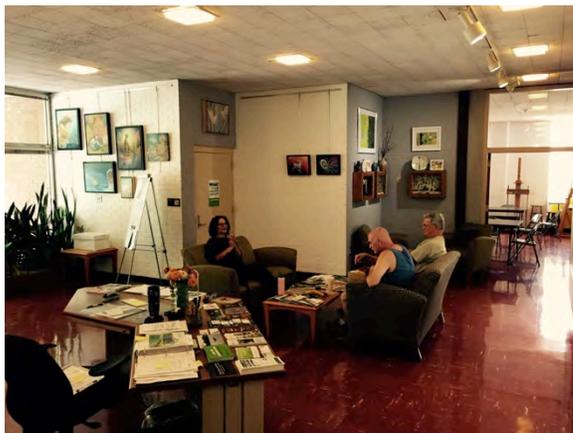
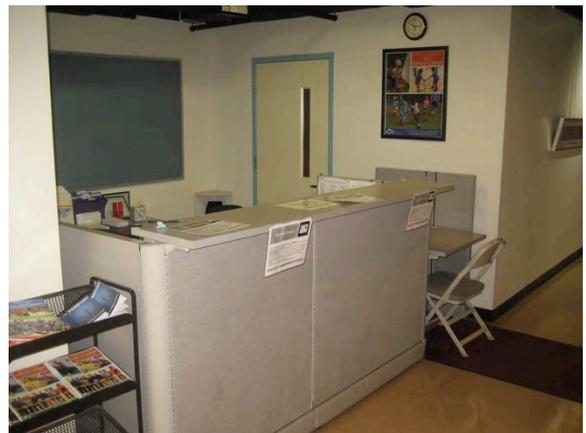
6. Public Spaces

- a. There are minimal public spaces within this facility. There is a reception area on the main floor just inside the front door with a reception desk and small seating area. There is also a small reception desk area at the lower level entry. In both cases, there are some display cabinets, but the facility, in general, lacks the type of public spaces and display areas normally associated with art centers.

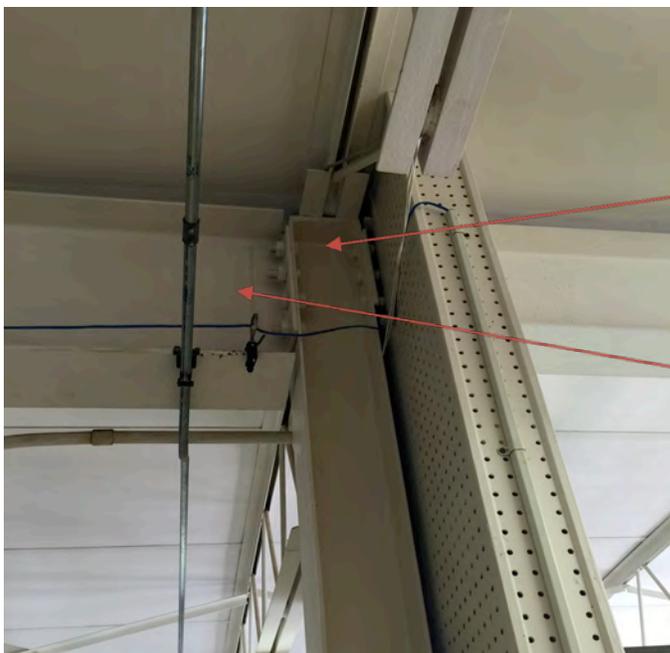
Picture 2

The building was constructed in 1961. The existing structure consists of CMU walls and brick veneer on the exterior. The interior structural system consists of four rows of continuous steel columns (except for two columns in the basement) with beams spanning east to west (Picture 2). The roof framing is constructed of a bar joist system at nearly 6' o.c. (Picture 1). The roof deck was concealed; therefore, it is unknown. There were no signs of any roof leaks. The first floor framing is similar to the roof framing with a bar joist system. The floor joists are approximately 2' o.c. with a corrugated metal deck with an assumed 3" thick concrete slab (Picture 3). The basement has a poured concrete retaining wall on front, rear, right wall of the building. Left basement wall is a partial height concrete retaining wall with windows above because the grade is sloping away. After sizing the existing steel and running the calculations, the existing structure meets the current building code and all interior walls can be removed except those which are a part of the stairwell to the basement. The roof joist, roof beams, floor joists, floor beams, and columns indicated the existing structure is independent of any interior walls. Calculations and structural drawings will be provided with this report.

Roof Joist (RJ1 - 20 J 6 assumed)

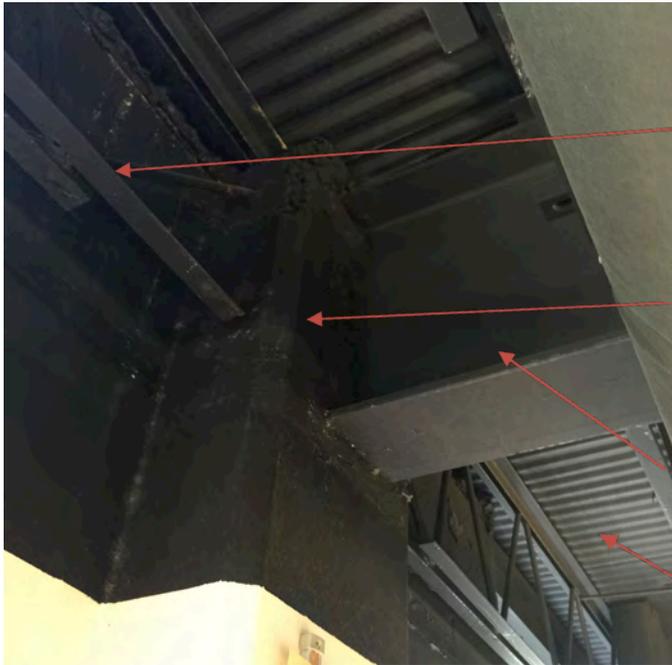
Picture3

Steel Column (C1 - 6 WF 25 assumed)

Roof Beam (RB 3 - 16 WF 36 assumed)

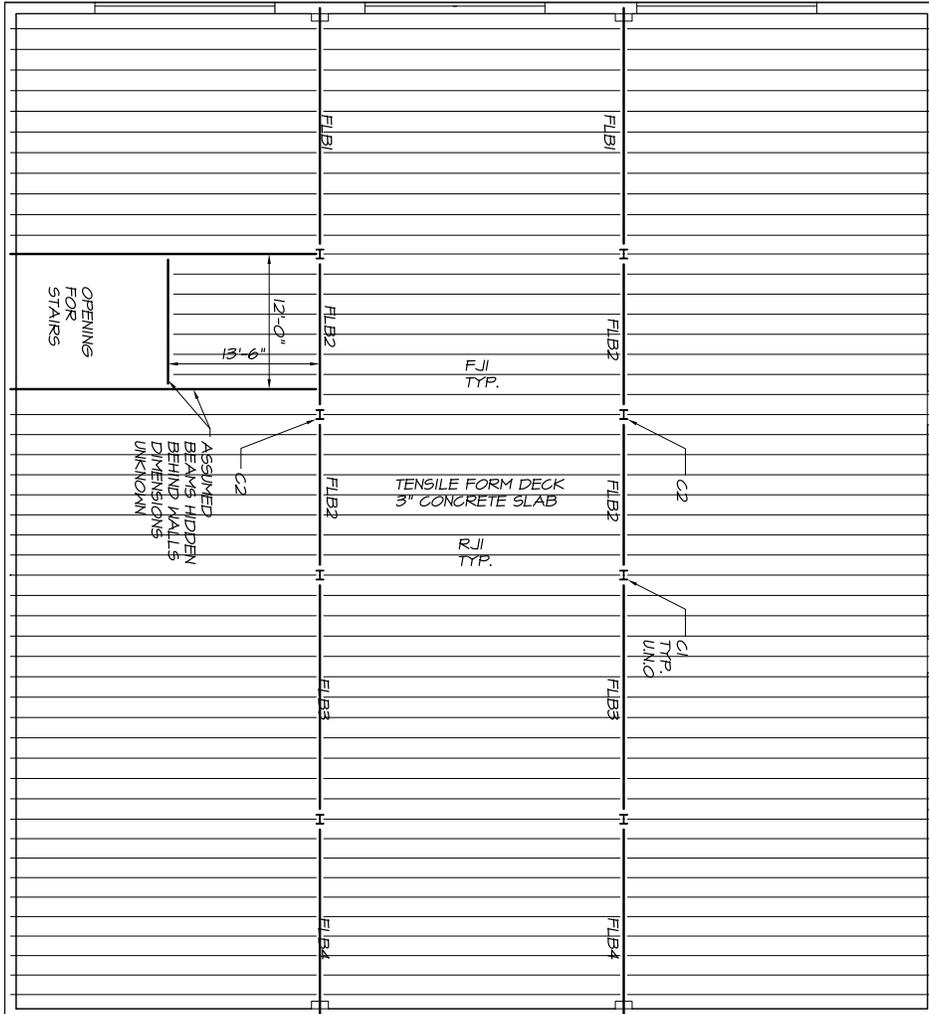
EXISTING FIRST FLOOR FRAMING PLAN
 $\frac{3}{8}$ " = 1'-0" SCALE

MK#	FLB1	FLB2	FLB3	FLB4
Ry, kips	211	193	210	227
Size	21 WF 55	16 WF 36	21 WF 62	18 WF 50
Sx, in ³	1094.7	56.3	1094.7	78.9
Ix, in ⁴	1140.7	446.3	1140.7	704.5
Span, ft	21.8	14.3	21.7	17.3
Spacing, ft	27.3	27.3	27.3	27.3
Dead Load psf	65.0	65.0	65.0	65.0
Live Load psf	50.0	50.0	50.0	50.0
LL Reduction, %	47.6	31.1	47.2	37.8
Total Load, plf	2485	2710	2490	2619
Mmax, ft-kips	148.1	68.8	146.1	98.3
Deflection, in	0.4	0.2	0.4	0.3
Actual Defl Ratio	682	880	647	744
Fy, ksi	36.0	36.0	36.0	36.0
M _r , ft-kips	197.5	101.3	197.5	142.0
Allow Defl Ratio	360	360	360	360
Status	OK	OK	OK	OK

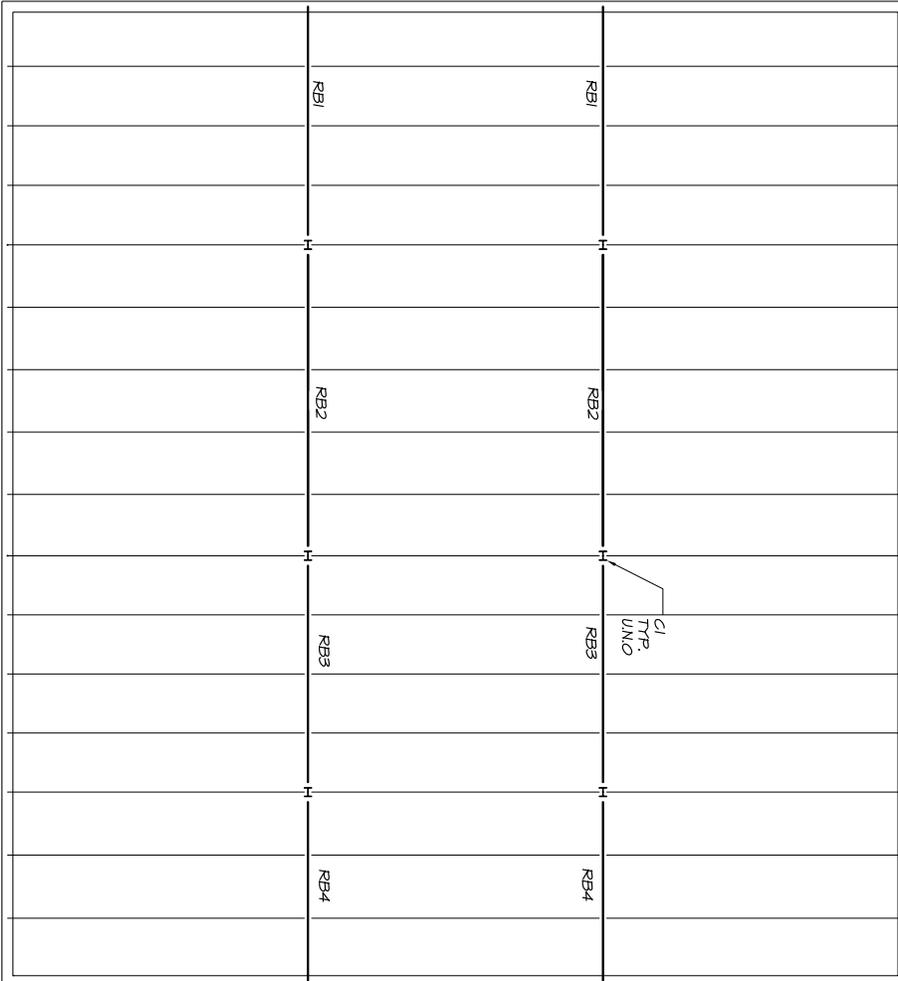
EXISTING ROOF FRAMING PLAN
 $\frac{3}{8}$ " = 1'-0" SCALE

JK#	RB1	RB2	RB3	RB4
Ry, kips	11.9	15.6	11.8	4.5
Size	16 WF 36	18 WF 45	16 WF 36	12 WF 27
Sx, in ³	56.3	78.9	56.3	34.1
Ix, in ⁴	446.3	704.5	446.3	204.1
Span, ft	21.8	28.5	21.7	17.3
Spacing, ft	27.3	27.3	27.3	27.3
Dead Load, psf	20.0	20.0	20.0	20.0
Live Load, psf	20.0	20.0	20.0	20.0
Total Load, pif	1092	1092	1092	1092
Mmax, ft-kips	65.1	110.9	64.1	41.0
Deflection, in	0.4	0.8	0.4	0.4
Actual Defl Ratio	607	431	621	555
Fy, ksi	36.0	36.0	36.0	36.0
Mt, ft-kips	1013	1420	1013	614
Allow. Defl Ratio	240	240	240	240
Status	OK	OK	OK	OK

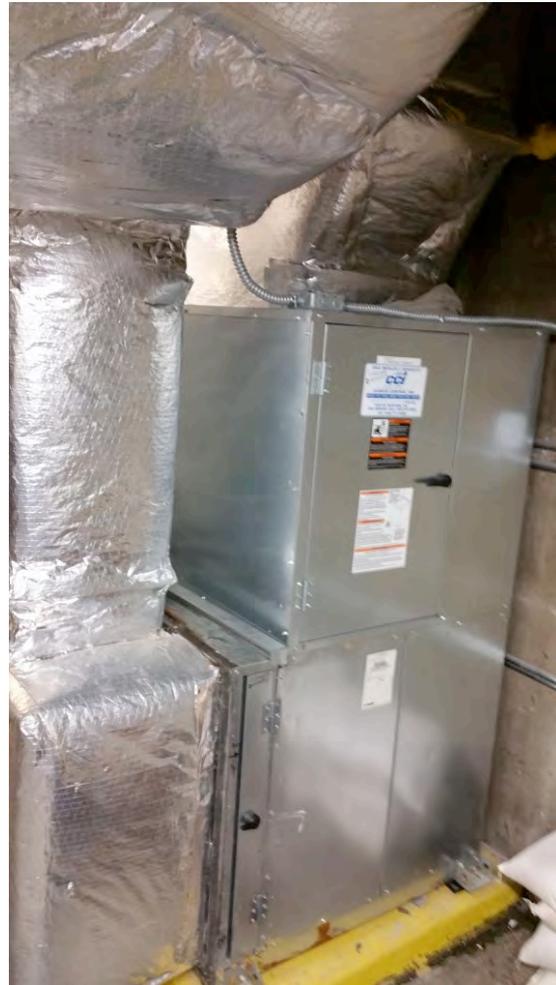
Existing Air Handler

The first issue that should be addressed is the non-code compliant return air pathway. On the first floor, the Painting room and Break Rooms all transfer their return air into the corridor, before going to AHU-2 return grill open to the hallway. This creates a smoke hazard, because if there was a smoke or fire event in either of these spaces, it would be carried into the exit corridor and into the path of other evacuees. This condition should be fixed in any renovation project.

Another air distribution issue is related to the size and location of the floor grilles. Where placed, these floor distribution devices are often covered up with shelving or equipment and fail to properly provide airflows into the space. These supply grilles are original to the building and are very undersized for the new airflows. They are creating high supply airflow velocities, that are not only loud, but also the “wind” generated is disrupting activities in the spaces. Any renovation project should plan to address this nuisance issue.

- a. Most of the Mechanical systems in the building are in excellent condition and should be salvaged or reused in any planned renovation project.
- b. AHU-2 return air needs to be re-worked so that the exit corridor is not used a return air pathway.
- c. Air distribution devices in the floor should be located to the ceiling and increased in size.
- d. Both of these items might be corrected by replacing AHU-2 with a Roof Top Unit instead.

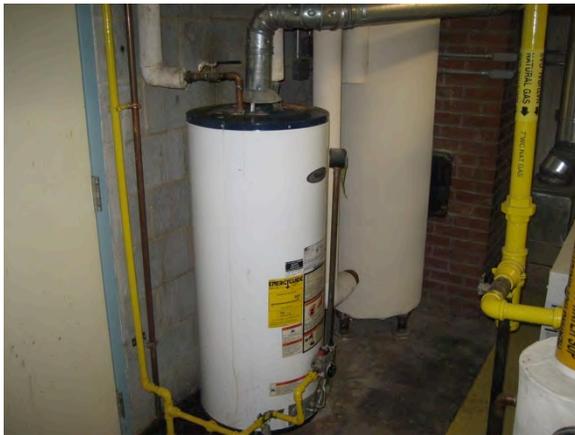
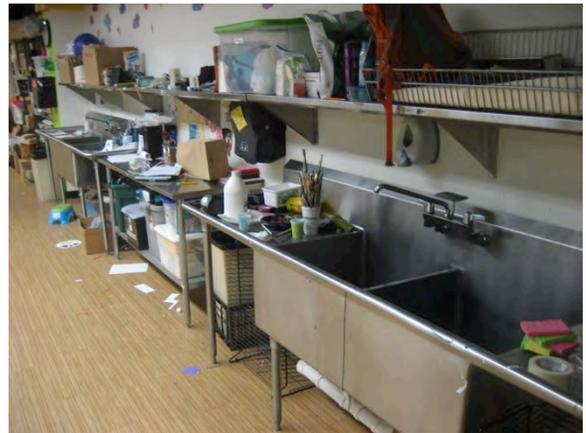
The building contains public restrooms on both floors, classroom sinks / counters and a series of large stainless steel double-bowl sinks. There are (2) water heaters in the Mechanical Room and a backflow preventer. There are also mop basins in both janitors' closets.

The building has an existing 6" Sanitary Sewer connection and a 1 ½ domestic water connection. The domestic water service connection is protected with an RPZ, however it is not in compliance with current City of Raleigh backflow requirements and so any renovation will need to address this. Additionally, the incoming 1 ½ is just large enough to serve the fixture count of the existing building but will likely need to be upsized if the supply water demand fixture count is increased.

Clay traps installed in the pottery room have been reported to drain very slowly or not at all, indicative of many years of material collecting in the traps. These traps could be replaced or cleaned.

- a. Clay traps should all be cleaned or replaced.
- b. Domestic water tap may need to be upsized to 2" if any more fixtures are added

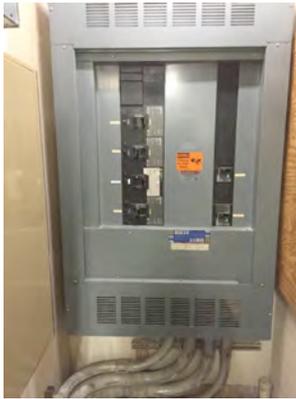
Electrical Distribution

The building is served from a Duke/Progress utility transformer sited at the NE corner of the building. Power is delivered at 208Y/120 volts and terminates in a 1200 ampere ILINE style panelboard in the main mechanical room in the first level.

The electrical panels are all in good condition and wiring methods appear to be safe and Code compliant. The main electrical panel appears to have two (2) Code related issues: issue #1-the Code mandated working space required in front of the panel is not present; issue #2-the panel has space for additional breakers which would violate the National Electrical Code.

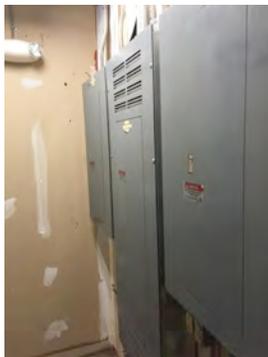
Electrical Panels-Basement

The main electrical panel feeds five (5) panels; four (4) are installed in the main electrical room and one (1) is installed in the HVAC service yard.

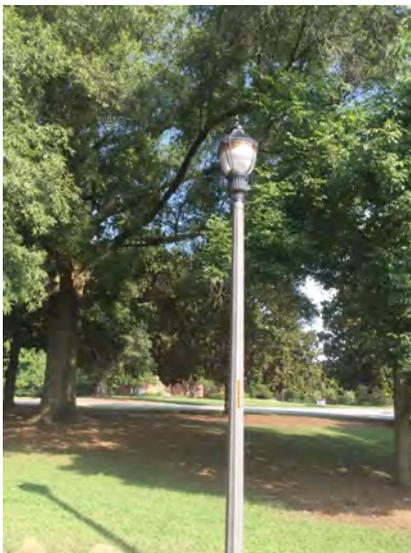
Decorative Exterior Lighting

Lighting on roads and in parking lots is provided by a combination of sources. Parking lot lighting is installed as decorative pole mounted “lanterns” with HID lighting sources. Lighting on the roadways into the site consists of newer LED “cobra” head style fixtures on wooden poles. They appear to be Duke/Progress leased fixtures.

Staff made note of exterior lighting deficiencies especially on the roadways.

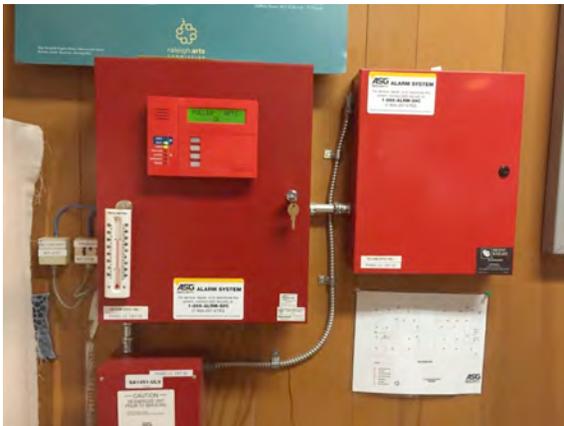
Main Fire Control Panel

The building has a relatively new fire alarm and security system. The Fire Control Panel is located in the front office. Detection and notification is provided throughout the building per current fire codes. Both fire alarm and security systems are monitored by ASG.
