## 174-17-CA

709 HINSDALE STREET  
GLENWOOD-BROOKLYN  
HISTORIC DISTRICT (R-10)

Nature of Project:  
Construct 2nd story rear addition;  
replace roofing; restore/replace  
exterior materials in kind; replace  
front door; restore chimney;  
replace mailbox and light fixture  
and install ceiling fan on front porch;  
install driveway; remove and replace  
shrubby

APPLICATION FOR A CERTIFICATE OF APPROPRIATENESS – STAFF REPORT

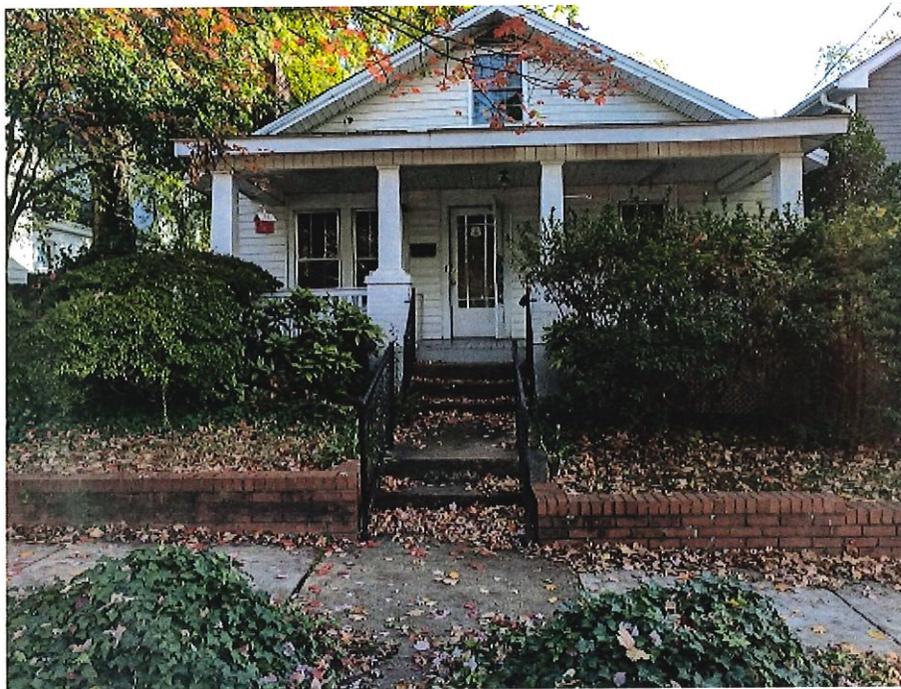
**PHOTO #1**

1. Remove overgrown shrubbery/plantings/ivy from the property, and replace with indigenous shrubbery and plants (i.e., similar or identical species) of appropriate scale and in same location as overgrown areas. **(PHOTO #1)**

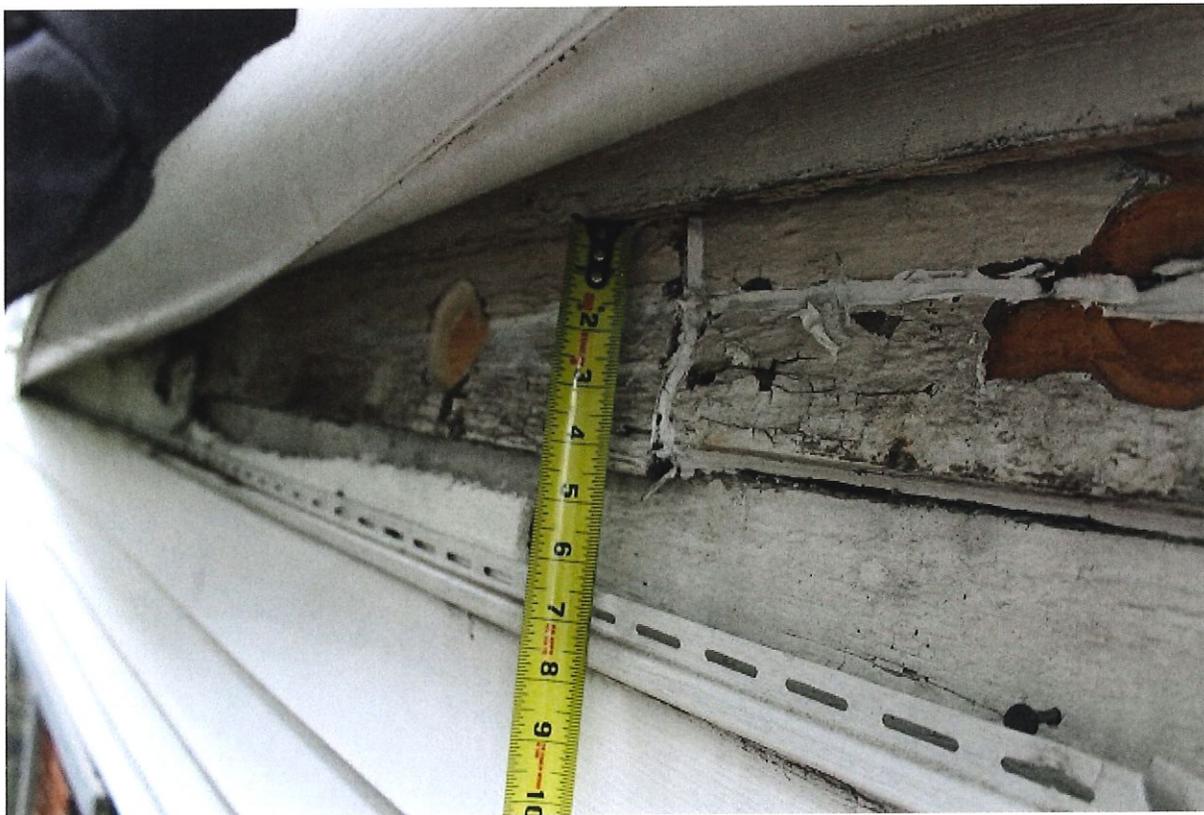
**PHOTO #2**

2. Renovate front of existing house exterior (as viewed from Hinsdale Street).
  - a. Remove the vinyl cladding and aluminum exterior trim (already submitted in a minor COA application). If more than every 4<sup>th</sup> row, or over 30%, of the existing wood siding and corner boards (underneath the existing vinyl cladding) are determined to be ruined and unusable, then all of the existing wood siding will be removed and replaced with new 4" Artisan James Hardie lap siding (**see Exhibits 1 and 2**) similar as was previously approved by the RHDC COA Committee for 1008 W. South Street in the Boylan Heights Historic District. The referenced photographs are representative of the existing wood siding under the vinyl siding where holes had been drilled in each stud bay at multiple height intervals to blow insulation into the walls from the exterior. It appears as though little or no care was taken when the insulation blowing was done; therefore, in effect decimating a great deal of the existing wood siding. **(PHOTOS #2, #3, and #4 showing considerable damage to the existing wood siding)**

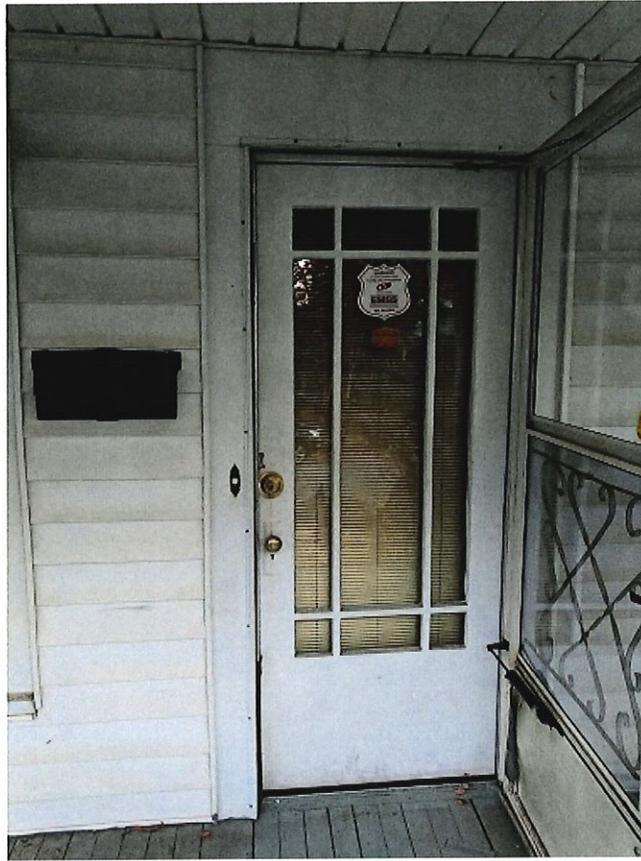
**PHOTO #5**

- c. Remove the existing front door which was manufactured circa 1950 and replace with a new craftsman style door representing a style from within the period of significance (i.e., 1907 to 1940). Final design to be selected from a style similar to those provided in **Figure 1**. The existing door is not the original and was altered to fit in the original opening as evident by: both sides are trimmed leaving no bevel on the edge; one side is trimmed smaller than the other and uneven creating an uneven reveal; and the jamb was altered to accommodate the screen door **(PHOTOS #5, #6, #7, and #8)**

- e. Replace metal wall mount mailbox with larger metal wall mount mailbox to be selected from a similar design as provided in **Figure 5. (PHOTO #5)**

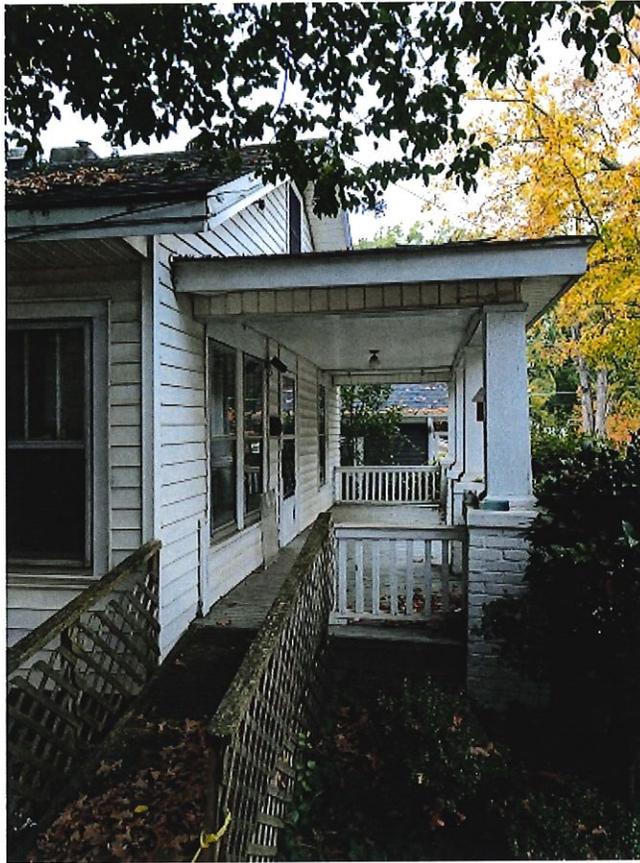
**PHOTO #9**

- d. Where possible, the existing front porch will not change. **(PHOTO #9)**
    - i. Floor boards that are determined to be unusable will be removed and replaced with new 5/4" x 4" tongue and groove pressure treated wood pieces.

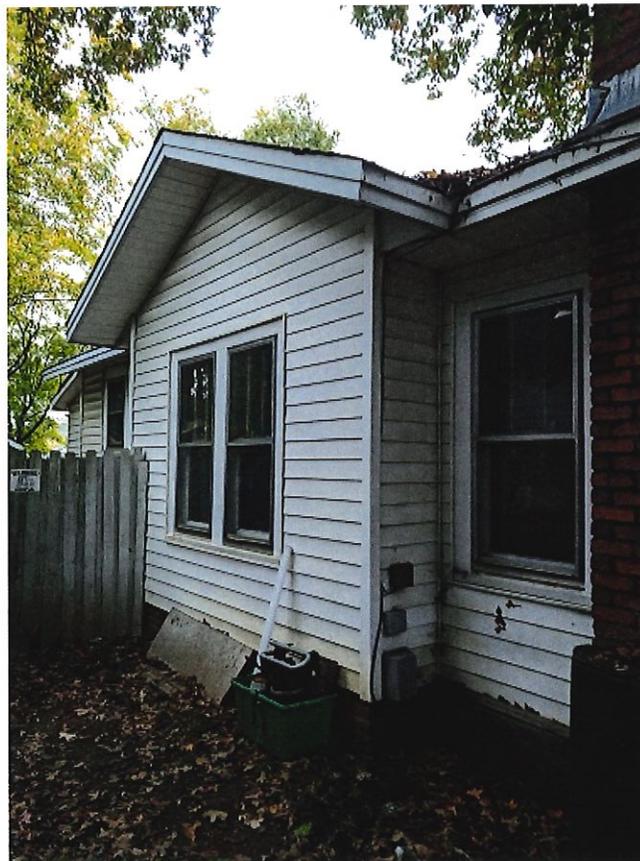
**PHOTO #10**

3. Renovate left side of existing house exterior (as viewed from Hinsdale Street).
  - a. The siding, soffit, and fascia materials proposed for the front of the house will remain consistent with the materials used for the left side of the house. **(PHOTO #10)**

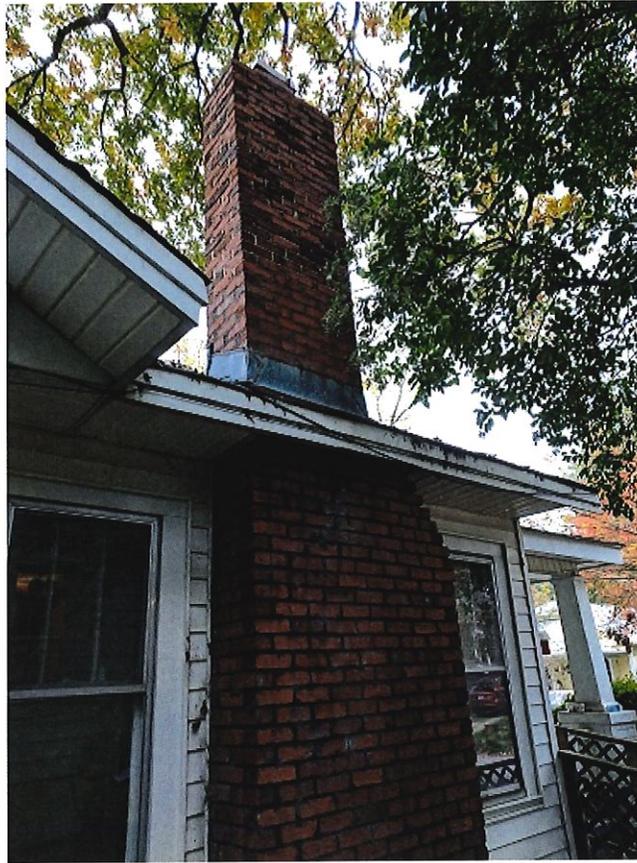
**PHOTO #11**

- b. The chimney bricks above the roof line will be removed and re-laid since they are starting to lean toward the roof of the house. If any new bricks are required Custom Brick will help match the existing as closely as possible with current suppliers. A “cricket” of similar design shown in **Figures 6 and 7** will also be added on the roof side of the house to help disperse the water around the chimney and should have little to no visible impact from the street. **(PHOTOS #11 and #12)**

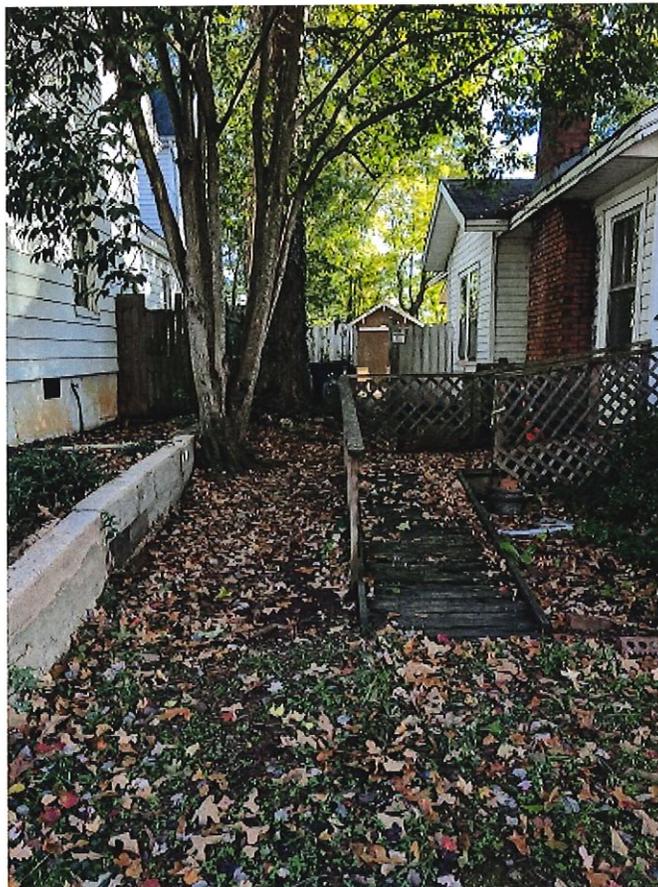
**PHOTO #12**

- c. Remove the existing wooden handicap ramp (already submitted in a minor COA application). Restore driveway with gravel and/or lattice pavers using existing curb cut. **(PHOTO #12)**

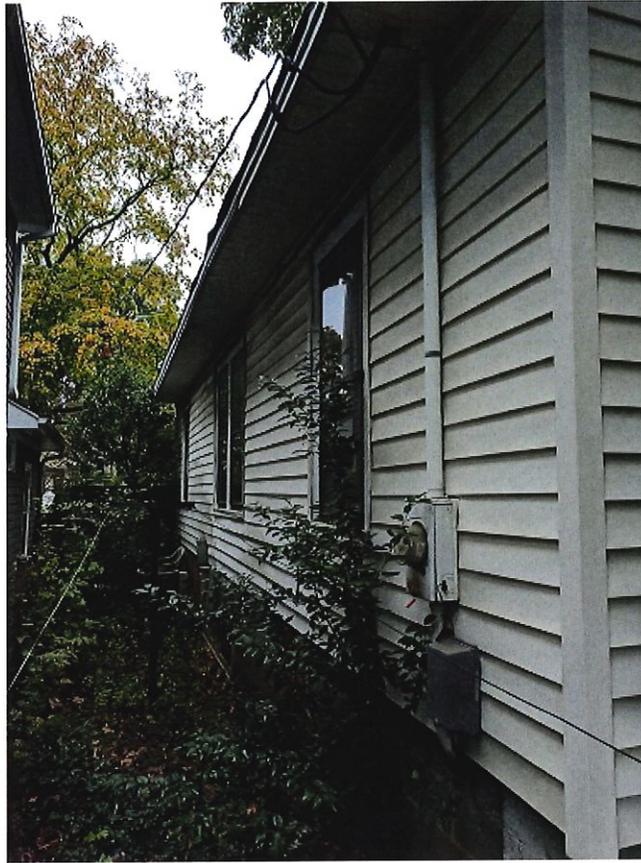
**PHOTO #13, taken from rear**

4. Renovate right side of existing house exterior (as viewed from Hinsdale Street). The siding, soffit, and fascia materials proposed for the front of the house will remain consistent with the materials used for the right side of the house. **(PHOTO #13)**

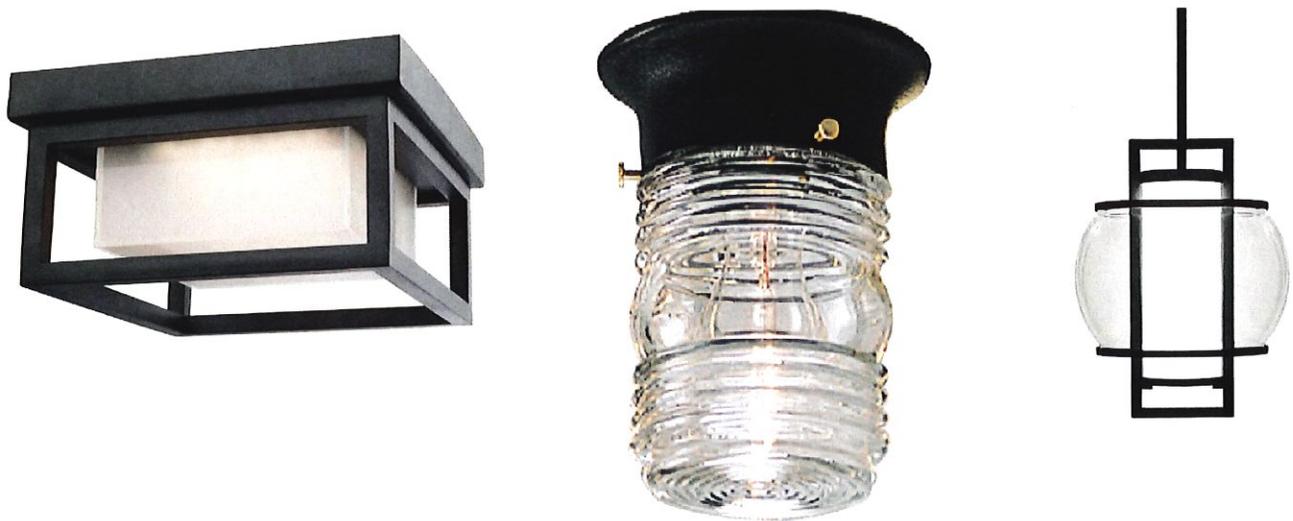
- iii. The porch railings will remain in place, but will be repainted.
    - iv. The porch ceiling appears to be in good shape, but we would like to replace the ceiling light fixture with one or two similar minimal light fixtures as provided in **Figure 2** and move location to center it with the front door; or if two light fixtures, then centered equally above porch dimension.

- 3\* The applicants propose removing the porch ceiling light fixture and replacing it with either one or two fixtures, and have provided three options of replacement fixtures, but have not specified which is their preferred selection.

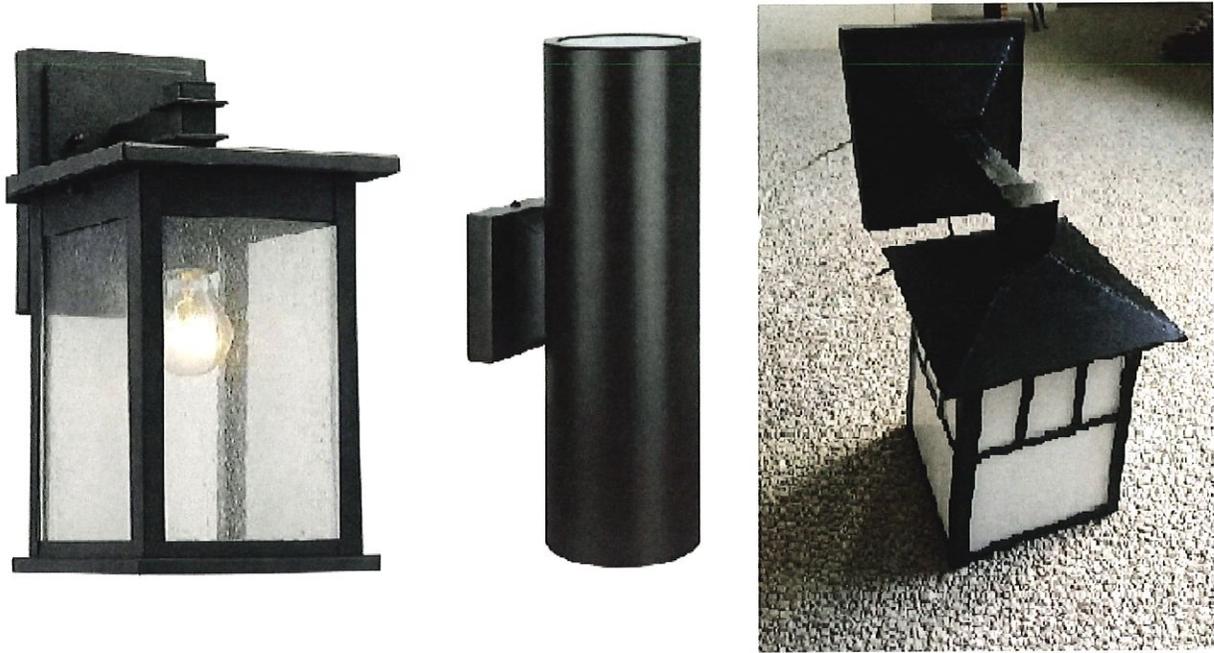
**Figure 3**

- v. Install porch sconce on left side of door to be selected from a similar design as provided in **Figure 3**.
    - vi. Install one or two ceiling fans on front porch ceiling to be selected from a similar design as provided in **Figure 4**.

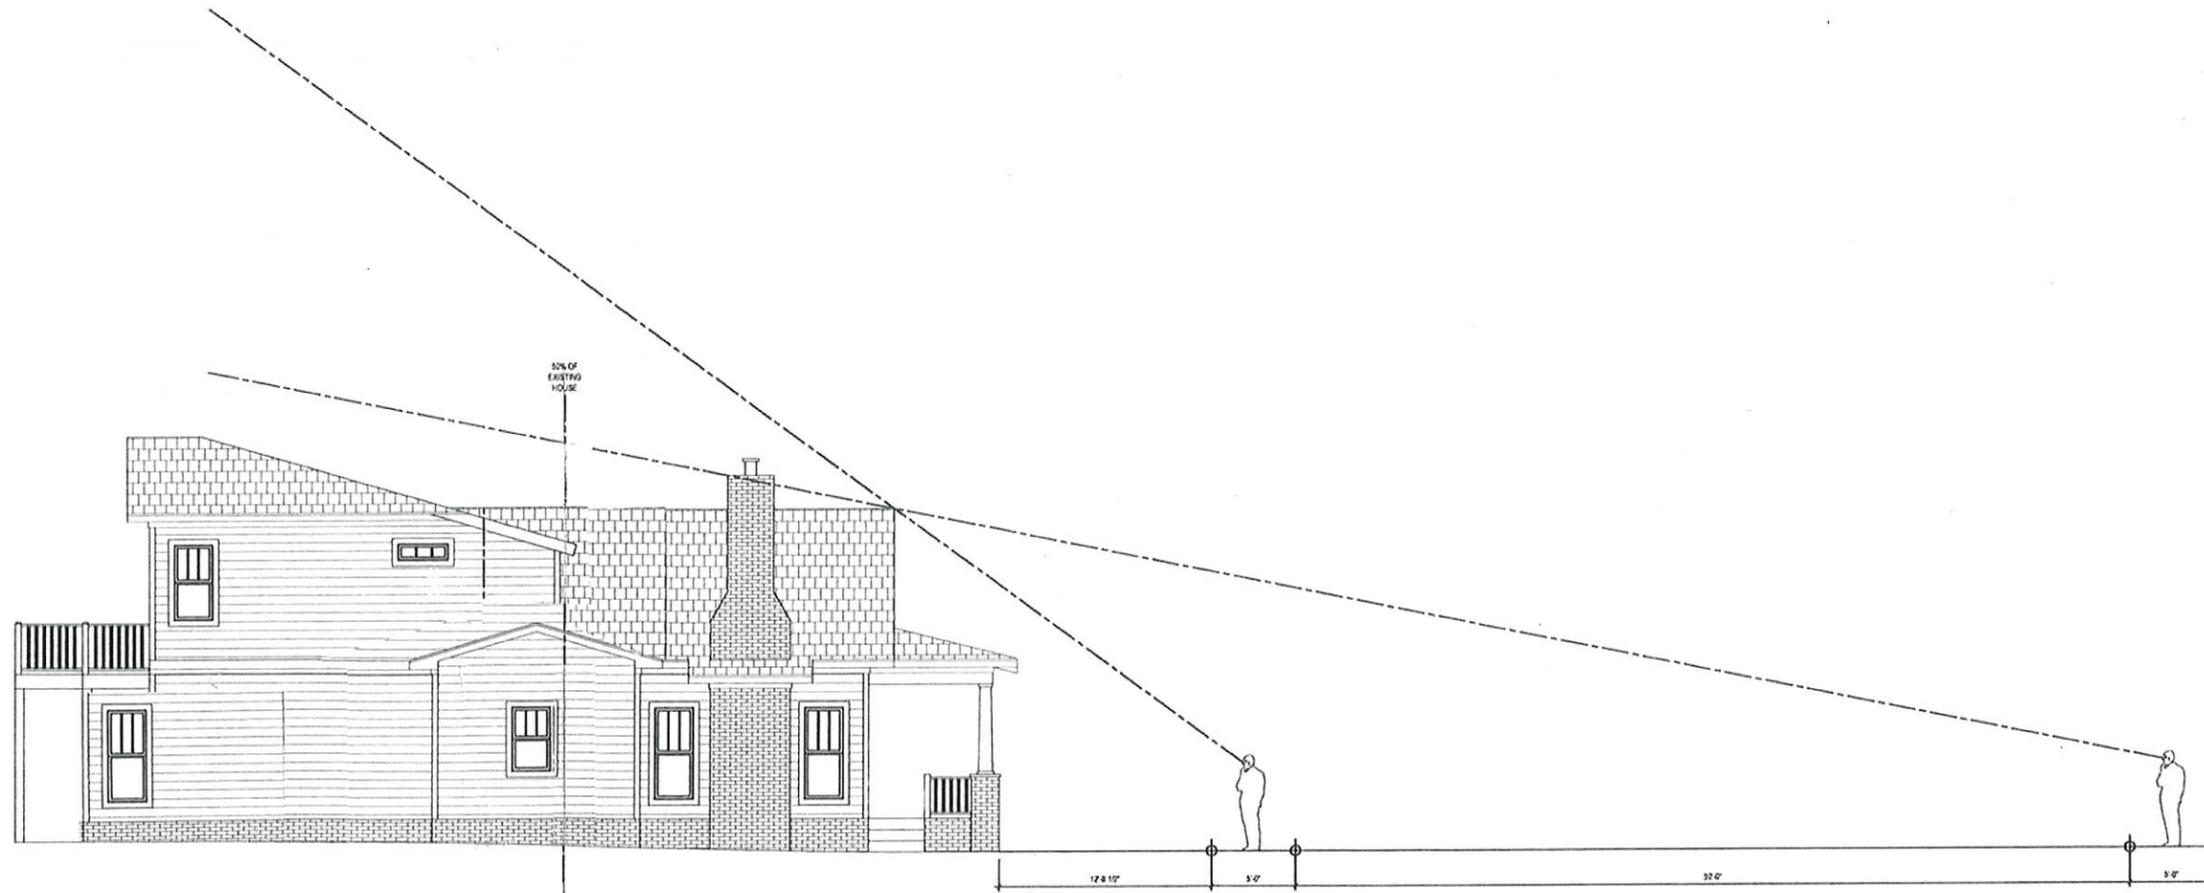
PROPOSED LEFT ELEVATION  
 1/4" = 1'-0"

LINE OF SIGHT CROSS SECTION

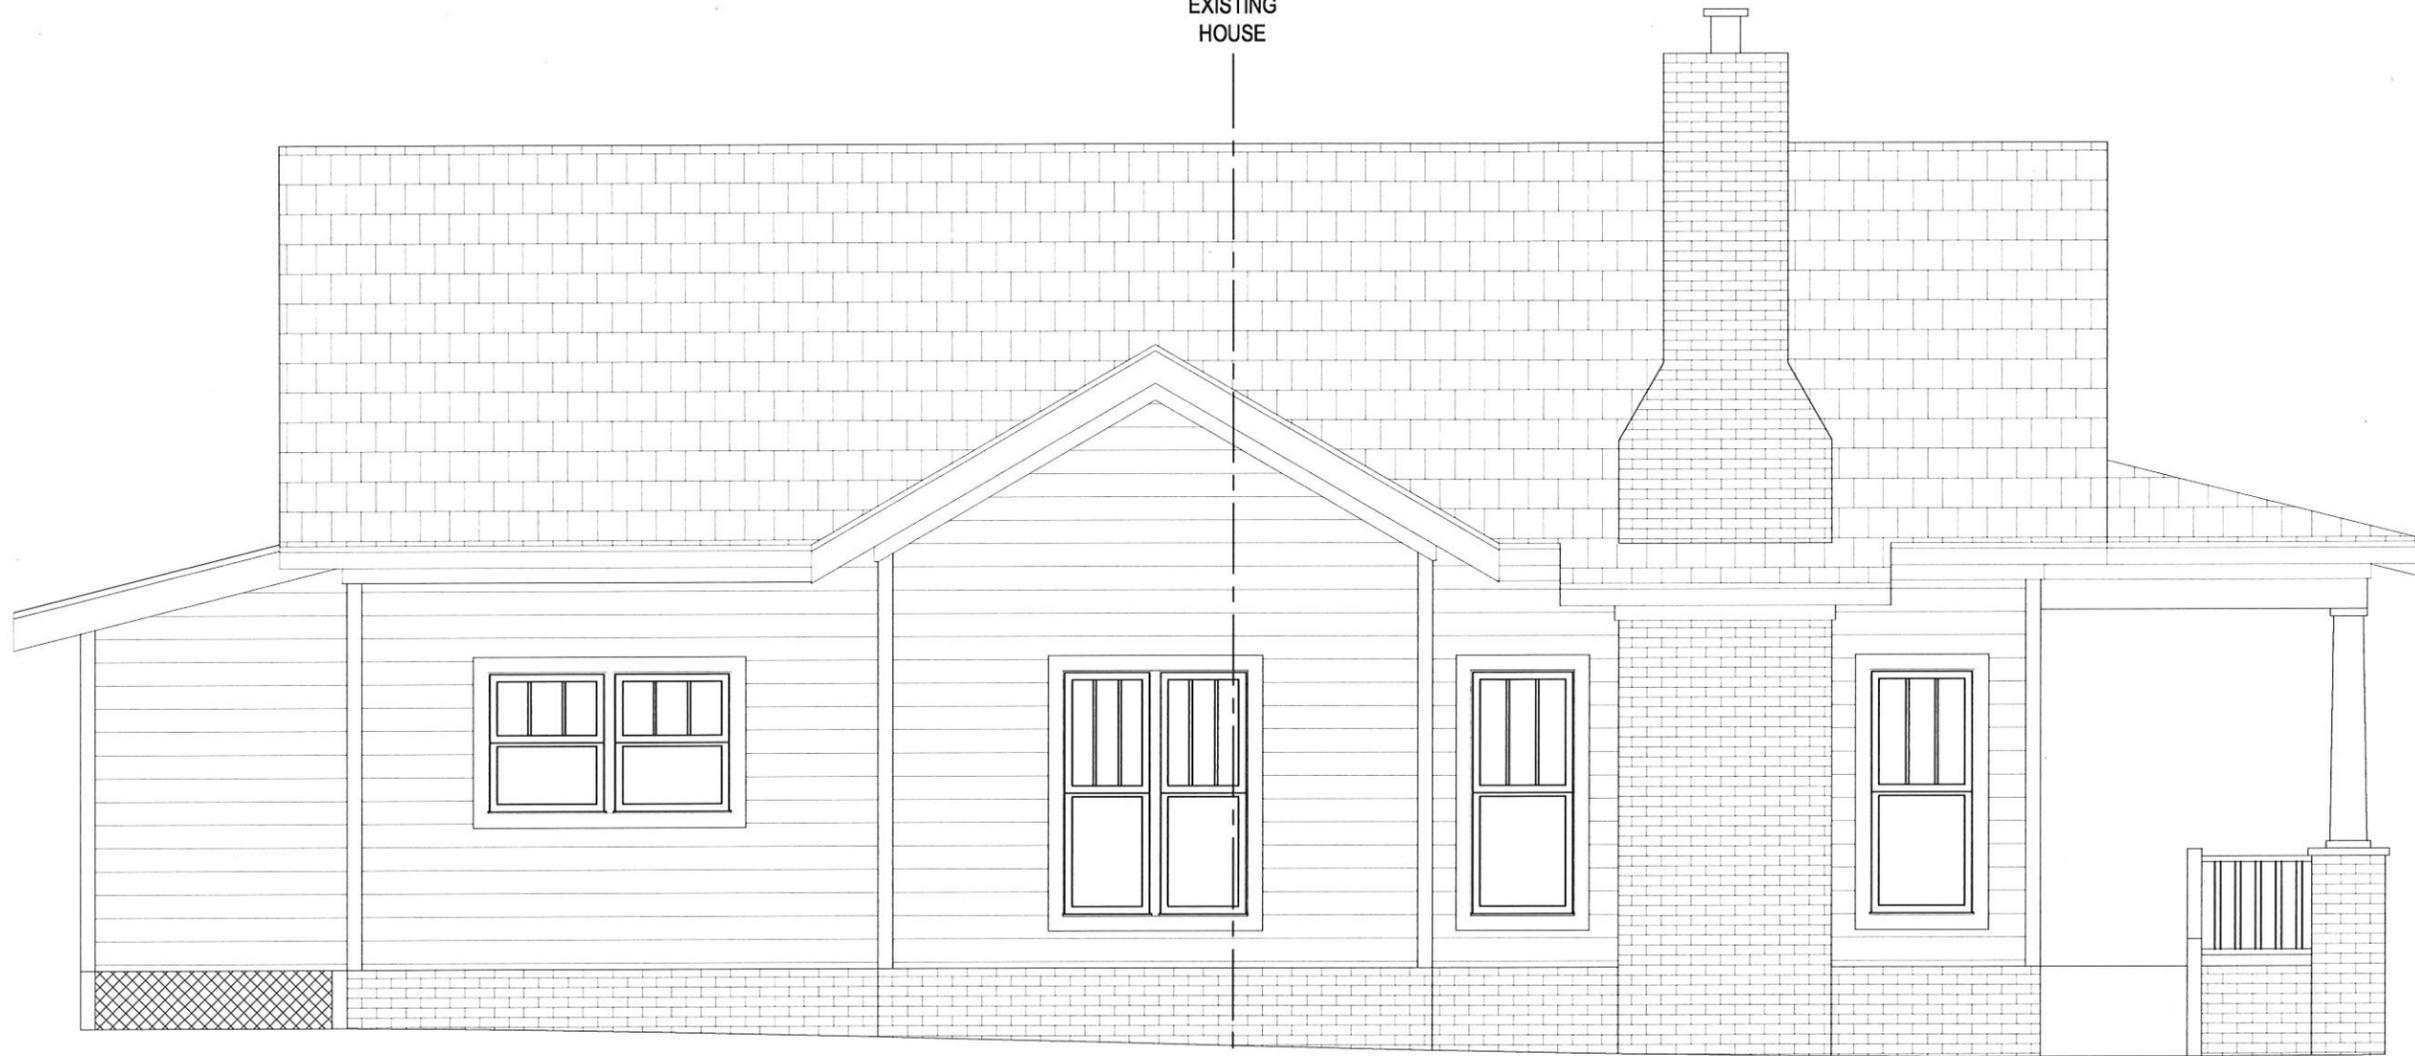
# EXISTING LEFT ELEVATION

50% OF  
EXISTING  
HOUSE

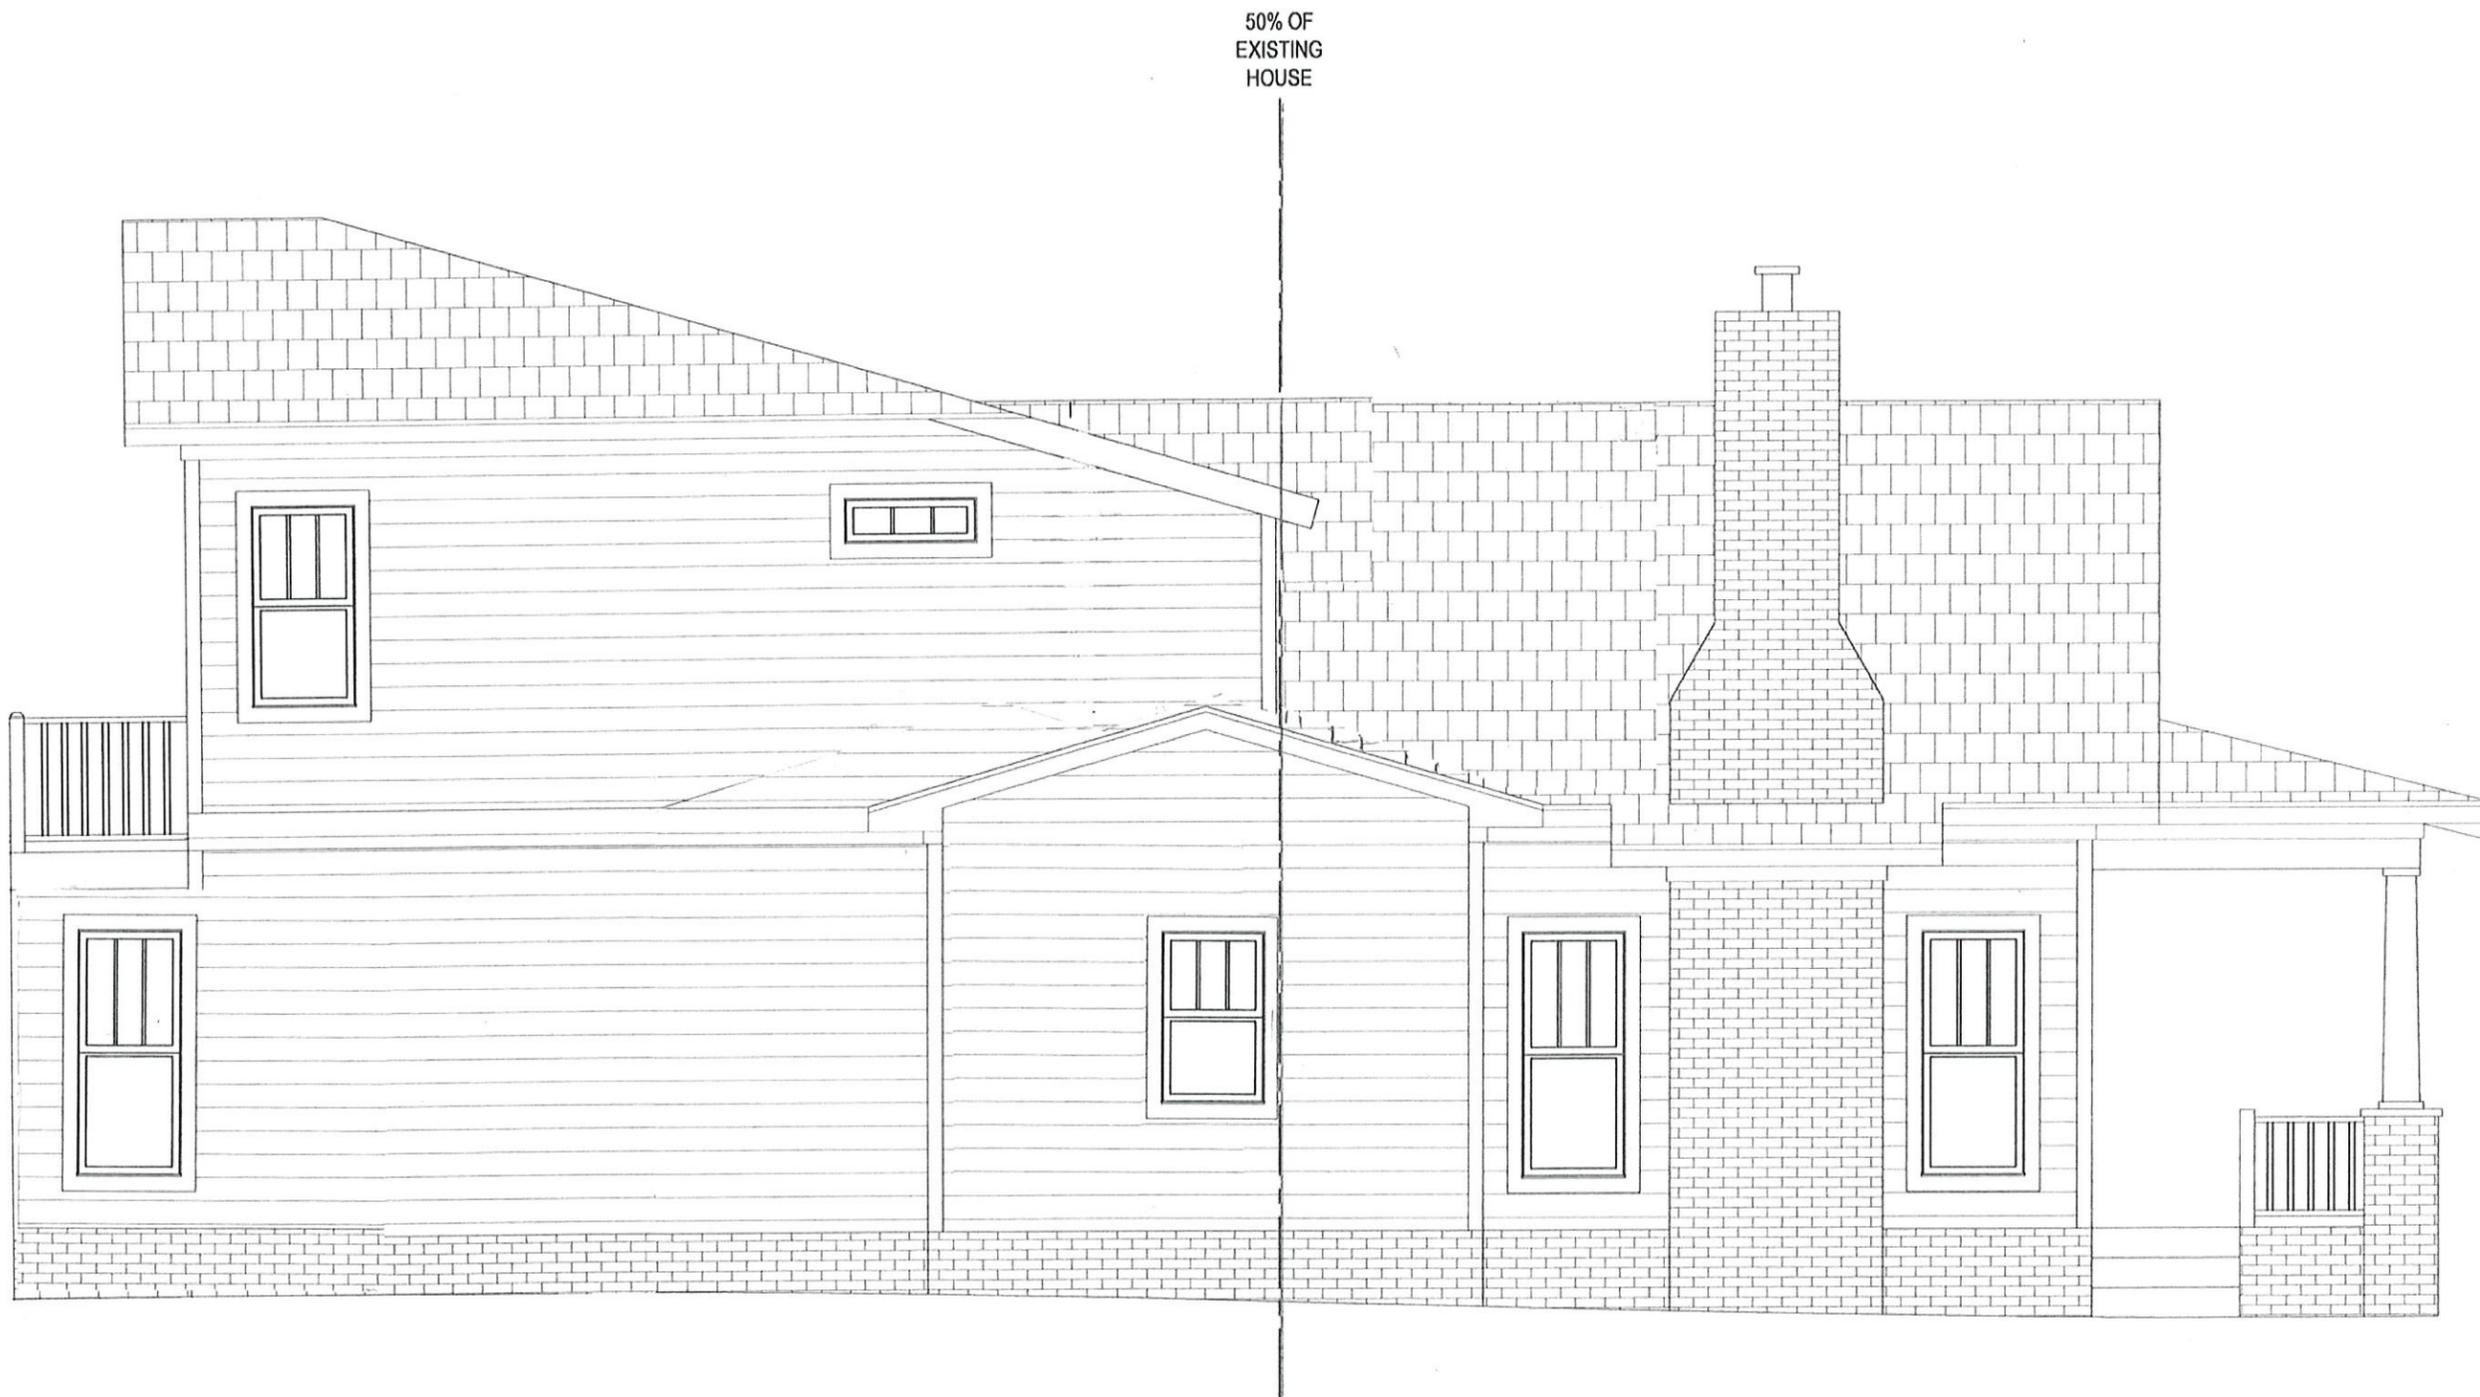
# PROPOSED LEFT ELEVATION

50% OF  
EXISTING  
HOUSE

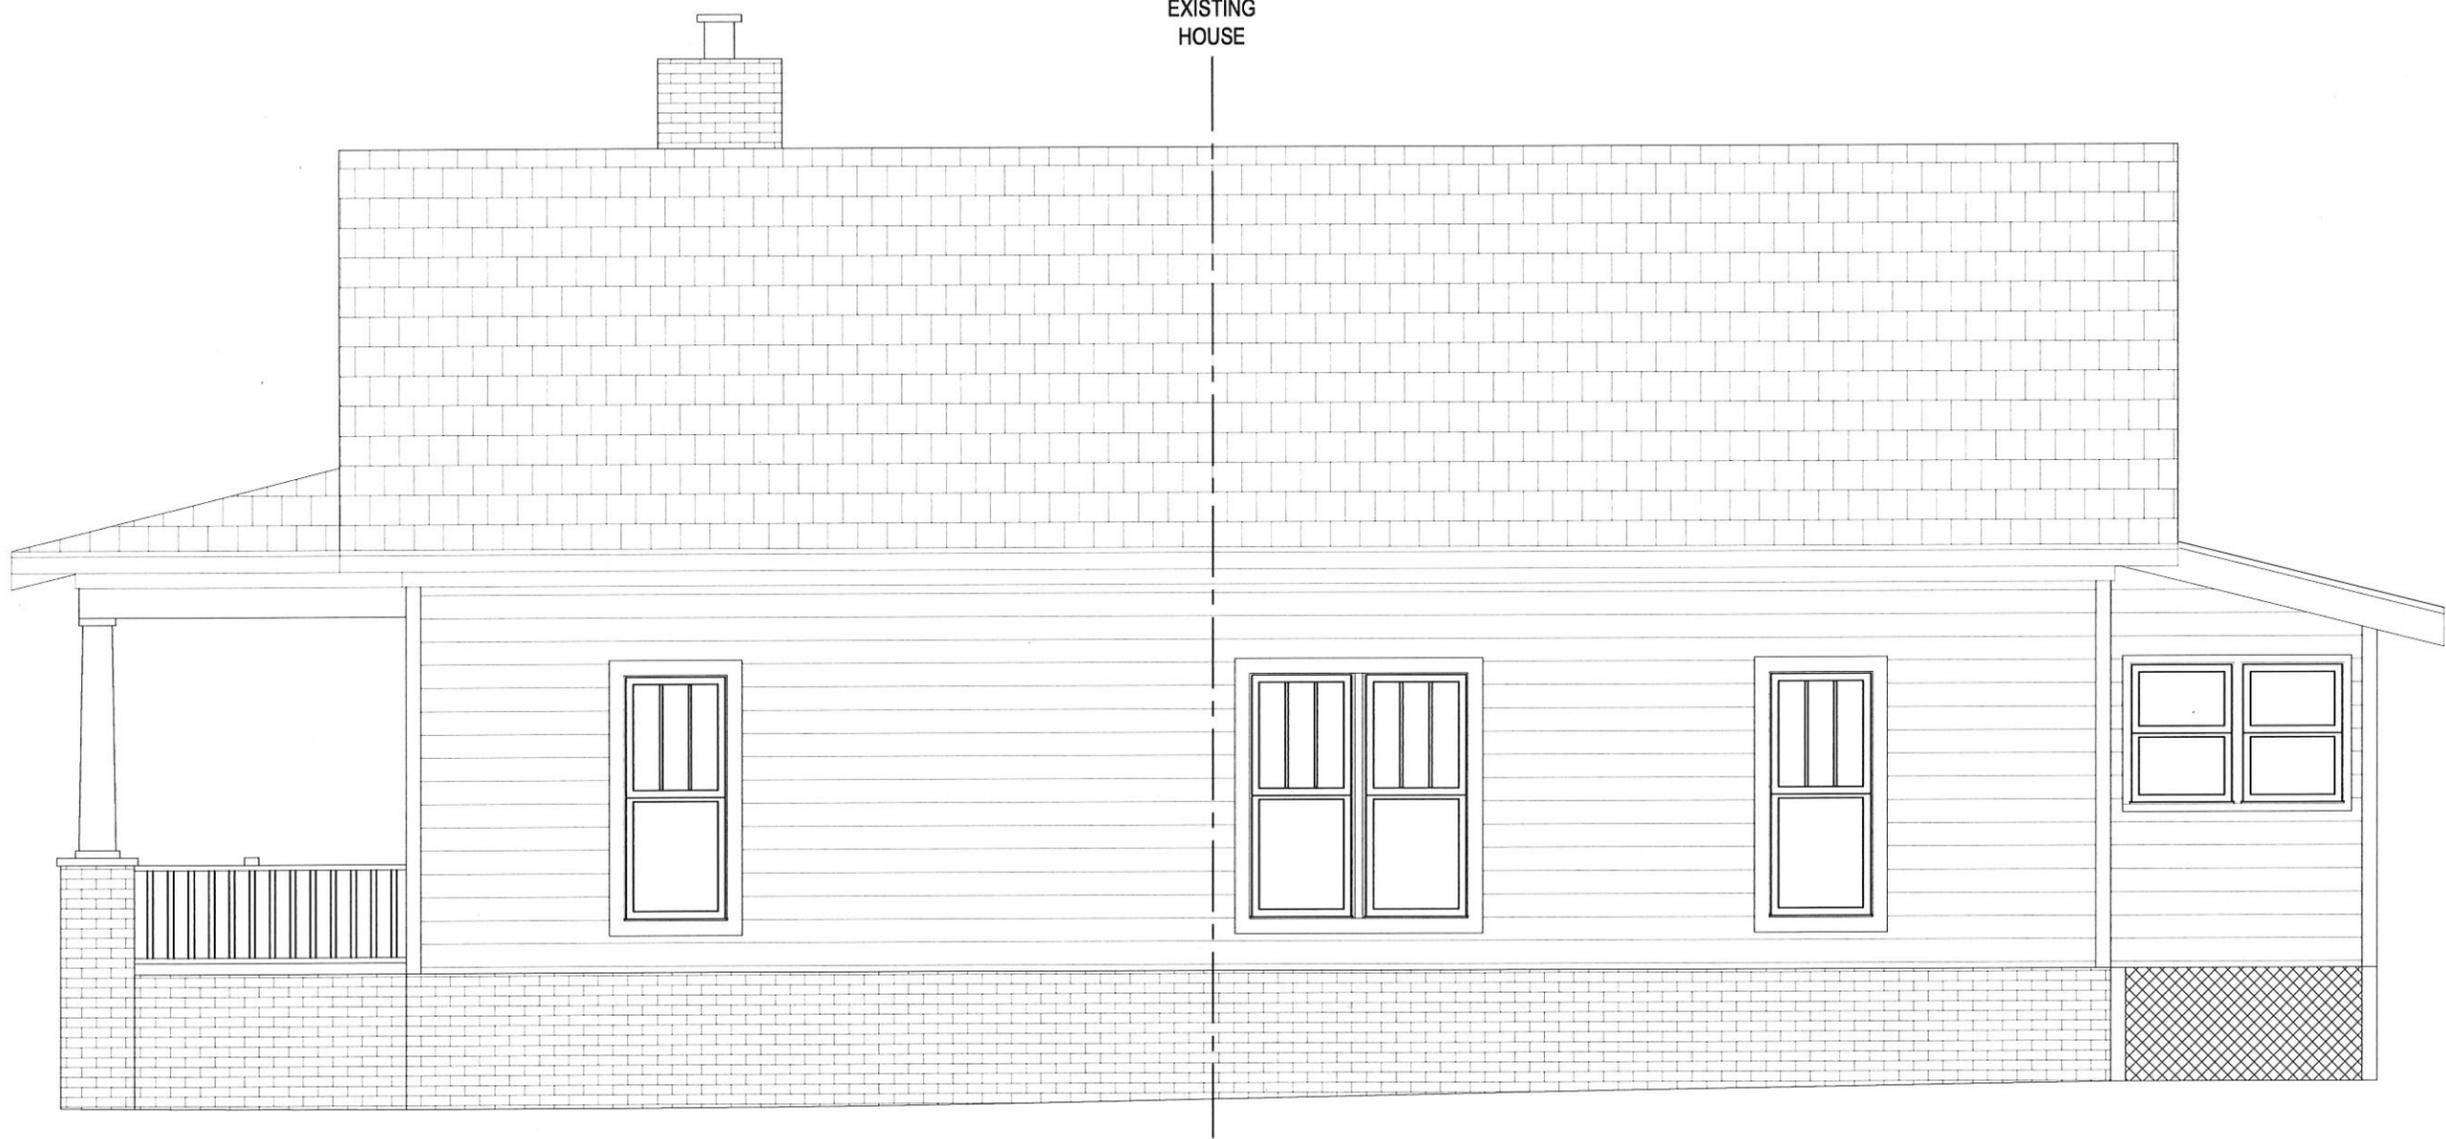
# EXISTING RIGHT ELEVATION

50% OF  
EXISTING  
HOUSE

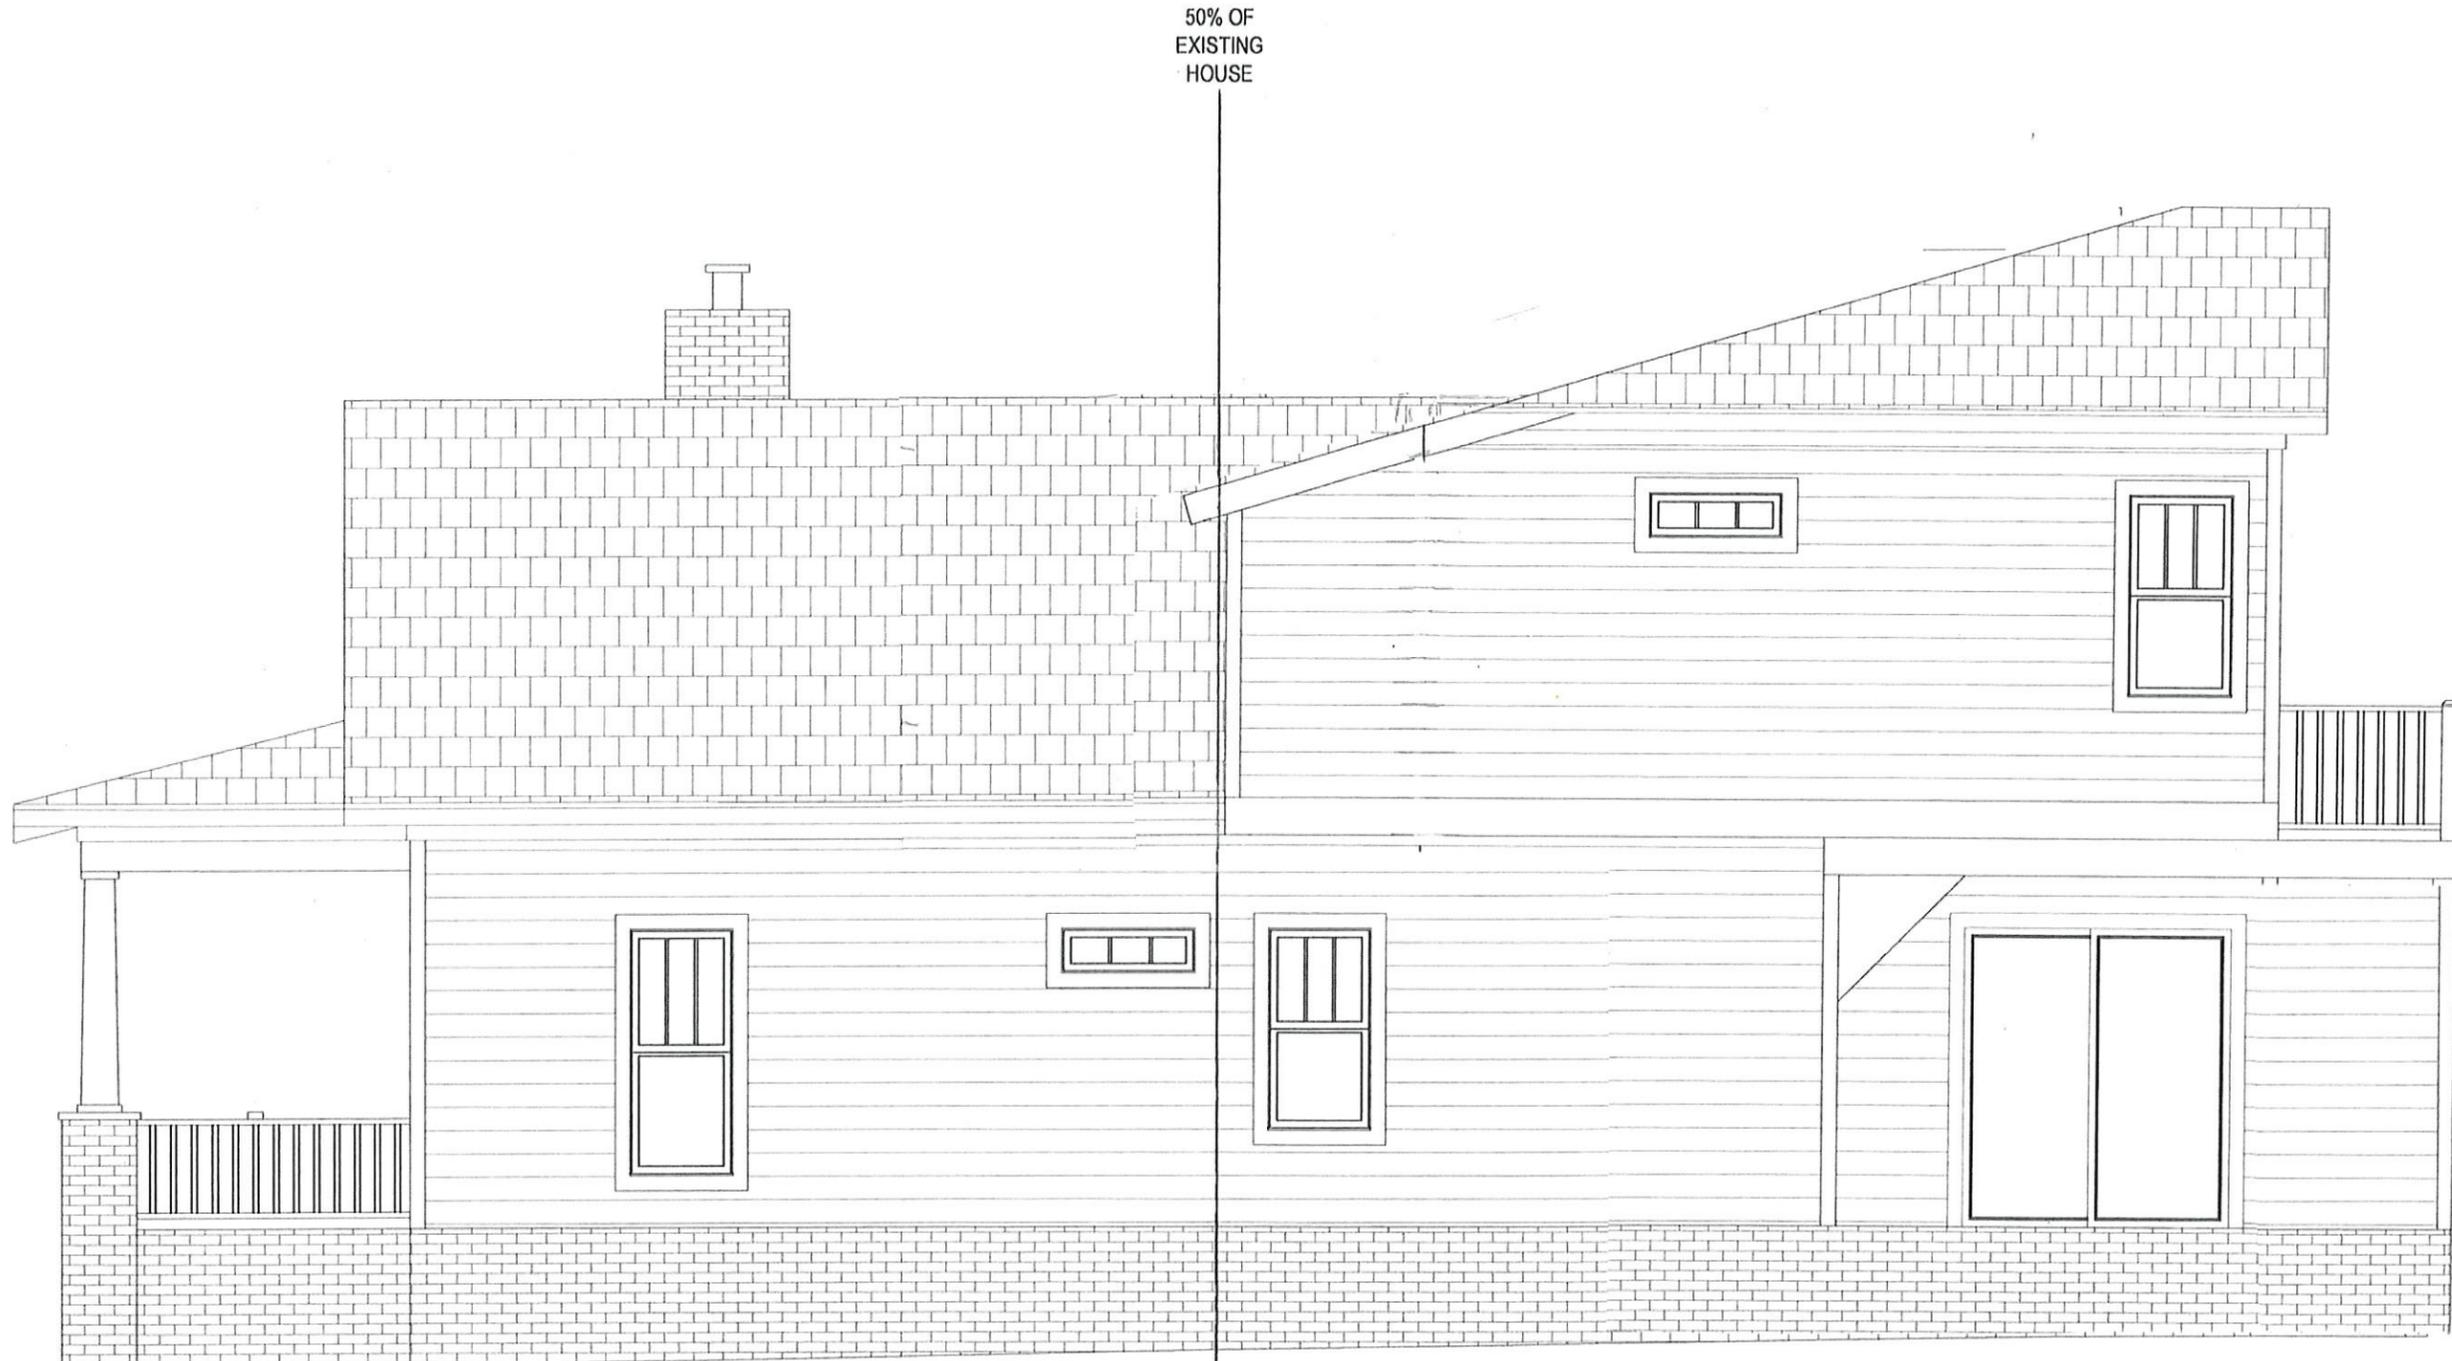
**PROPOSED RIGHT ELEVATION**

50% OF  
EXISTING  
HOUSE
