## 174-17-CA

709 HINSDALE STREET  
GLENWOOD-BROOKLYN  
HISTORIC DISTRICT (R-10)

Nature of Project:  
Construct 2nd story rear addition;  
replace roofing; restore/replace  
exterior materials in kind; replace  
front door; restore chimney;  
replace mailbox and light fixture  
and install ceiling fan on front porch;  
install driveway; remove and replace  
shrubby

APPLICATION FOR A CERTIFICATE OF APPROPRIATENESS – STAFF REPORT

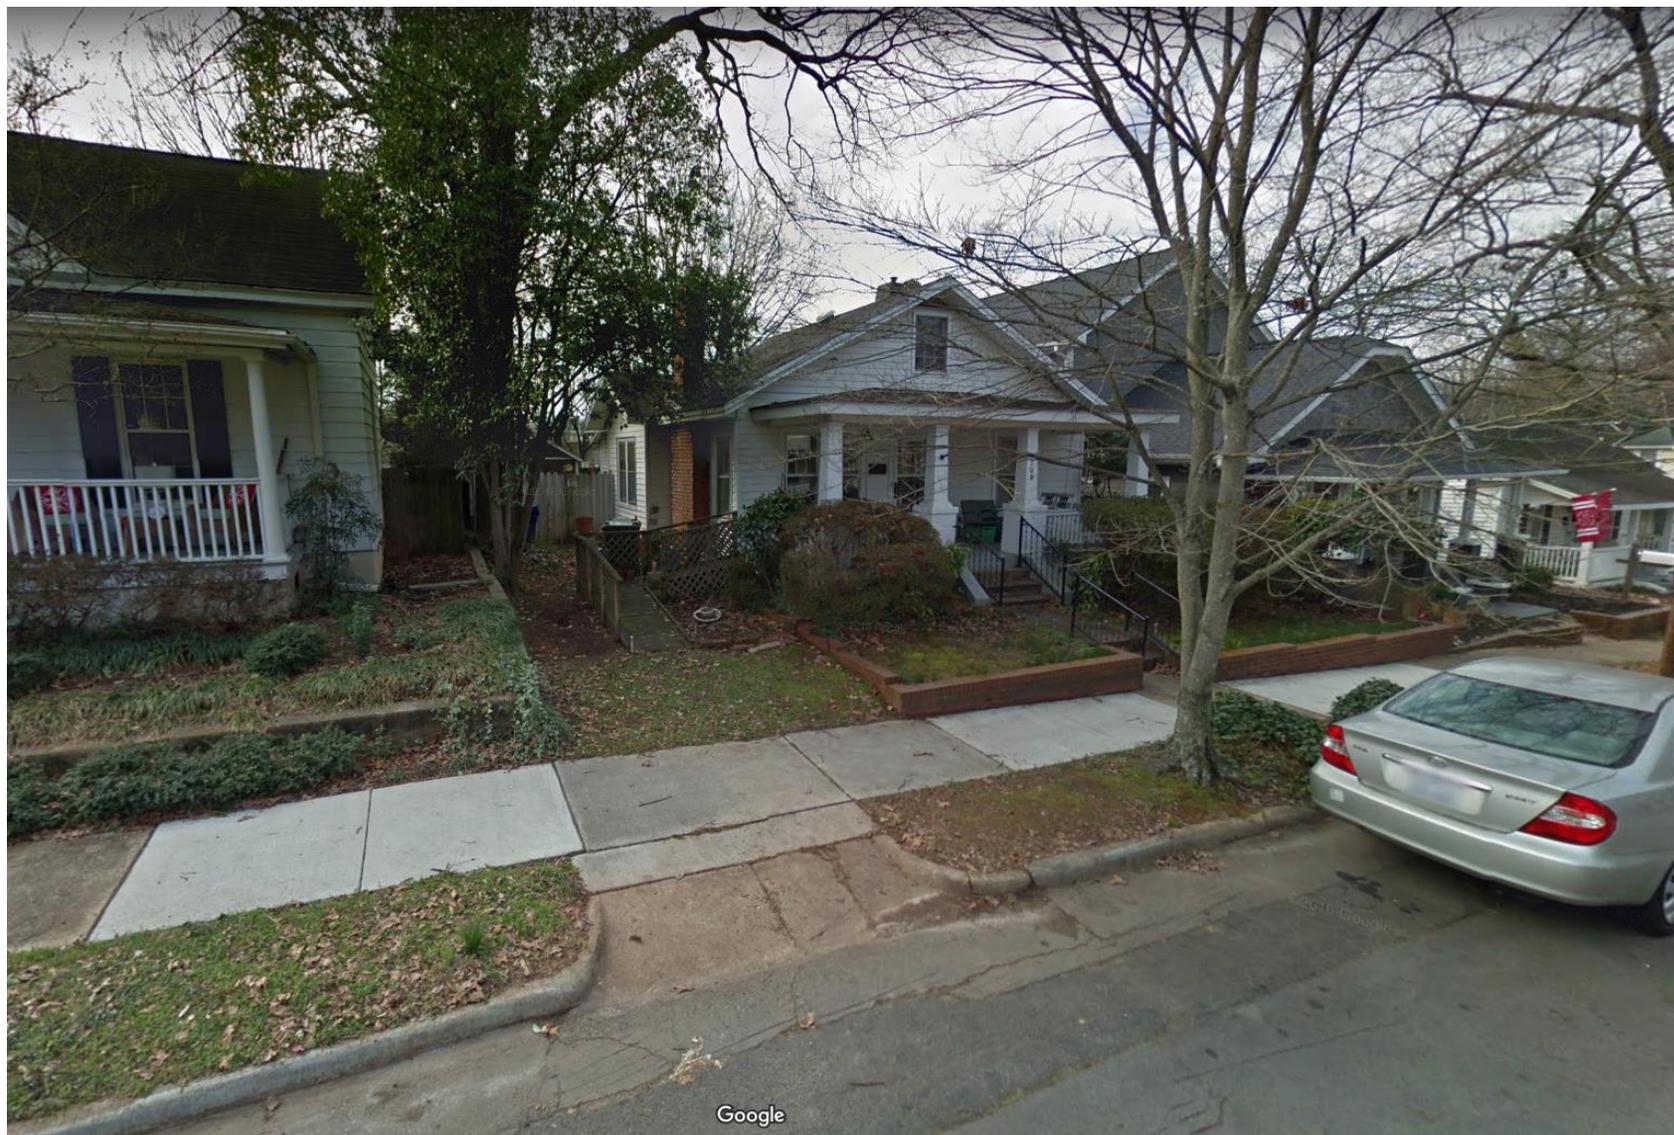
Staff Evidence: 709 Hinsdale Street (174-17-CA), February 2016

rear wall →

← Front wall

← 1<sup>st</sup> 50% of house →

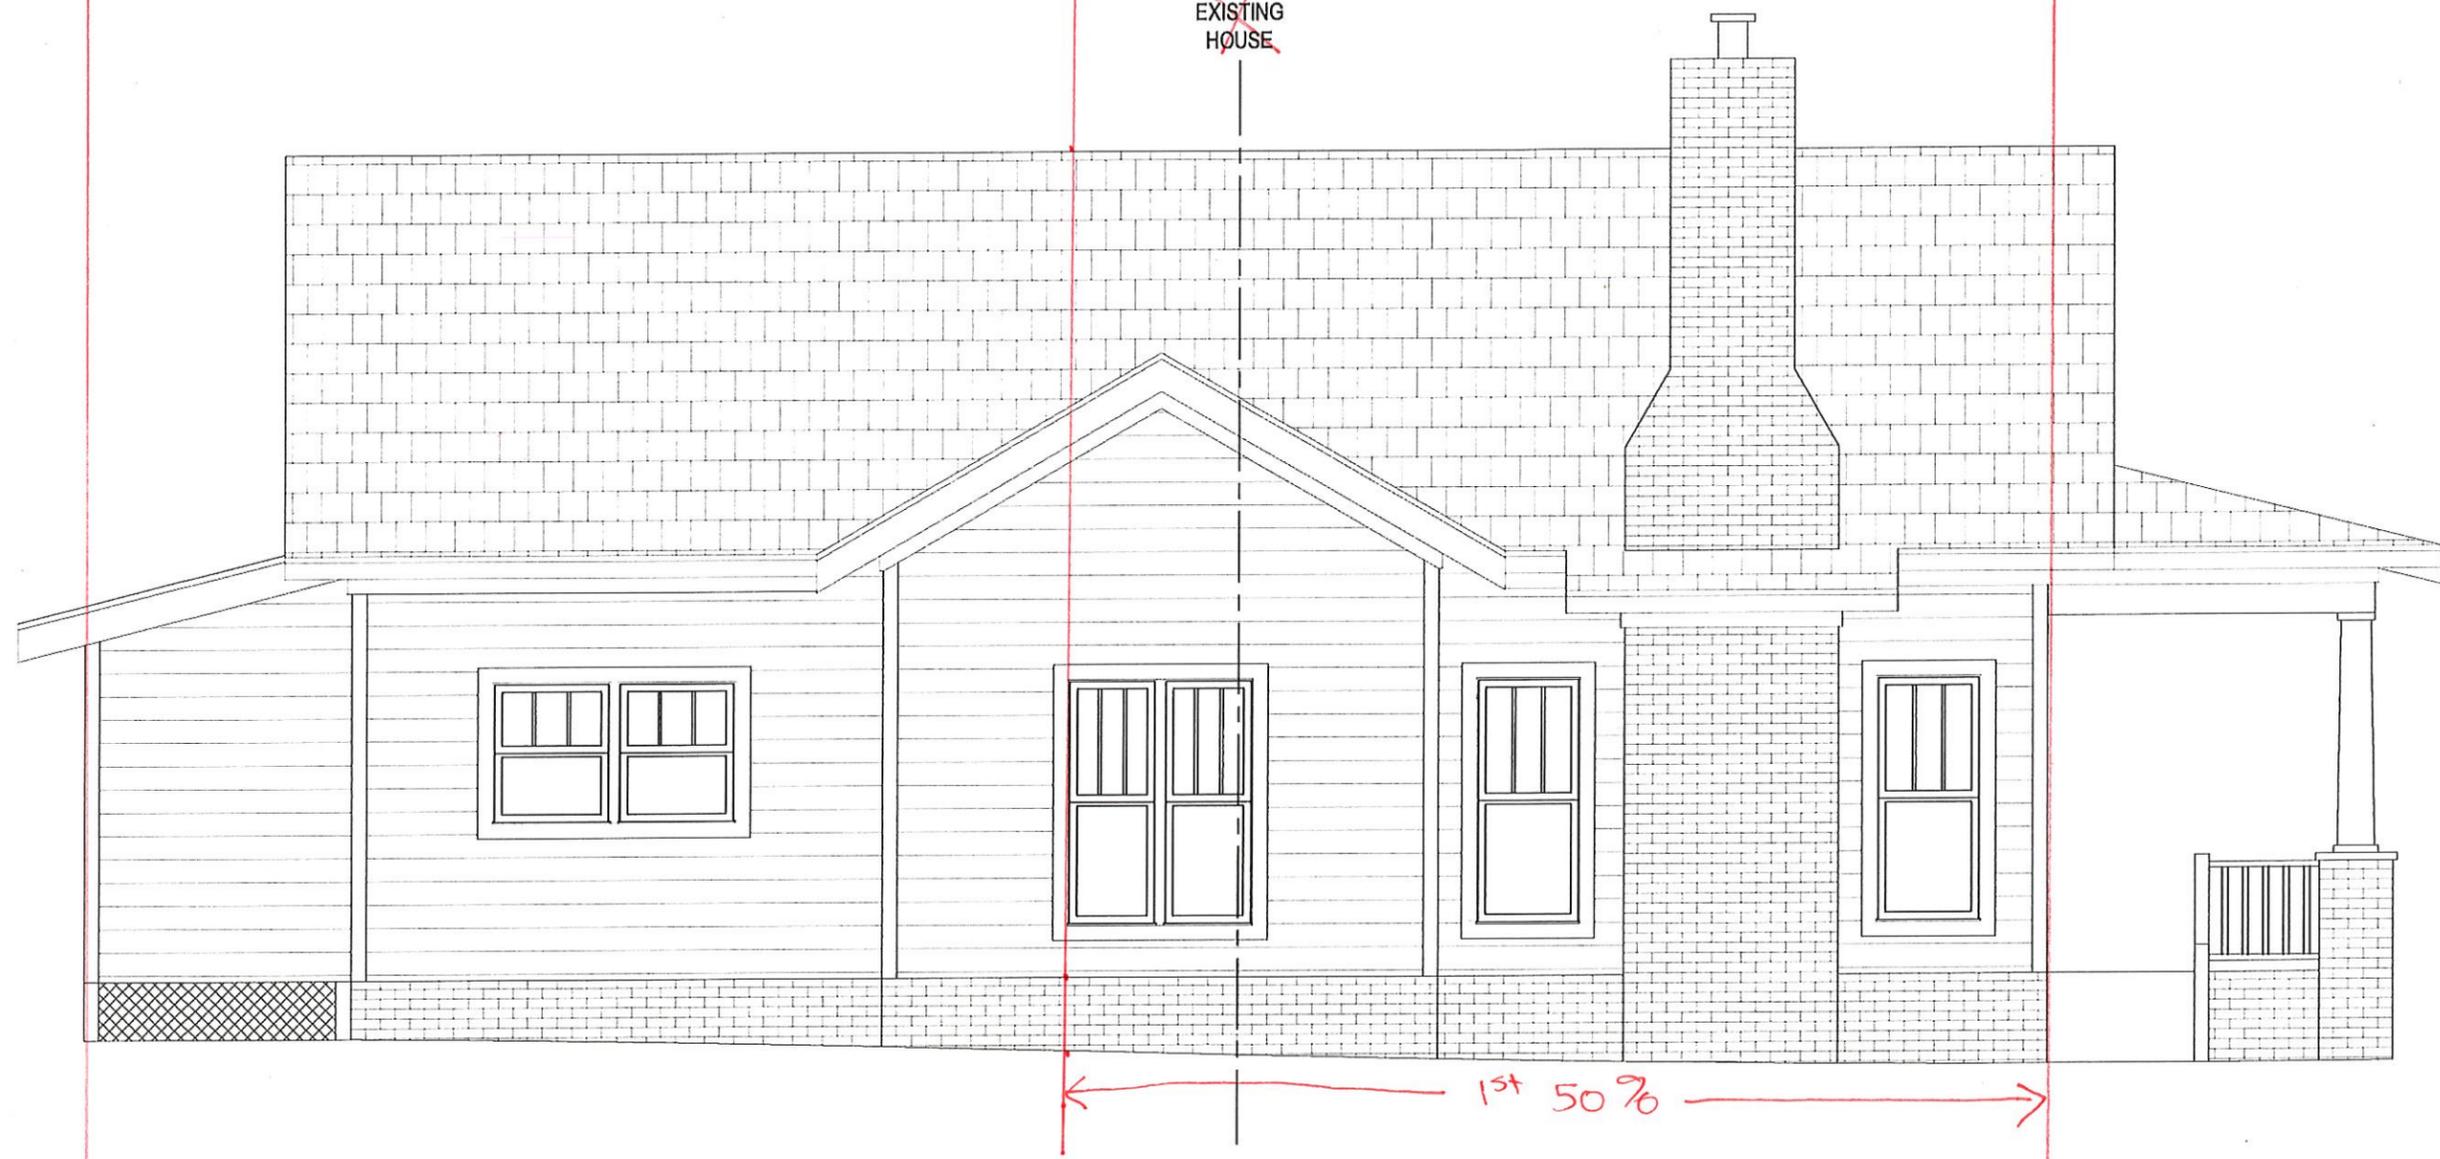
**EXISTING LEFT ELEVATION**

50% OF EXISTING HOUSE
